LOT 13 MOON CRESCENT, STRETTON RESERVE

## **Pre-Purchase Standard Property Report**

Report number:	APCI01566
Inspection Date:	08 Mar 2024
Property Address	LOT 13 MOON CRESCENT, STRETTON RESERVE
Special conditions or instructions	
Special conditions or instructions	There are no special conditions or instructions.
The parties	
Name of Client:	Benjamin McDonough
Client's email:	benjamin.a.mcdonough@gmail.com
Client's telephone number:	0433876670

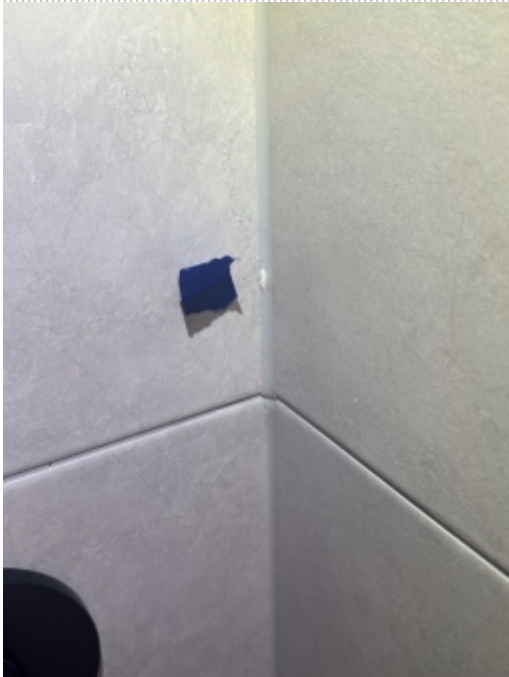
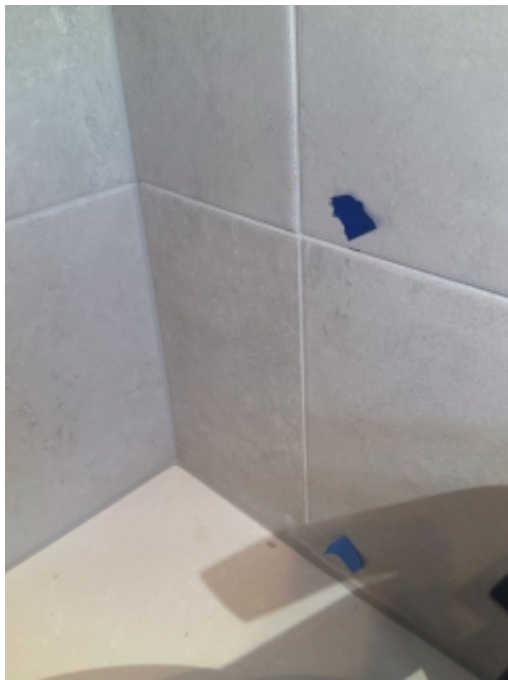
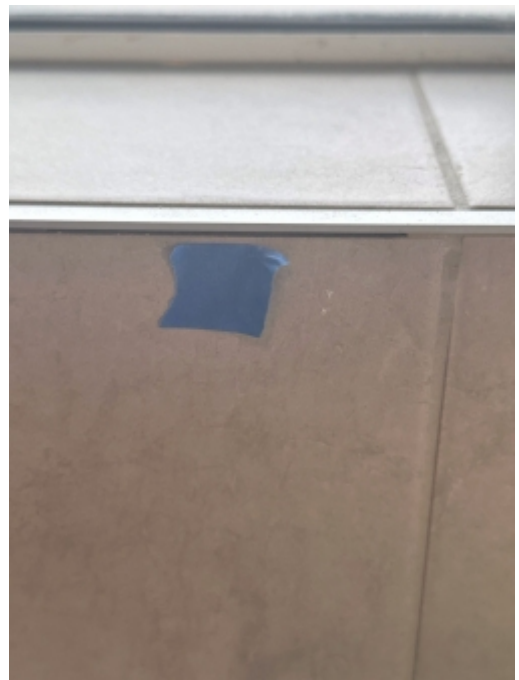
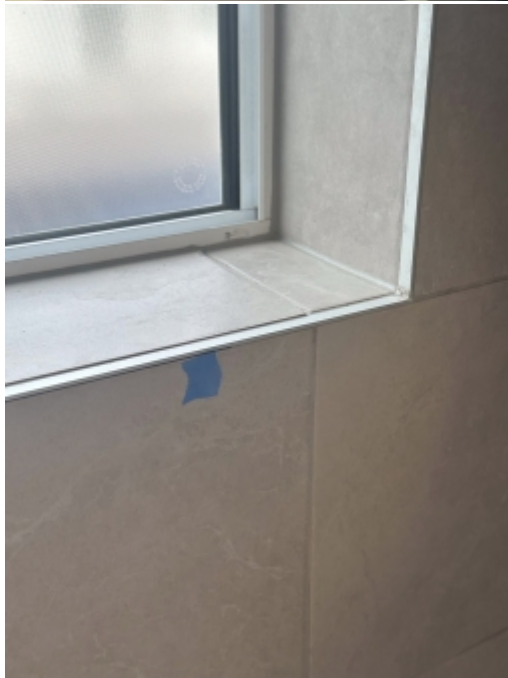
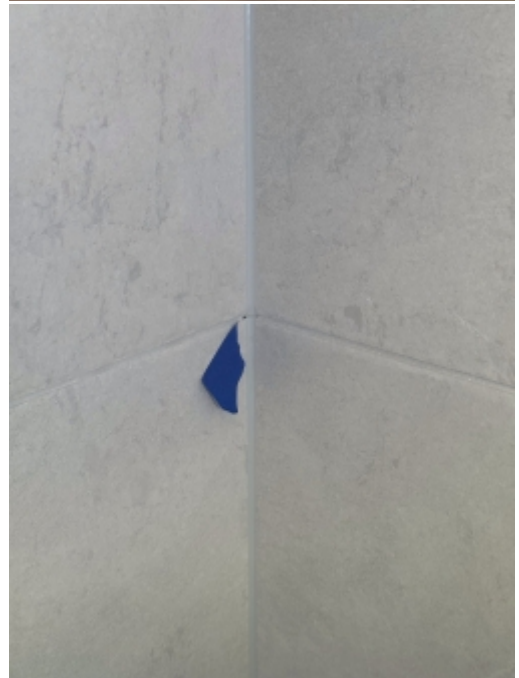
Details of Major Defect	Cracked/loose and missing silicone/grout to parts of wet areas. Recommend engaging a tiler to reseal the areas to reduce the risk of water leaks and damage
Photo(s) of Defect

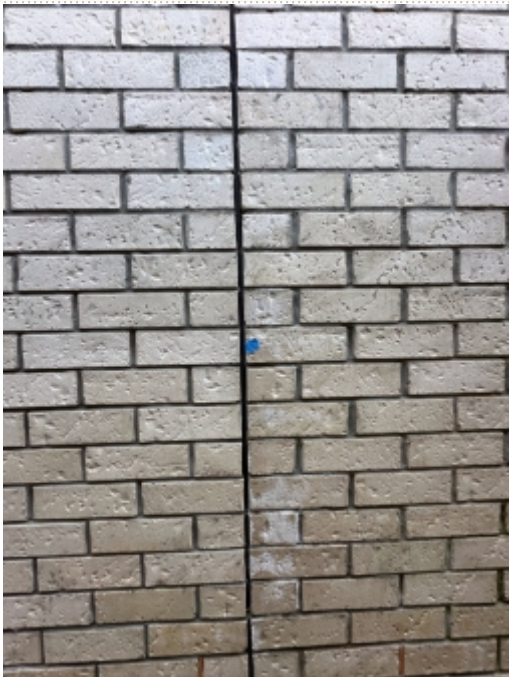
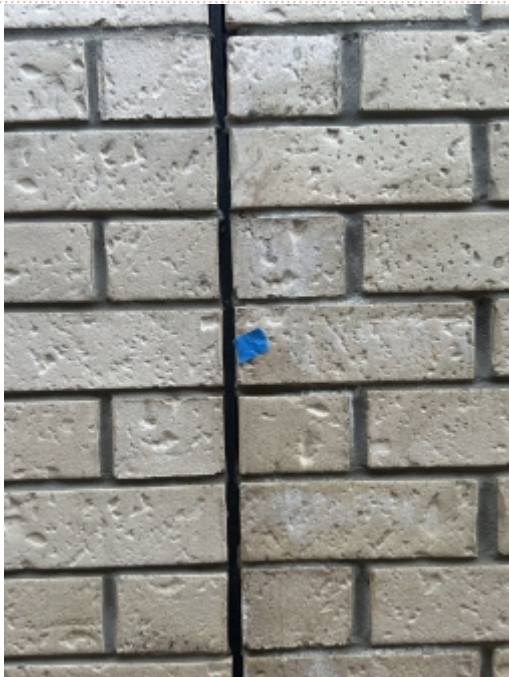
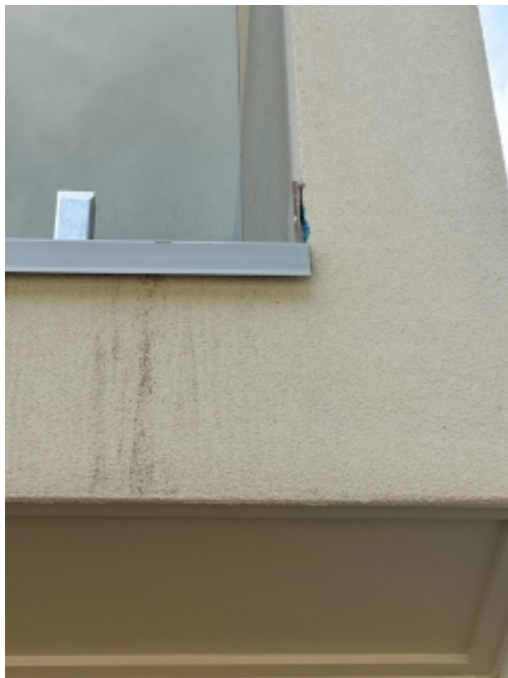
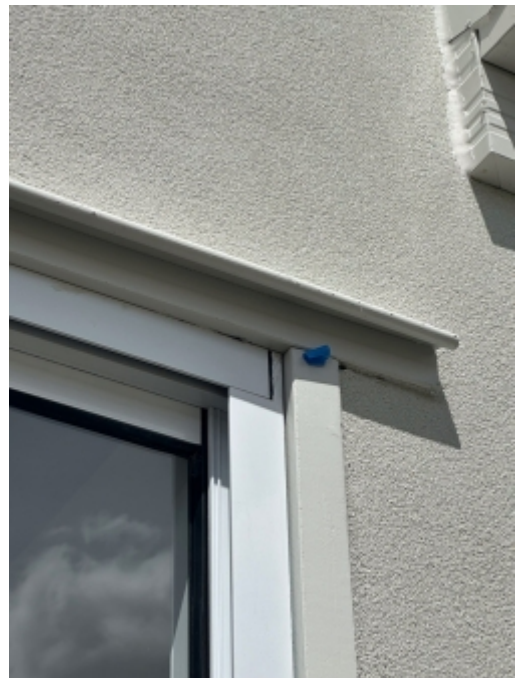
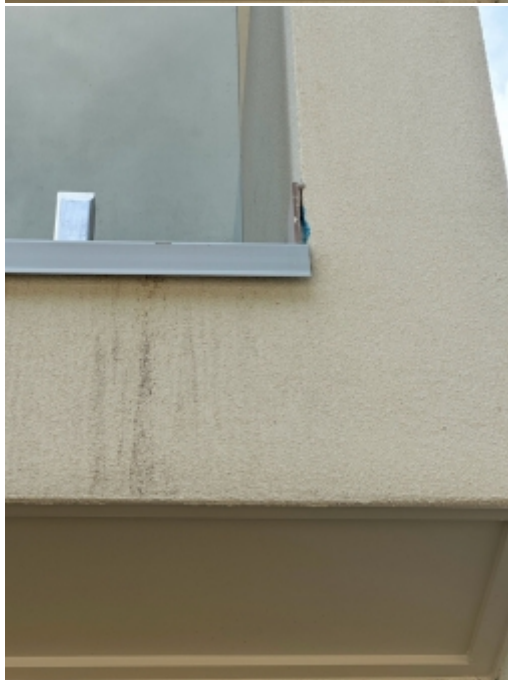
Details of Major Defect	<p>It appears several penetrations to the exterior of the building may require sealing. This presents a risk of water penetration and possible deterioration. Recommend engaging a carpenter to rectify as soon as possible.</p> <p>It appears the expansion joints to the brickwork may require re-sealing. This presents a risk of water penetration and vermin-related issues. Recommend engaging a bricklayer to rectify. Recommend undertaking the above as soon as practical.</p>
-------------------------	---

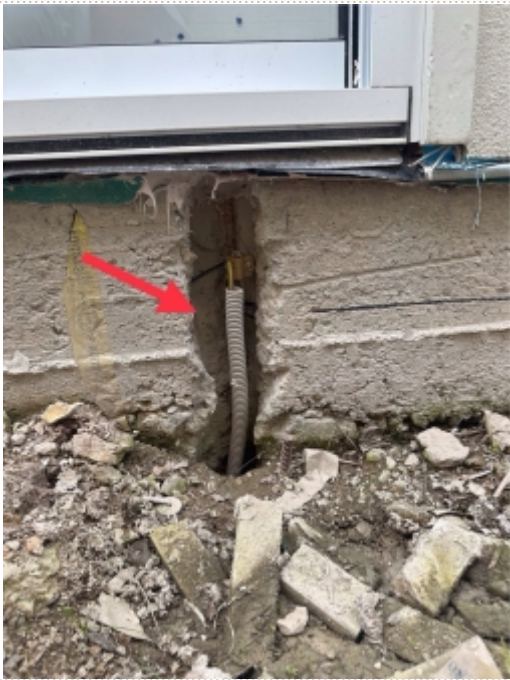
Windows	No evidence of Major Defect was found
External doors (including patio doors)	No evidence of Major Defect was found
Platforms (including verandahs, patios, decks and the like)	No evidence of Major Defect was found
Other external primary elements	No evidence of Major Defect was found
Other external secondary & finishing elements	No evidence of Major Defect was found
Roof exterior (including roof covering, penetrations, flashings)	No evidence of Major Defect was found
Rainwater goods	No evidence of Major Defect was found
The grounds	The following evidence of Major Defects was found
<b>Grounds Defects</b>	
Details of Major Defect	Cut to concrete slab and physical termite barrier to left hand side of the building. Recommend engaging a building for further advice on repairs to prevent possible deterioration of the building.

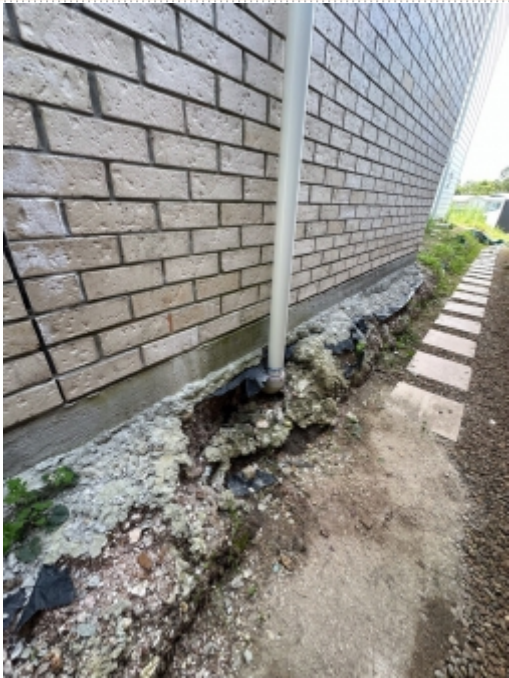
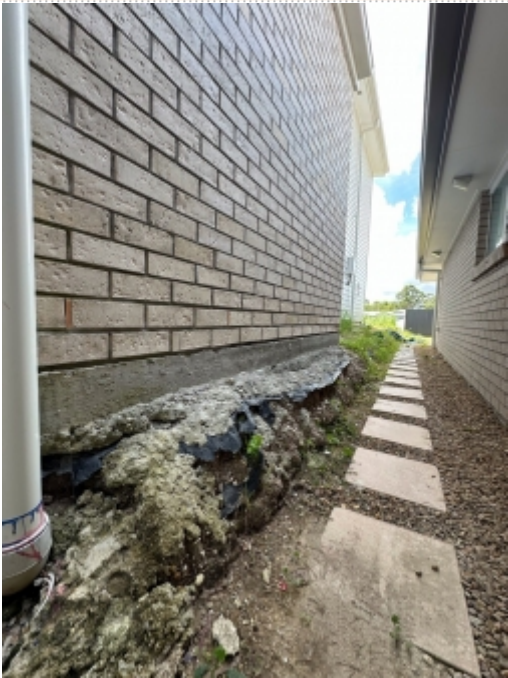
Soil erosion under the concrete slab to the right hand side of the building. No retaining wall is installed at the time of the inspection. Recommend engaging a building for further advice on repairs to prevent possible deterioration of the building.

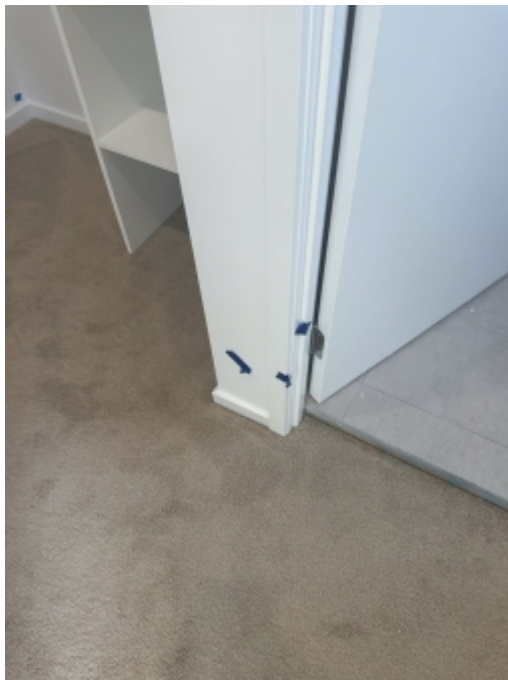
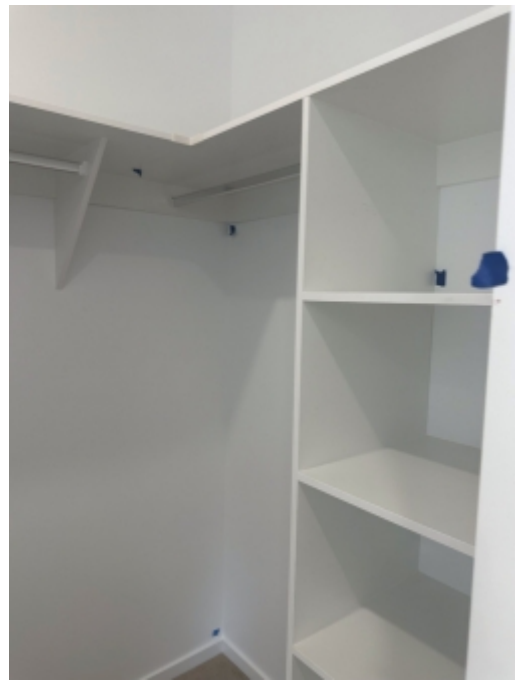
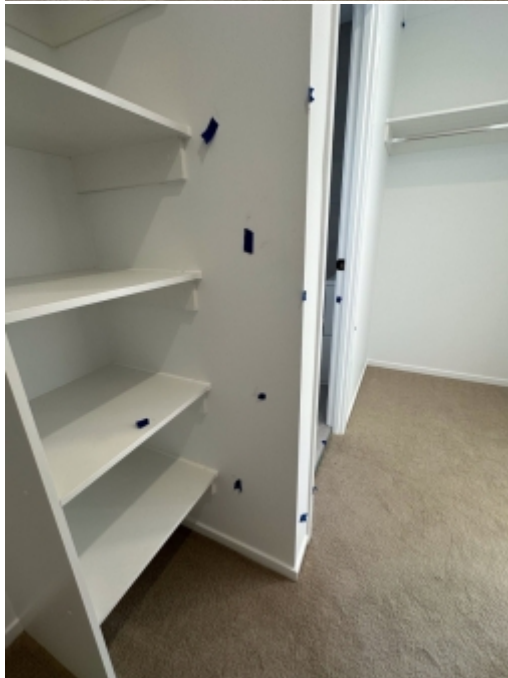
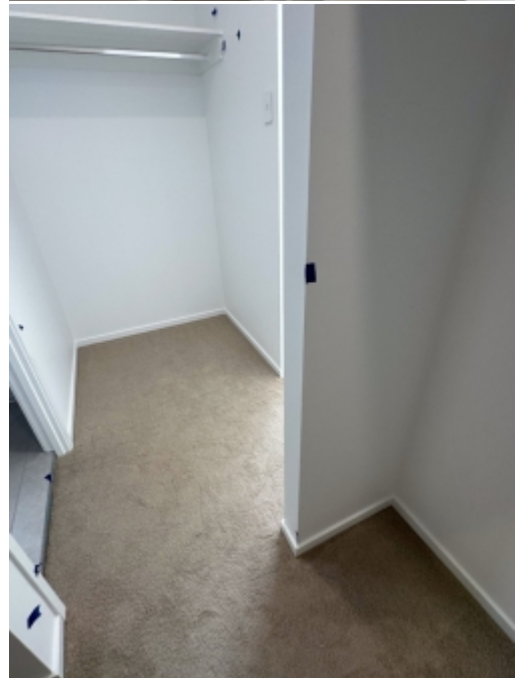
Showing examples of defective paintwork to the Master Bedroom

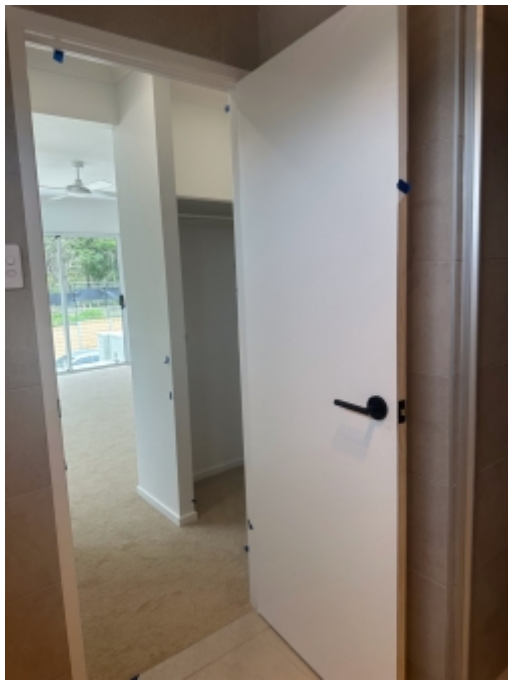
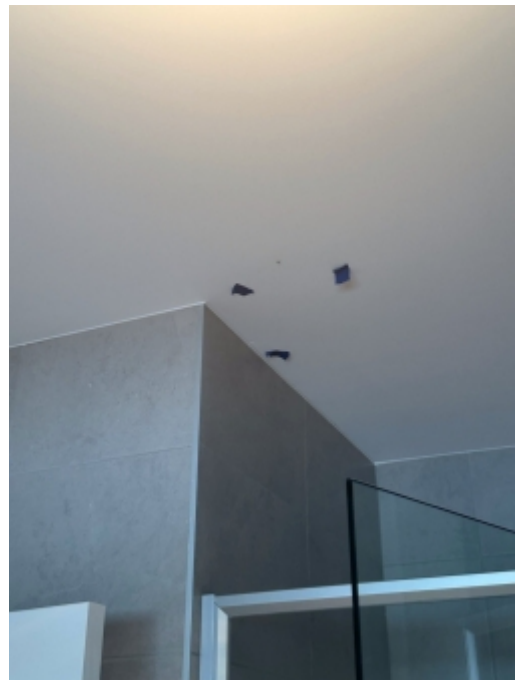
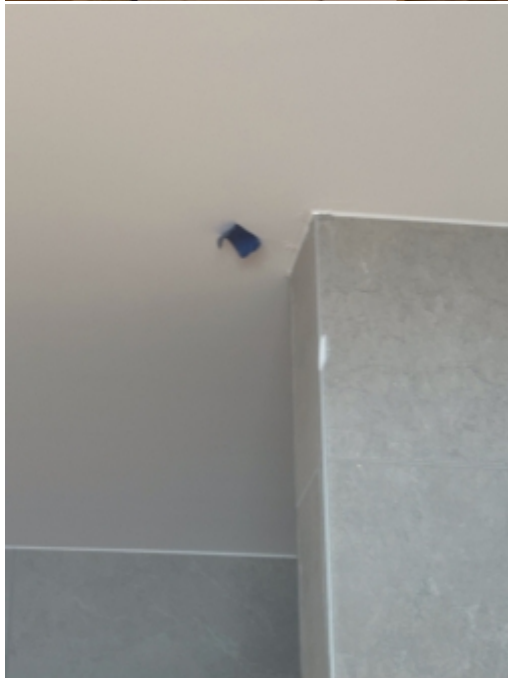
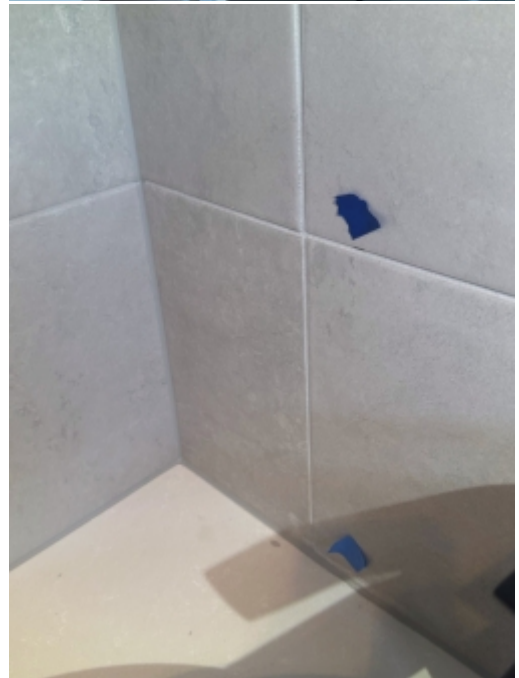
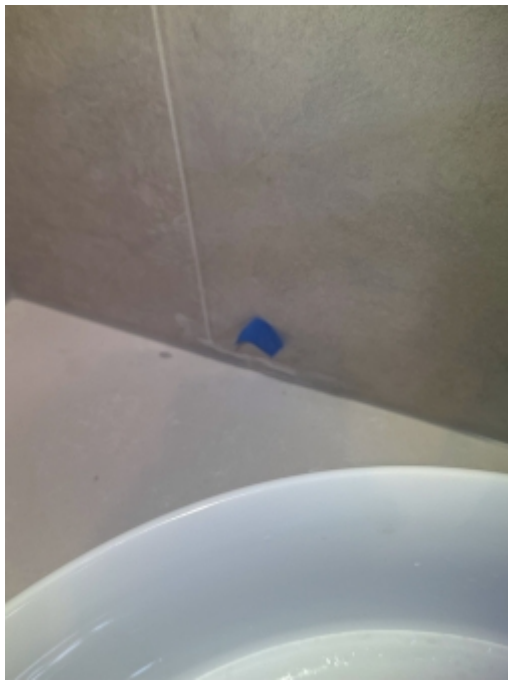
Showing examples of defective paintwork to the Ensuite

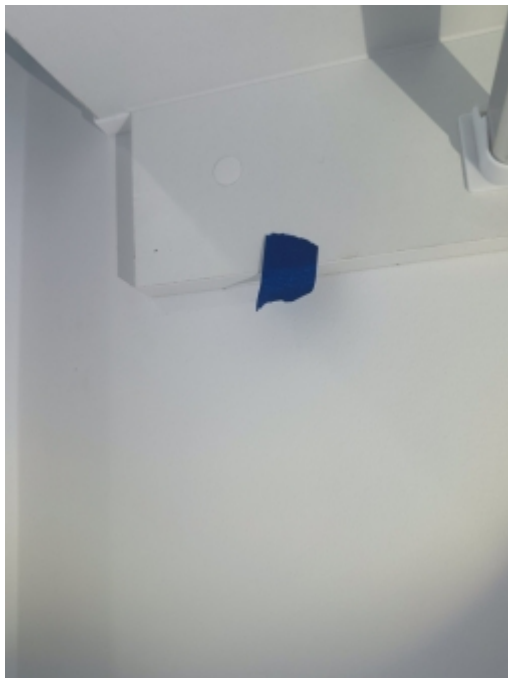
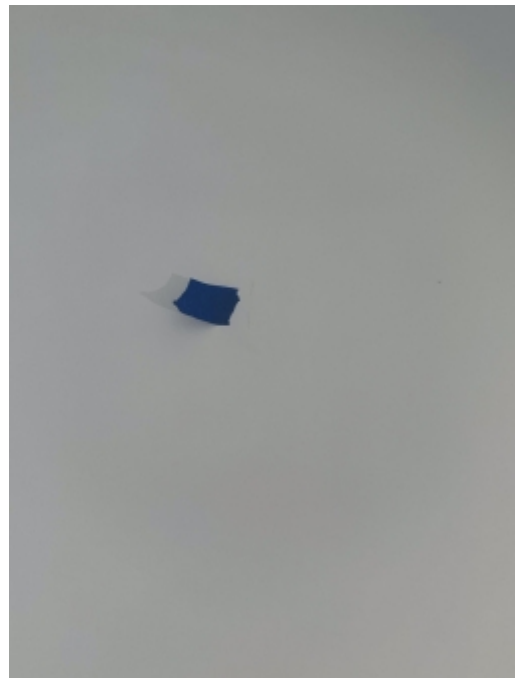
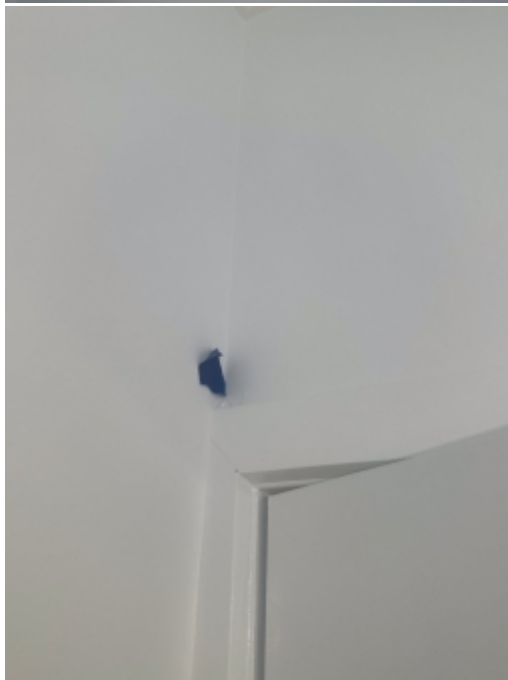
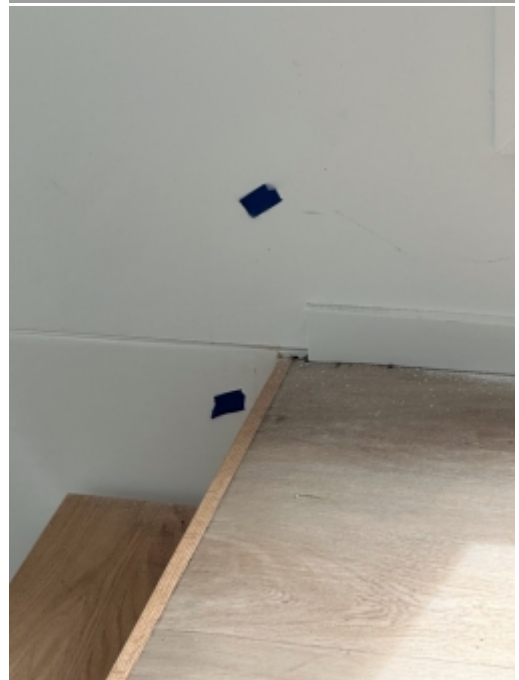
Showing examples of defective paintwork to the upstairs common area

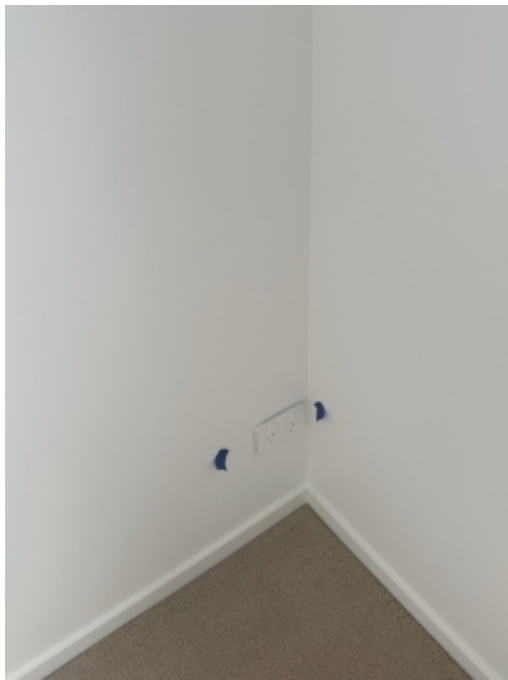
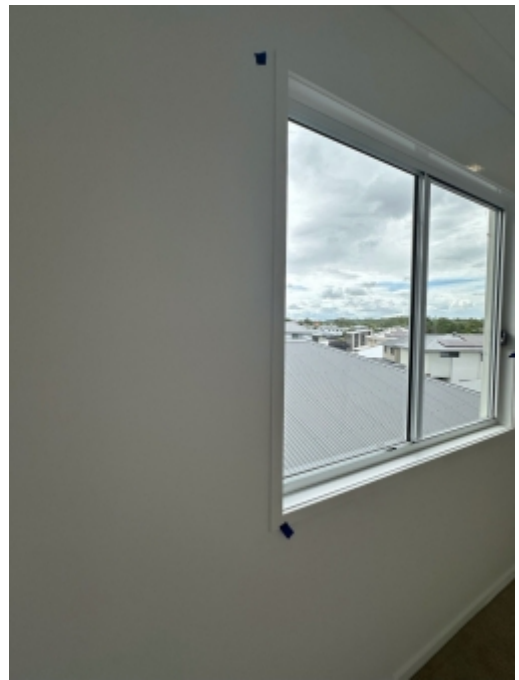
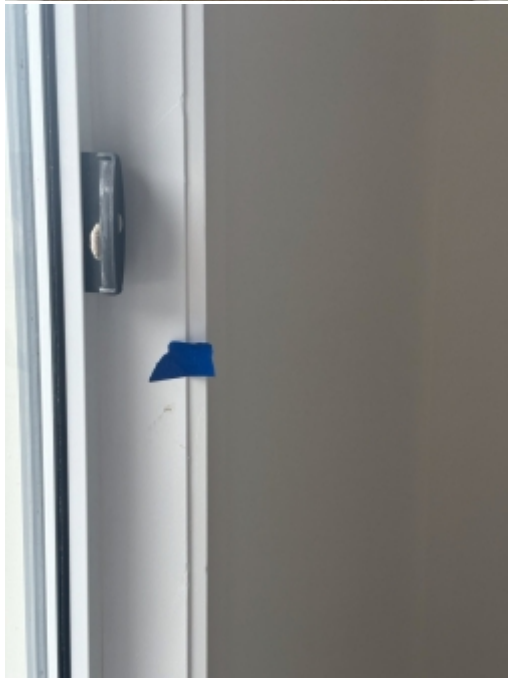
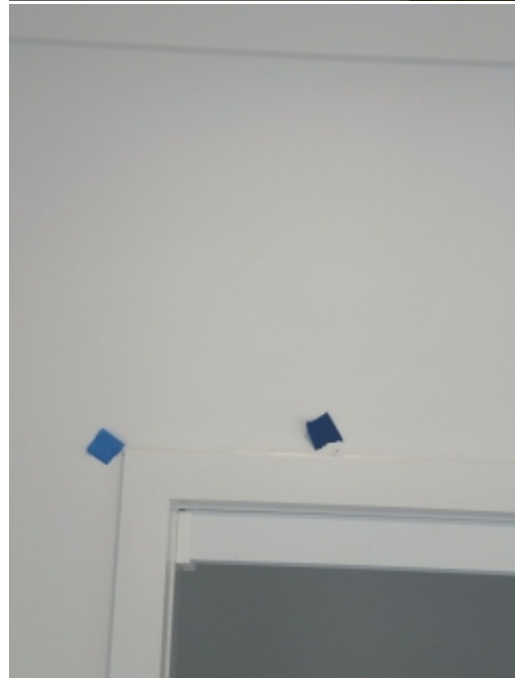
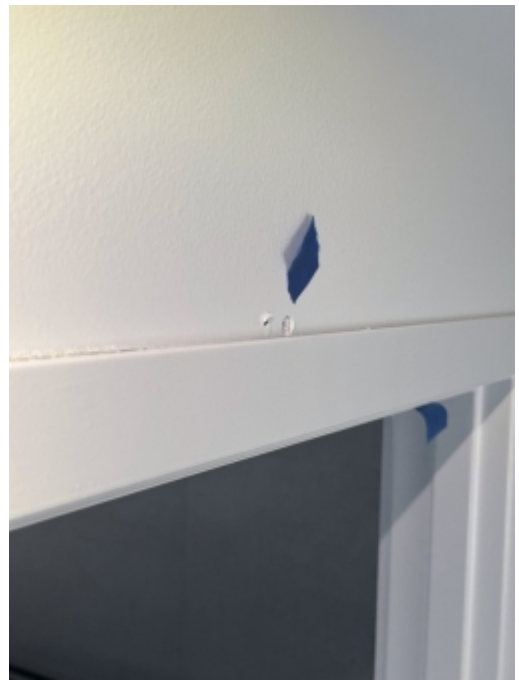
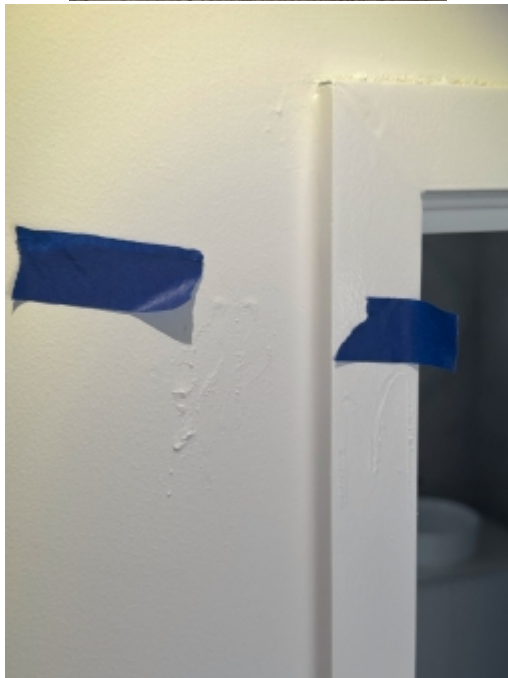
Showing examples of defective paintwork to the Bedroom 2

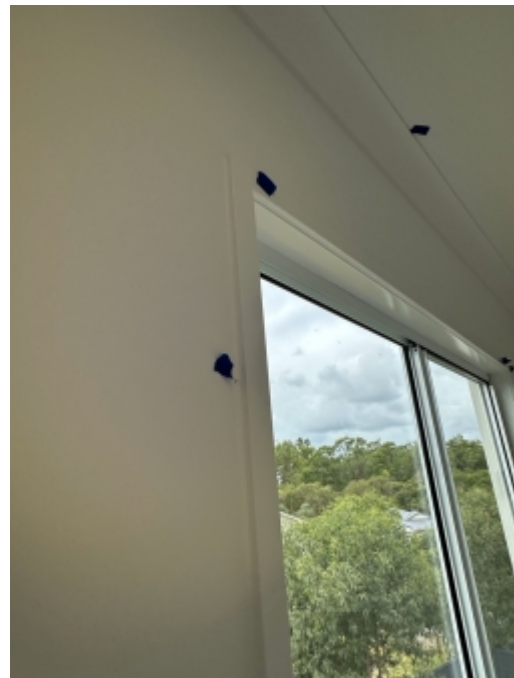
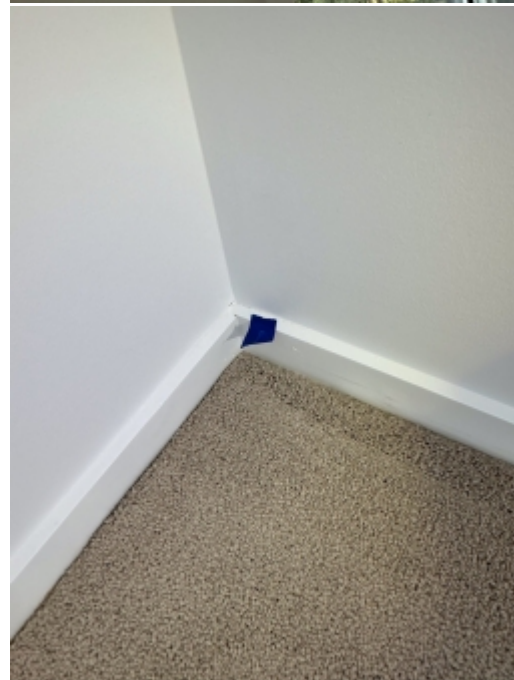
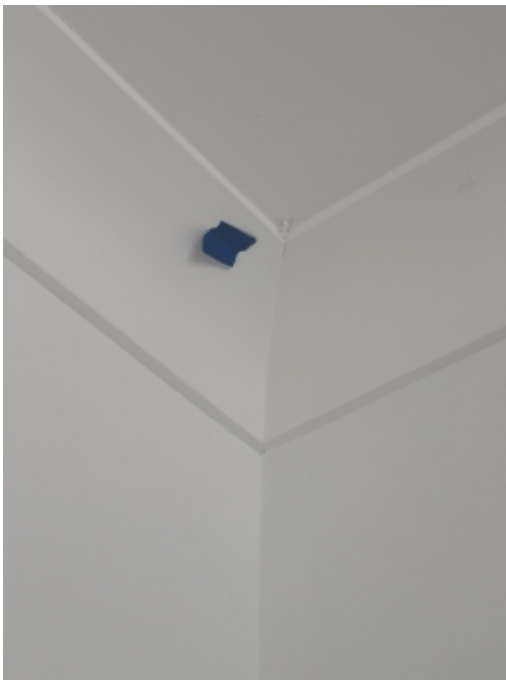
Showing examples of defective paintwork to the Bedroom 3

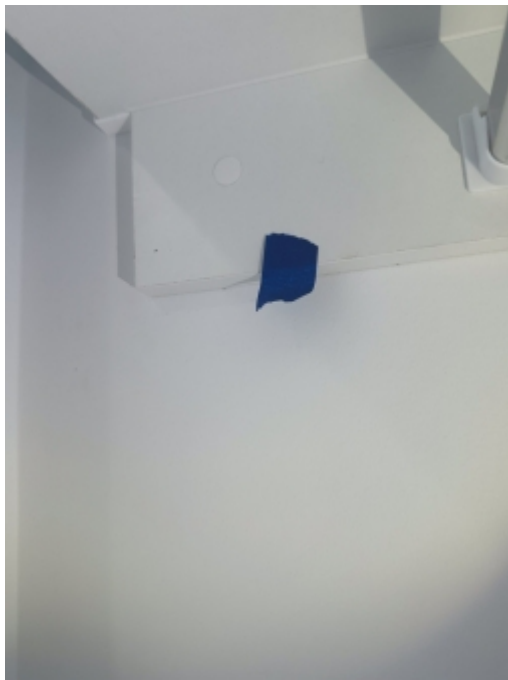
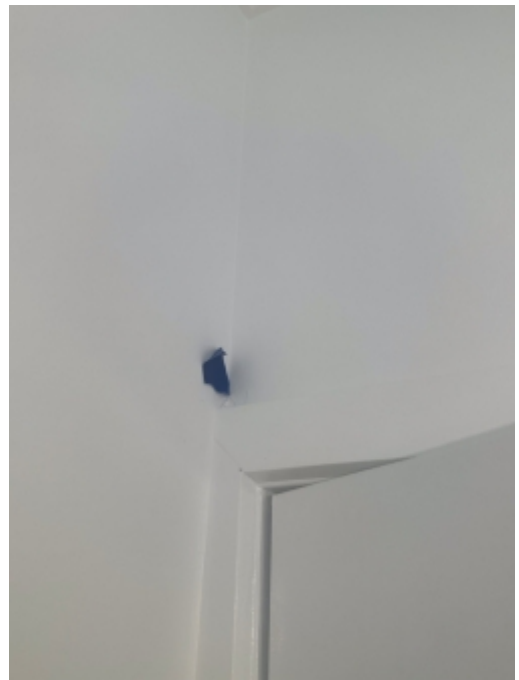
Showing examples of defective paintwork to the Bedroom 4

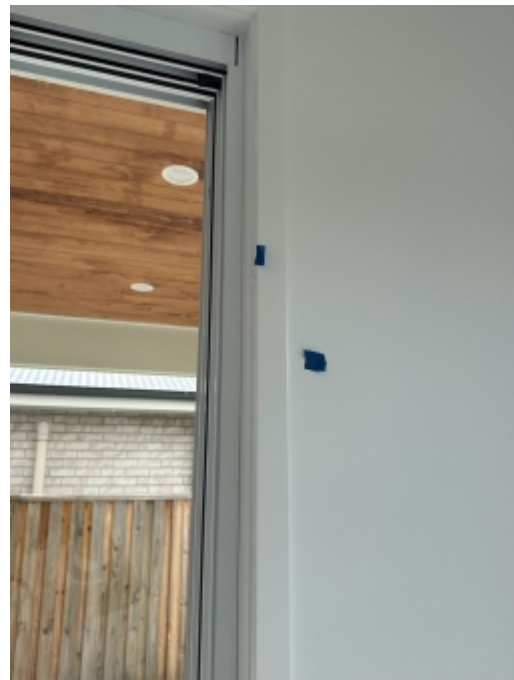
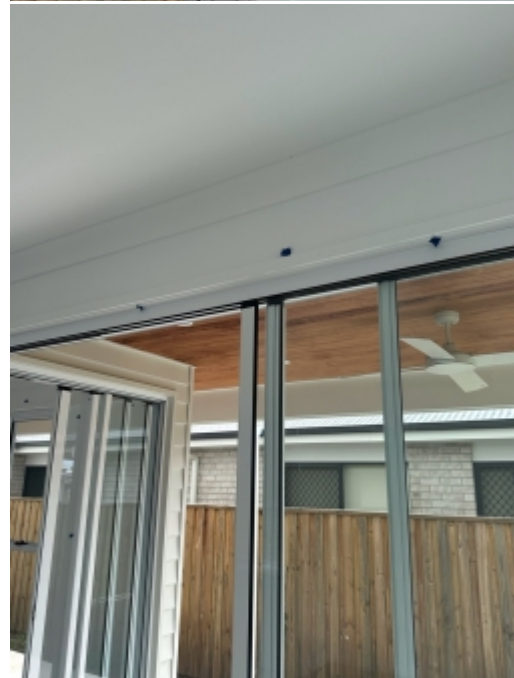
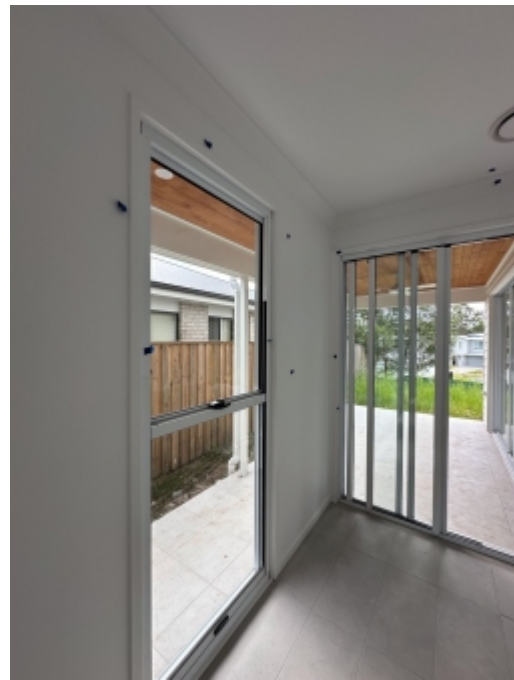
Photo Comments	Showing examples of defective paintwork to the downstairs common areas
Photo

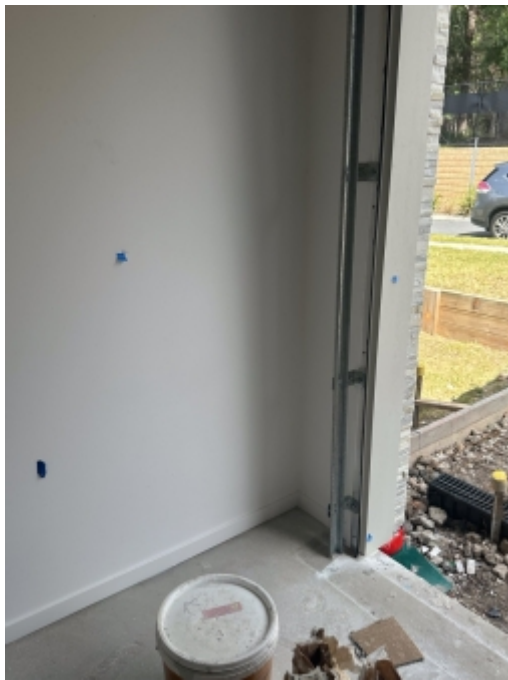
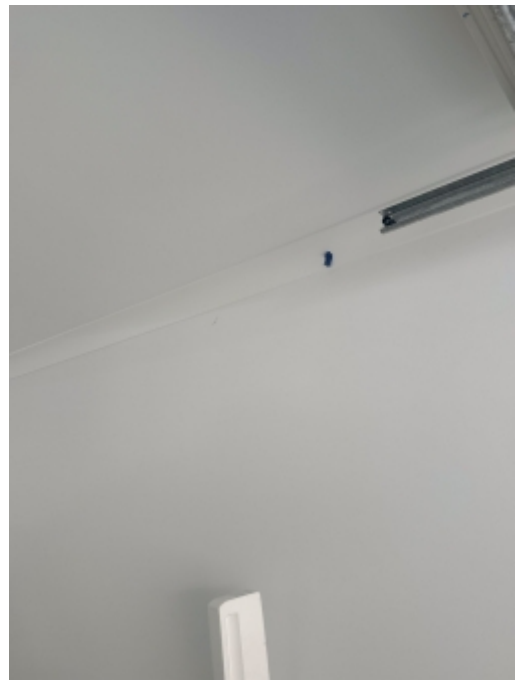
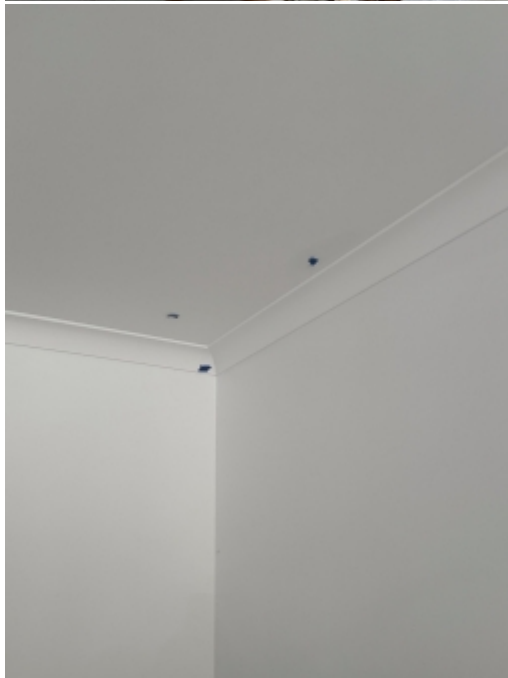
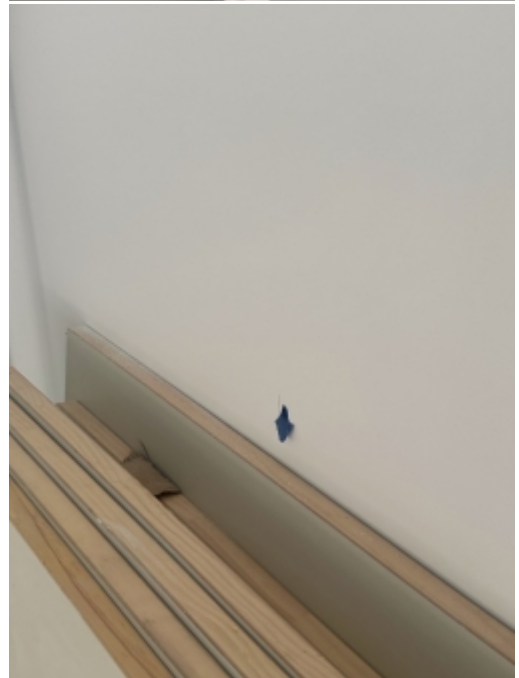
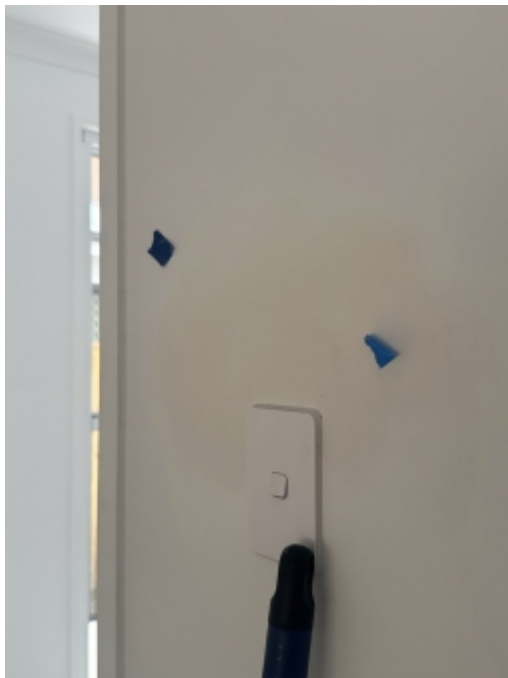
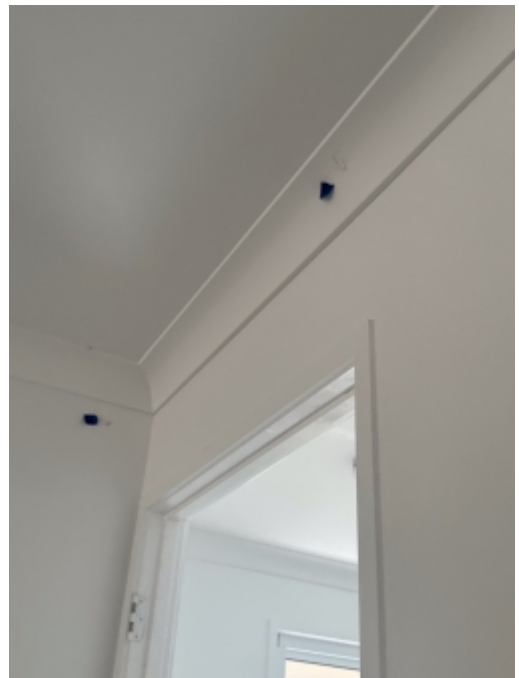
Showing examples of defective paintwork to the garage

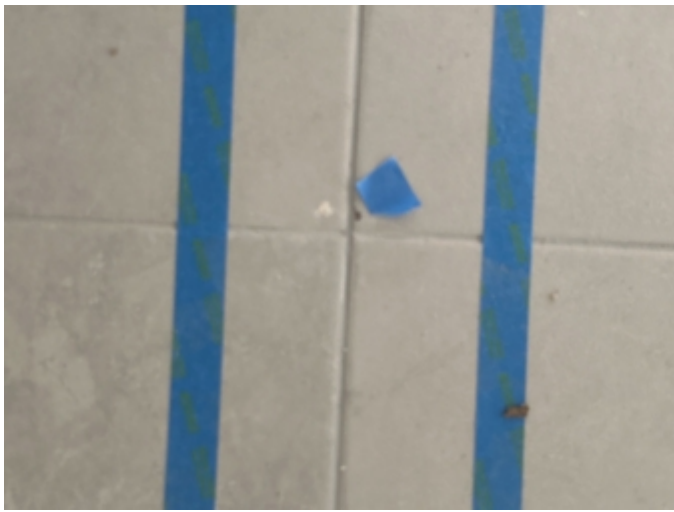
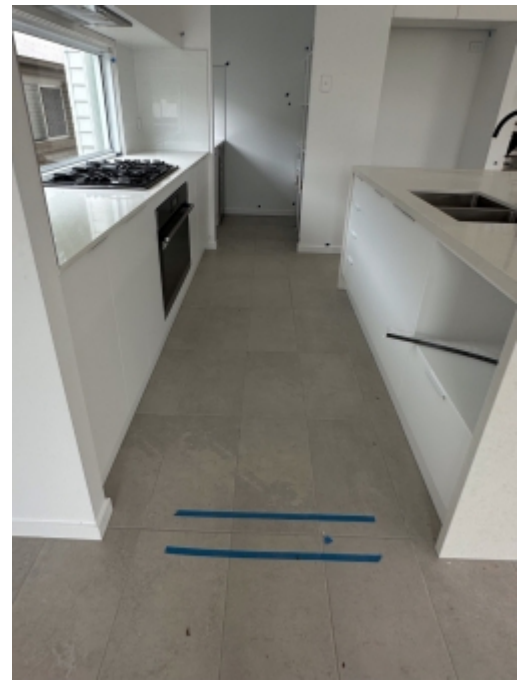
Showing chipping tile to the kitchen

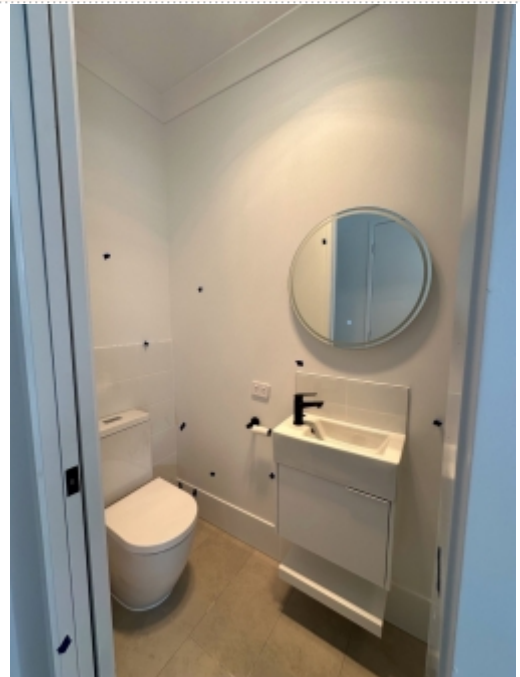
Showing missing cavity door tract to the separate toilet

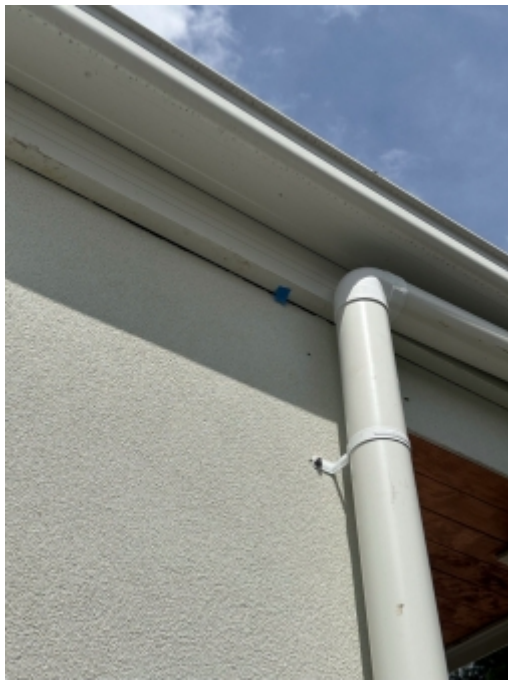
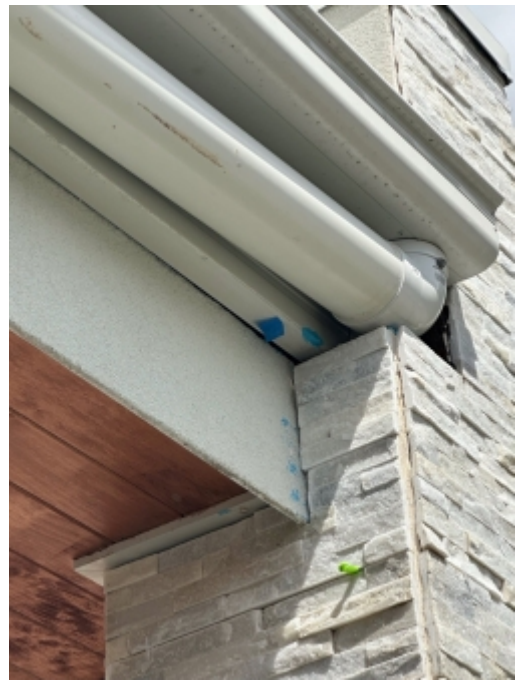
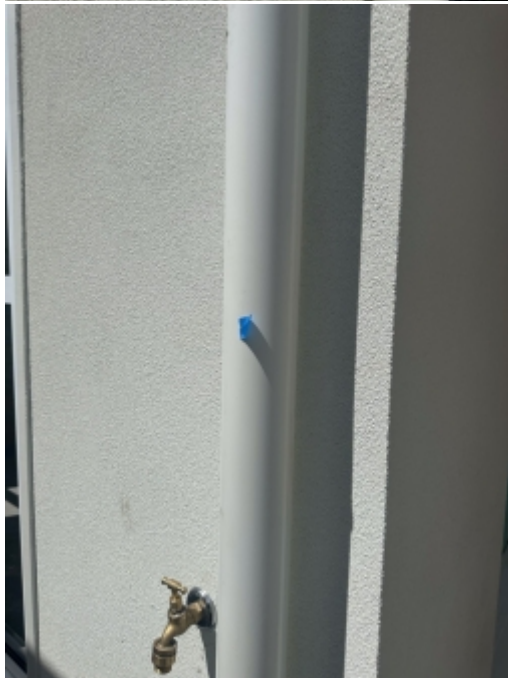
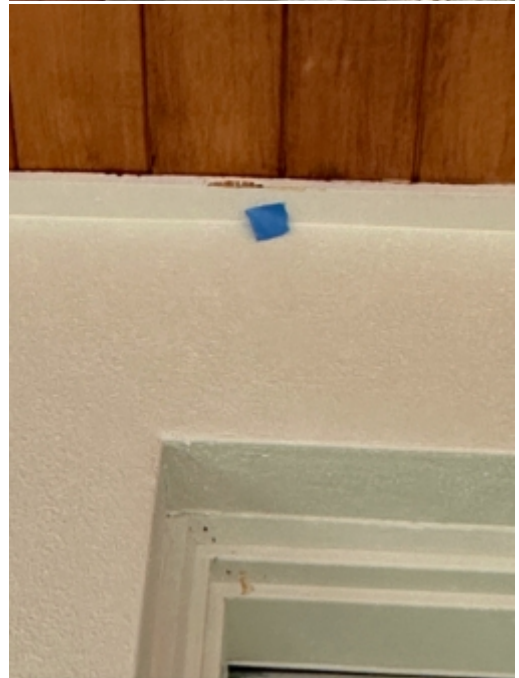
Showing examples of defective paintwork to the house external
