Pre-Purchase Standard Property & Timber Pest Report

9 Ruthenberg Street Lowood 4311 Queensland Australia

15 Jun 2023

Report number:	ABP01341
Inspection Date:	15 Jun 2023
Property Address	9 Ruthenberg Street Lowood 4311 Queensland Australia

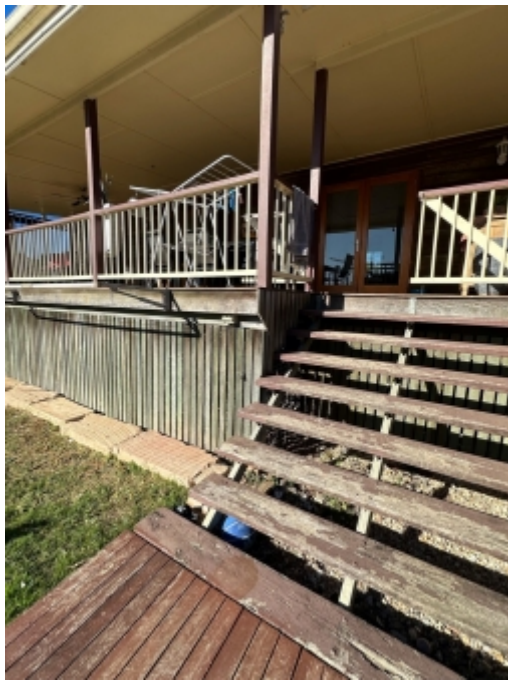
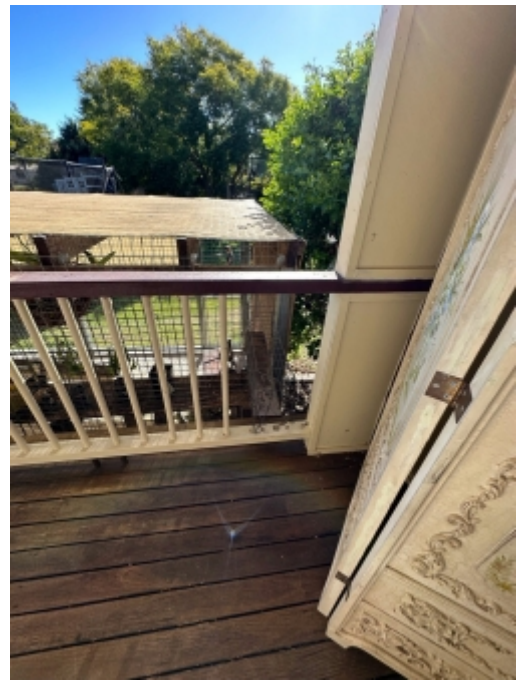
Serious Safety Hazard Missing balustrades to parts. Recommend engaging a carpenter to install to reduce the risk of people falling.

Showing missing balustrades

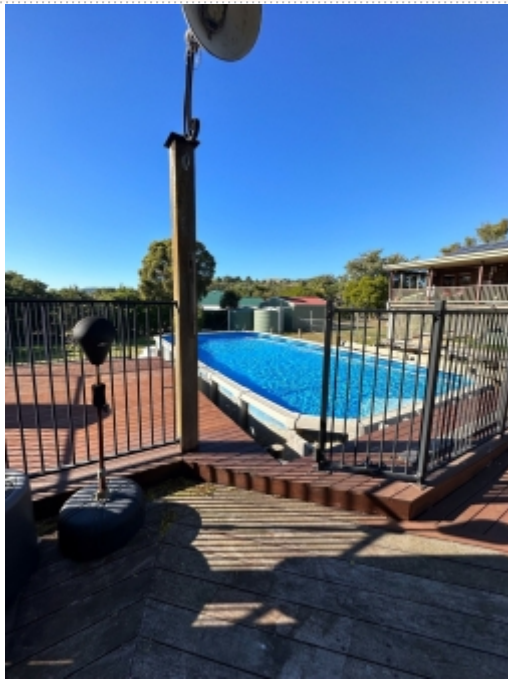
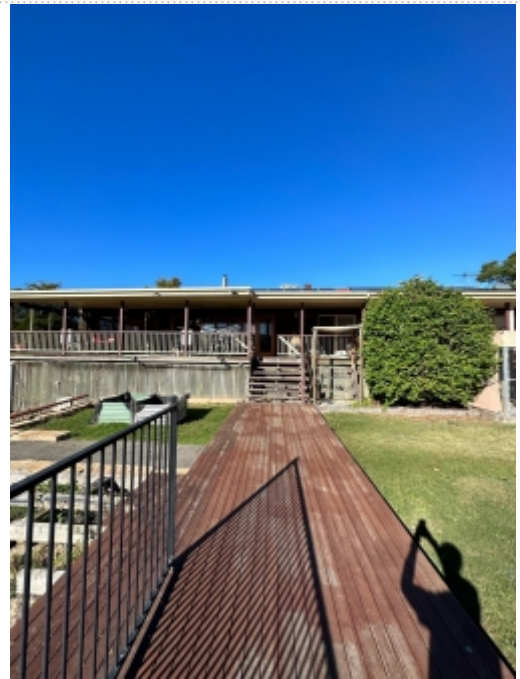
Pool gate not self-latching. Safety Hazard.

Pool gate is not completed at the time of the inspection. Needs rectifying to reduce the risk of kids access to the pool area.

Showing pool fencing

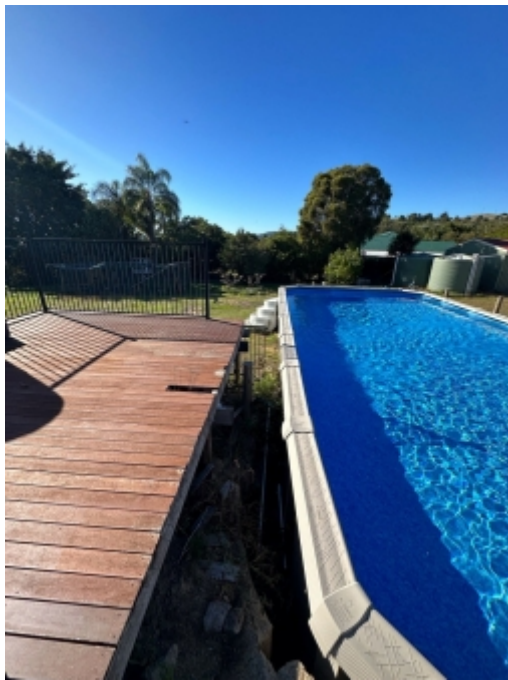
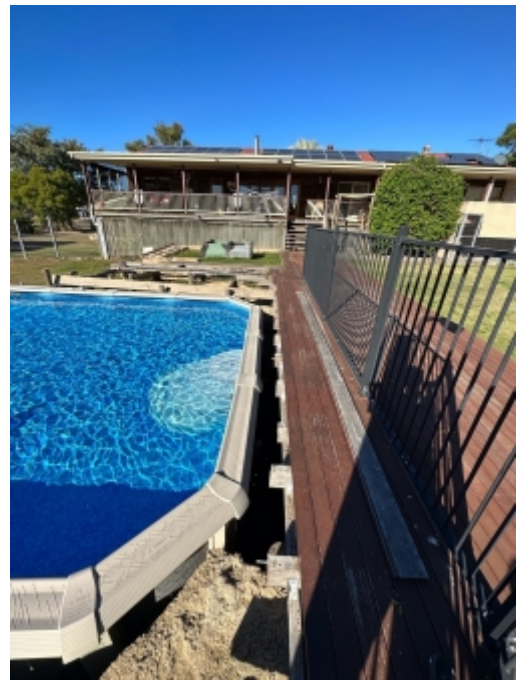
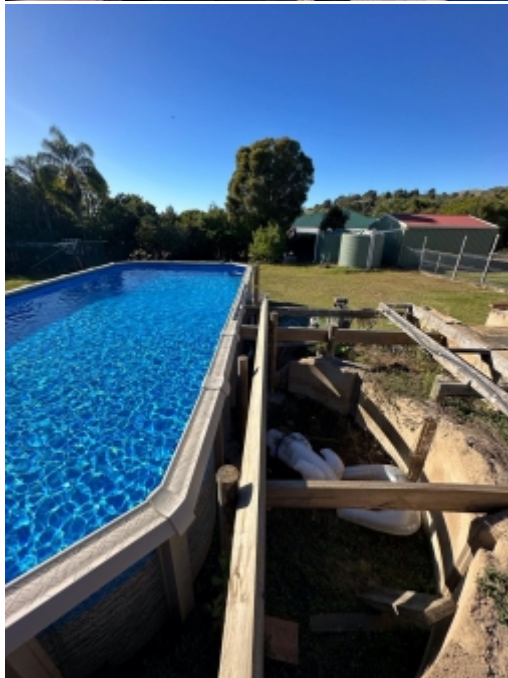
Pool decking is not completed at the time of the inspection. Needs rectifying to reduce the risk of people falling.

Showing pool deck

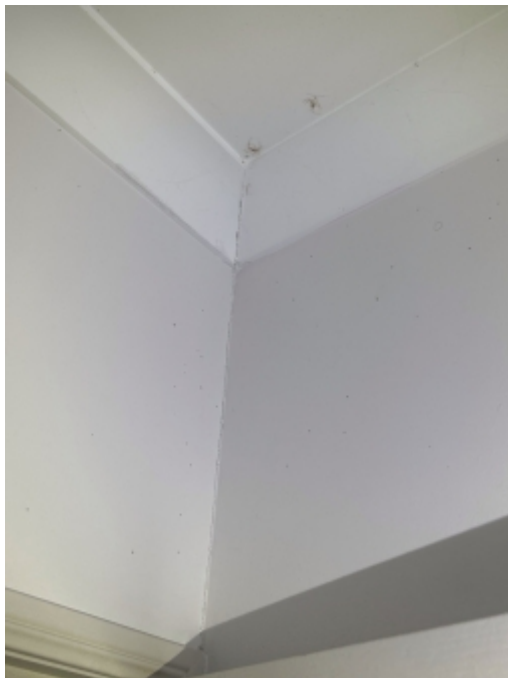
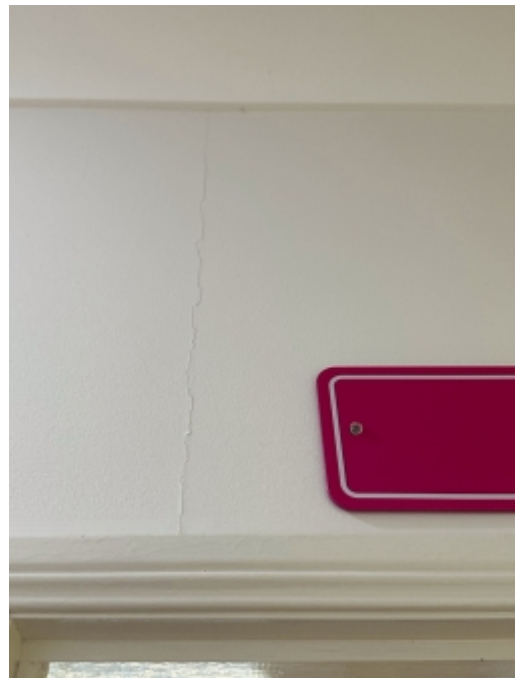
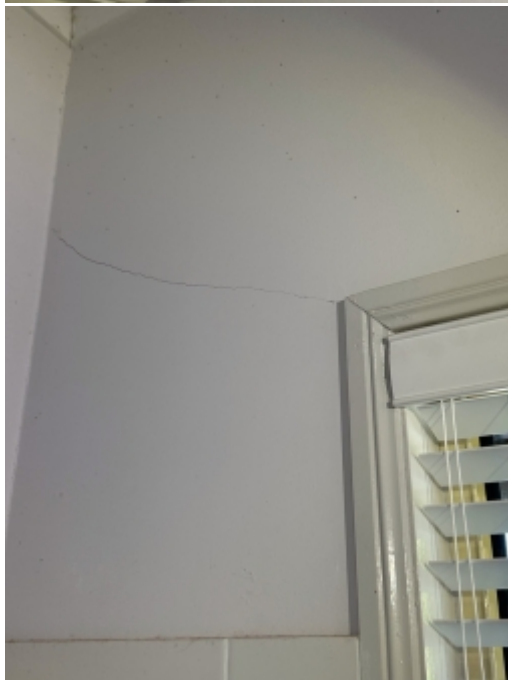
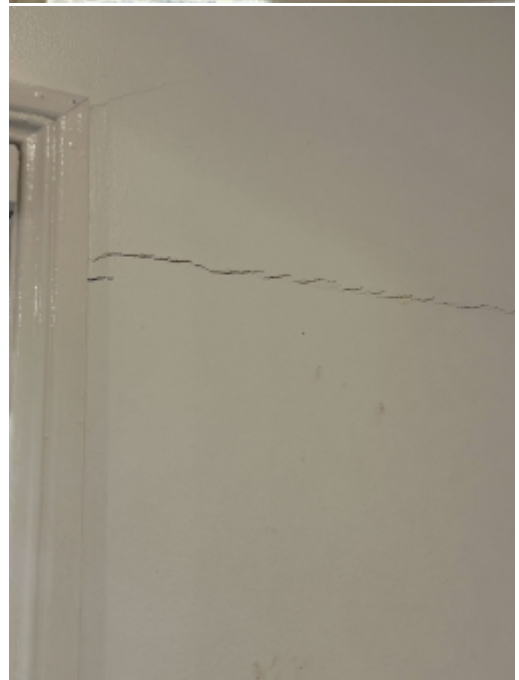
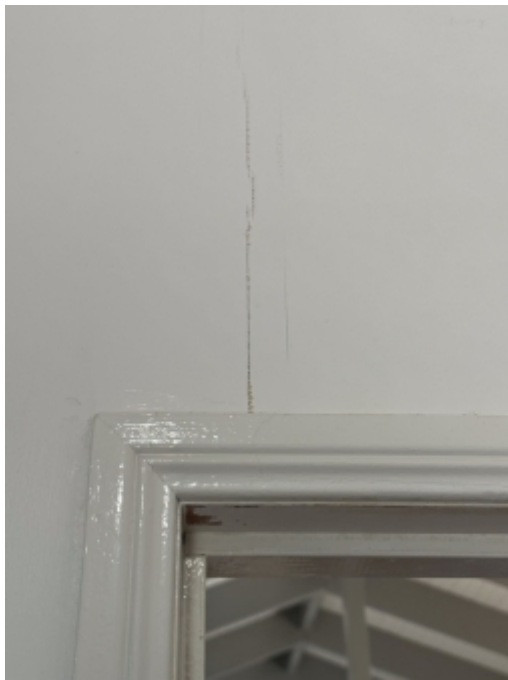
Ceilings	No evidence of Major Defect was found
Internal Walls	The following evidence of Major Defects was found
Internal Wall Defects	
Detail of Major Defect	Movement Cracks to walls in seperate locations, Recommend repair by engaging a Licensed Plasterer.
Photo(s) of Defect

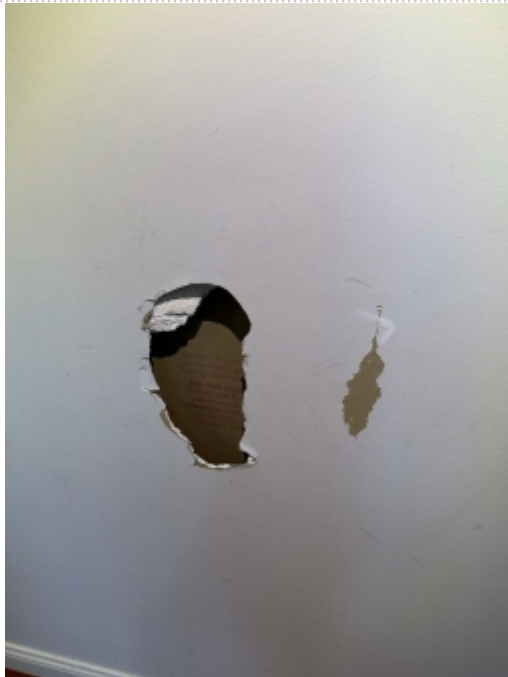
Damage to wall at hallway. Recommend engaging a plasterer to repair to prevent further deterioration.

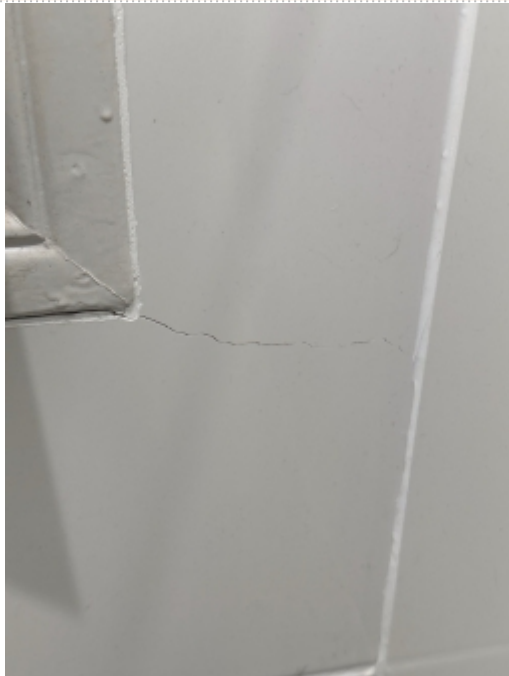
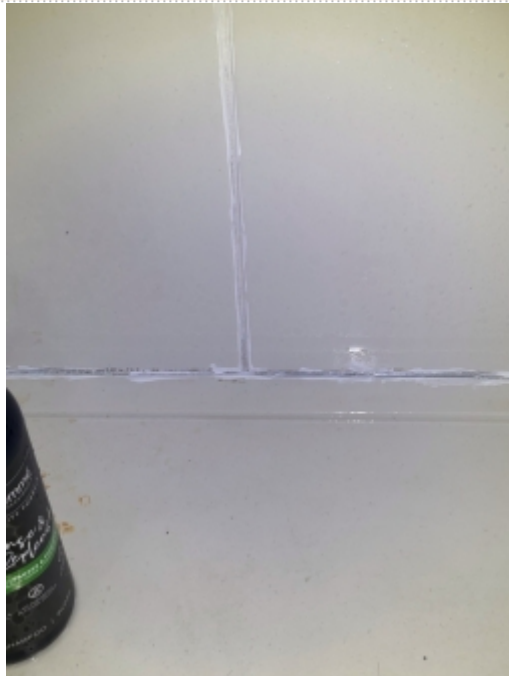
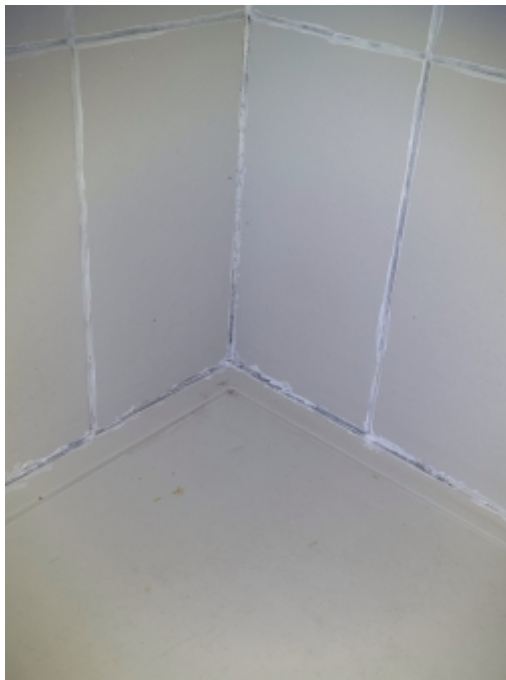
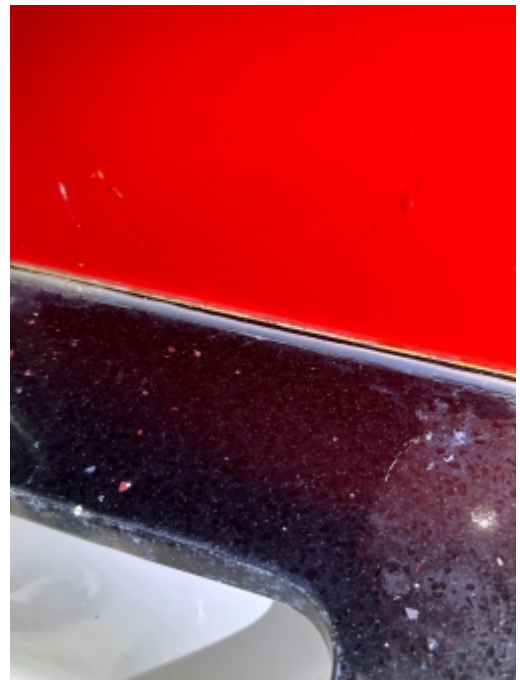
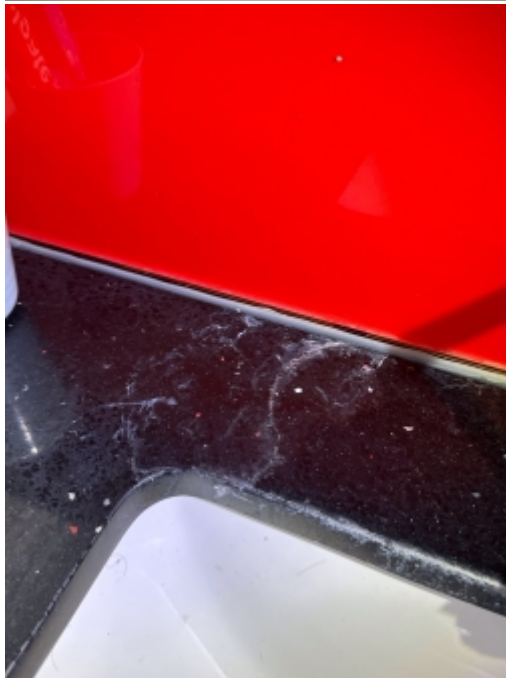
Details of Major Defect	Cracked tiles and loose silicone/grout to parts of wet areas. Needs resealing properly to reduce the risk of water leaks and damage.
Photo(s) of Defect

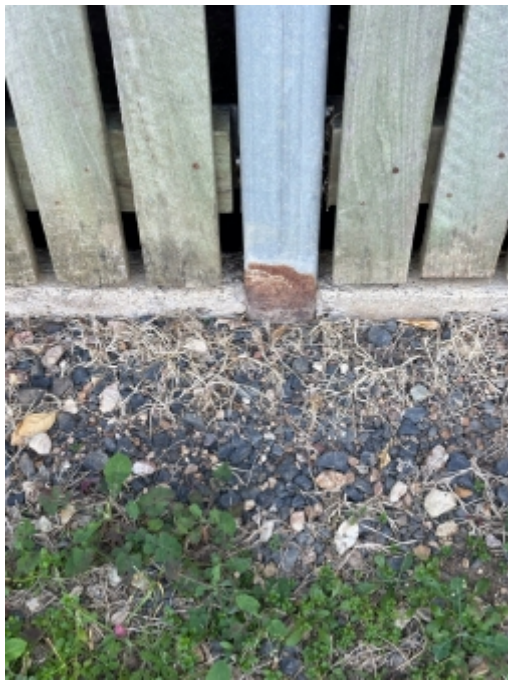
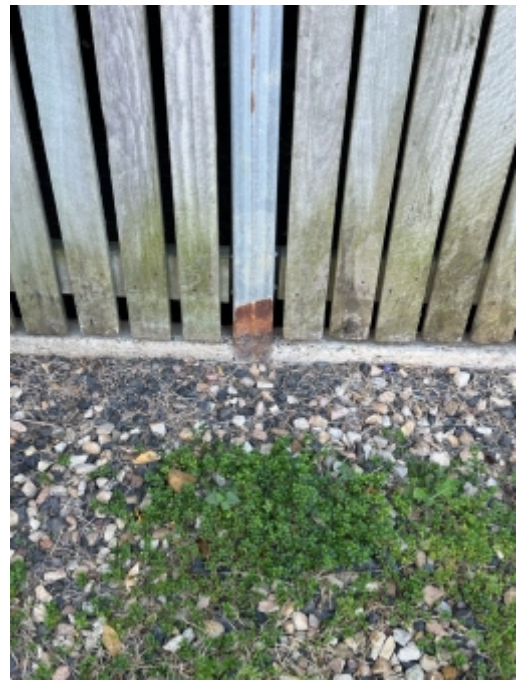
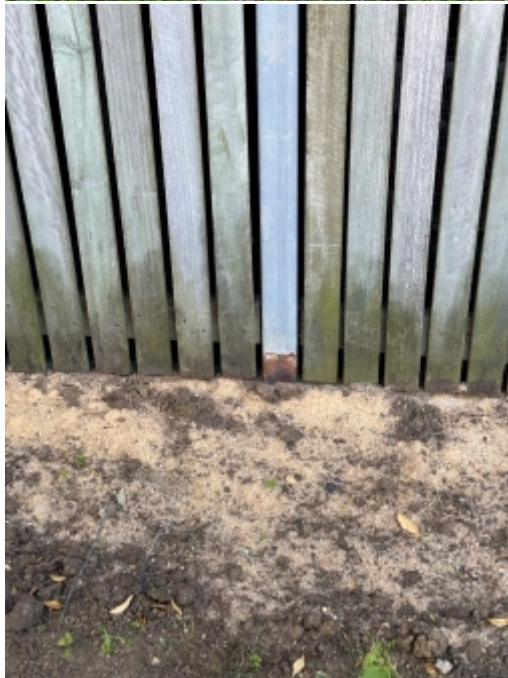
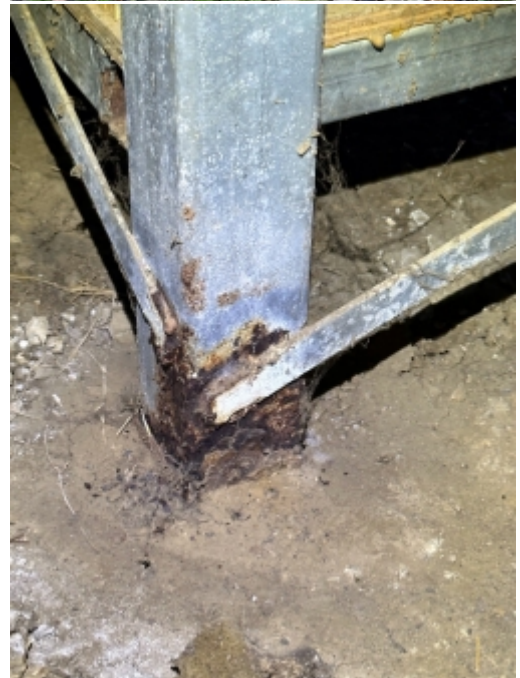
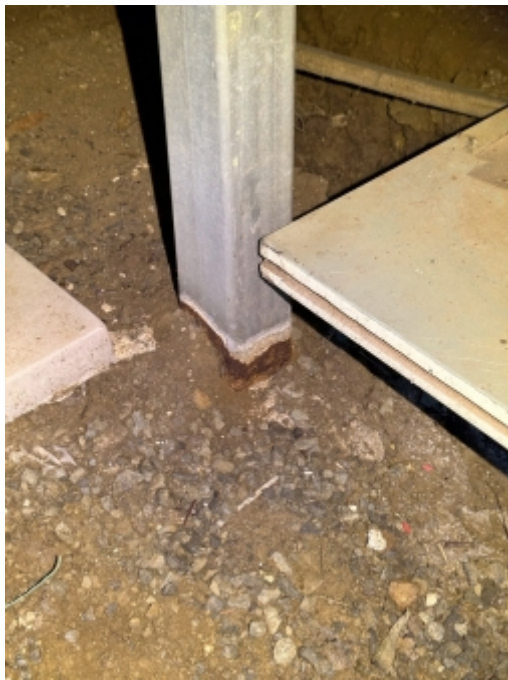
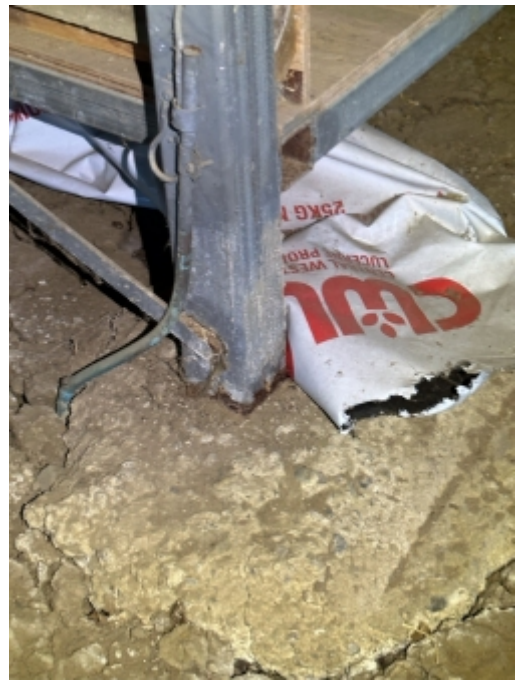
Other inside detail (e.g. fireplaces, chimney breasts and the outside of flues)	Not inspected due to construction design
Roof space	No evidence of Major Defect was found
Subfloor space	The following evidence of Major Defects was found
Subfloor Defects	
Details of Major Defect	<p>A few rusted metal posts- Recommend replace damaged posts, then applying Tar coating and installing a domed concrete surrounds to reduce the risk of ongoing rust and Corrosion.</p> <p>A few metal posts are covered by soil. Recommend removing the soil surrounding the posts and sealing the bottom of the posts above the ground level with a bituminous coating to reduce the risk of ongoing rust and corrosion.</p>
Photo(s) of Defect

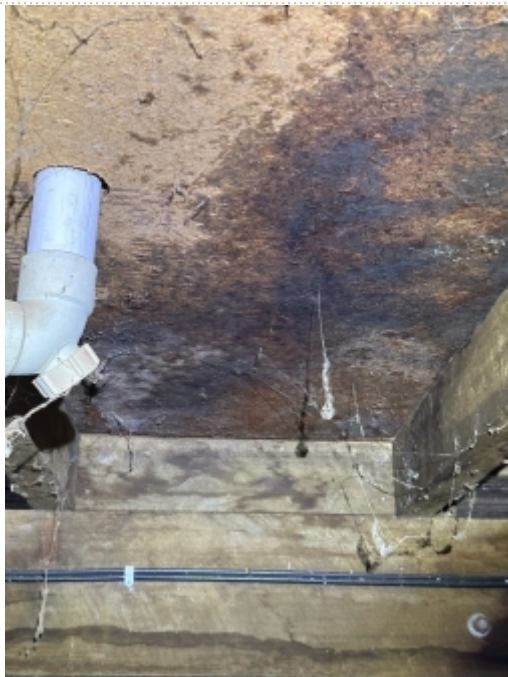
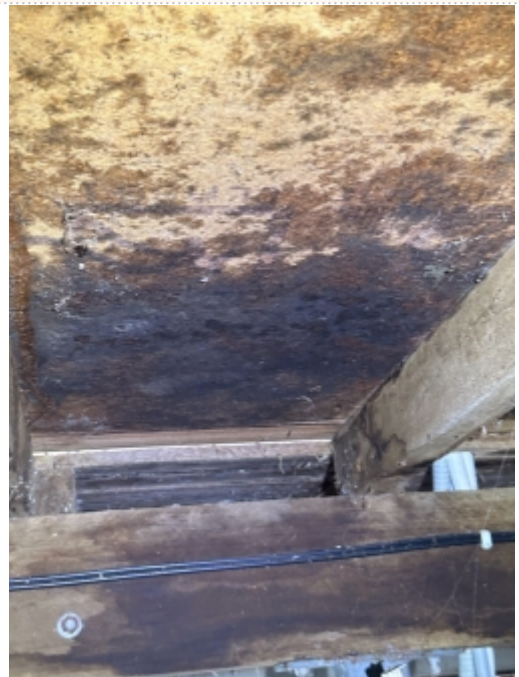
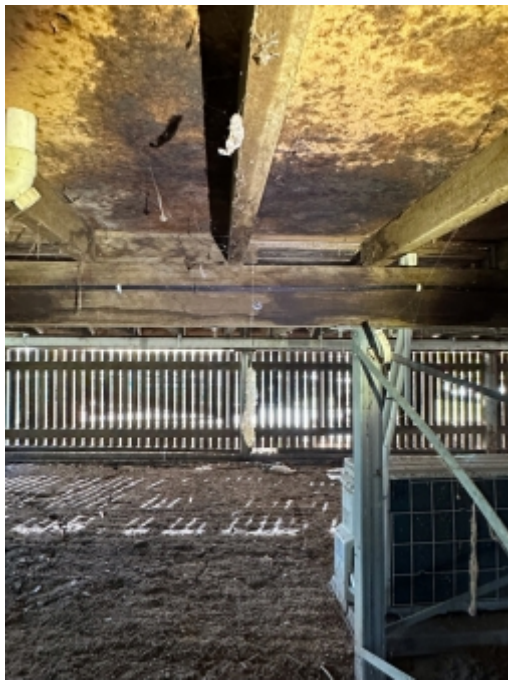
It appears some plumbing fittings may be leaking. The presence of moisture was detected. There appear to be signs of dampness below on the ground. Recommend engaging a plumber to rectify to reduce the risk of termite attack and structural damage. Recommend the above be implemented as soon as possible.

Moisture staining to parts of flooring underneath the ensuite. Recommend engaging a builder/plumber for further inspection and advise on repairs to prevent further deterioration.

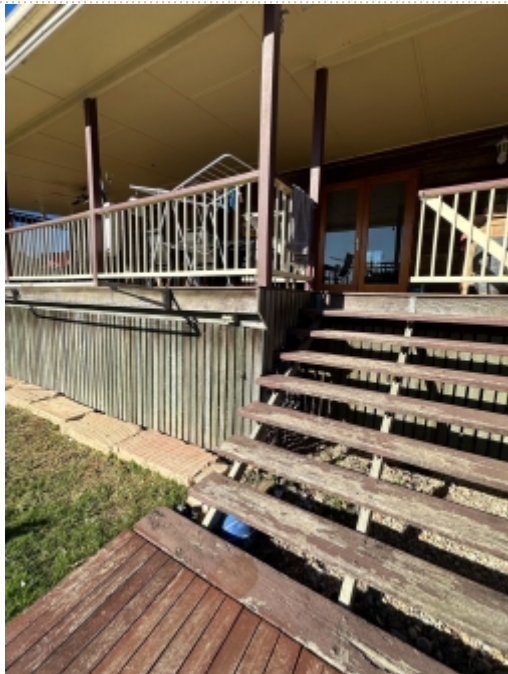
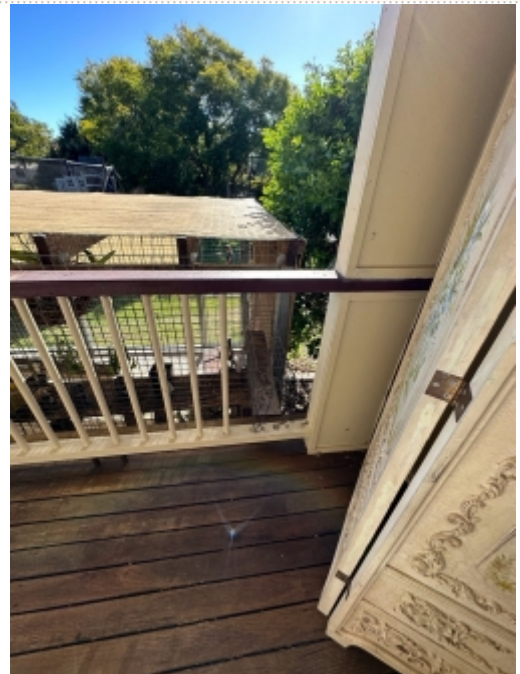
Details of Major Defect	Insufficient balustrades. Recommend engaging a Builder/Carpenter to rectify to reduce the risk of people falling.
Photo(s) of Defect

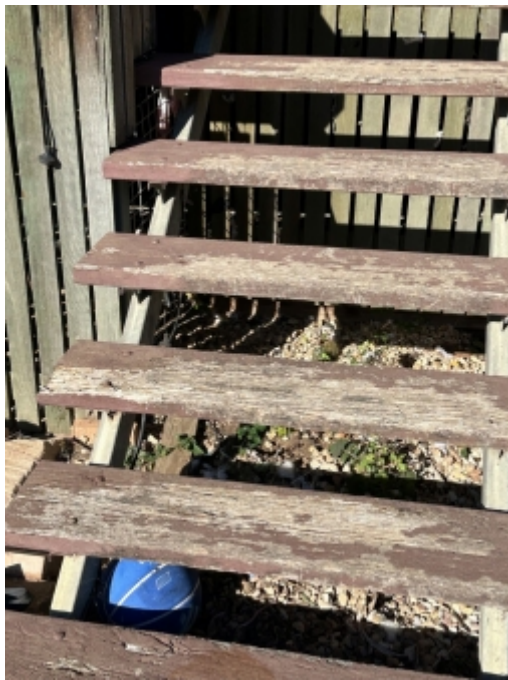
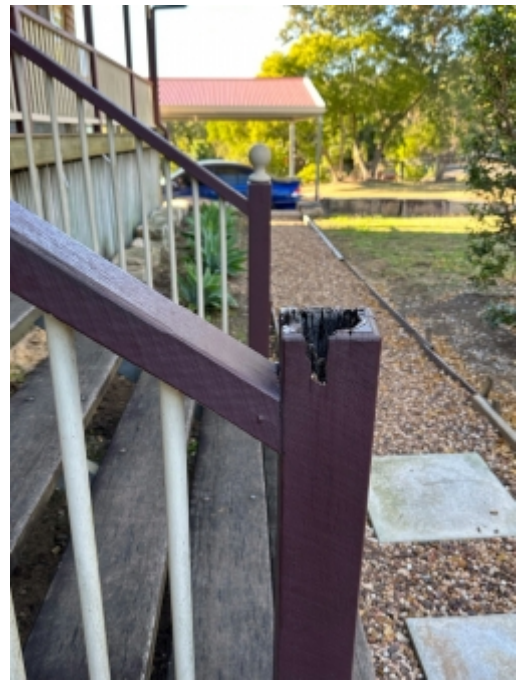
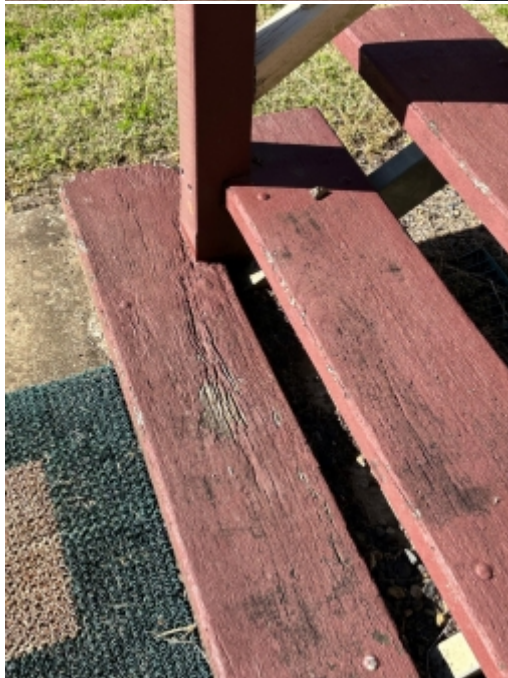
Details of Major Defect	Wood rot to parts of framing. Recommend engaging a Builder/carpenter to repair/replace to prevent further deterioration.
Photo(s) of Defect

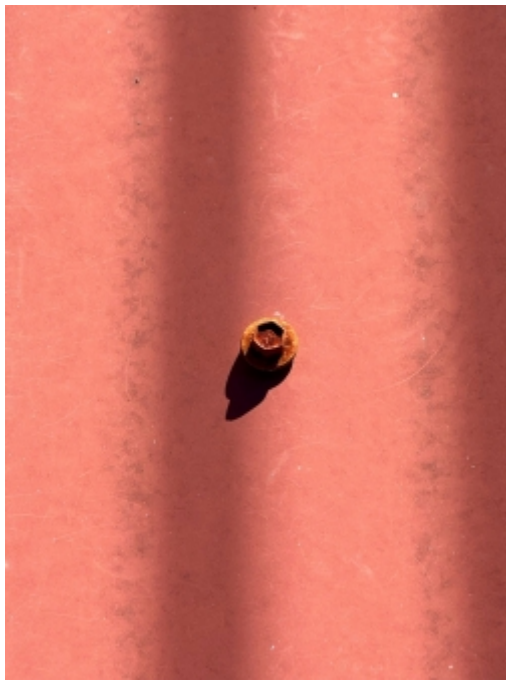
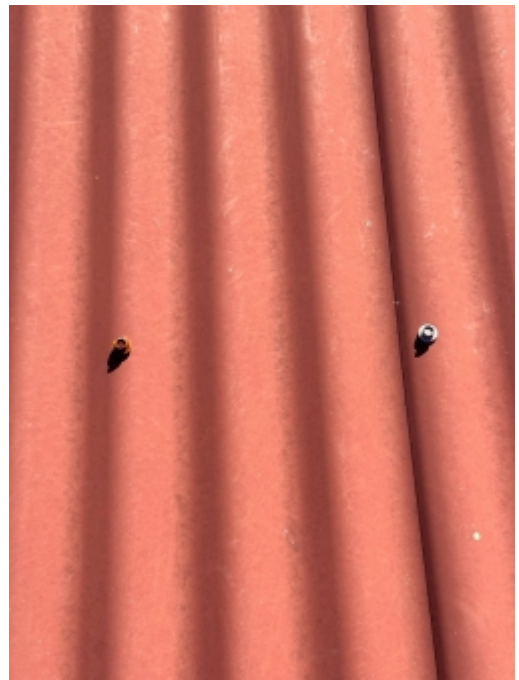
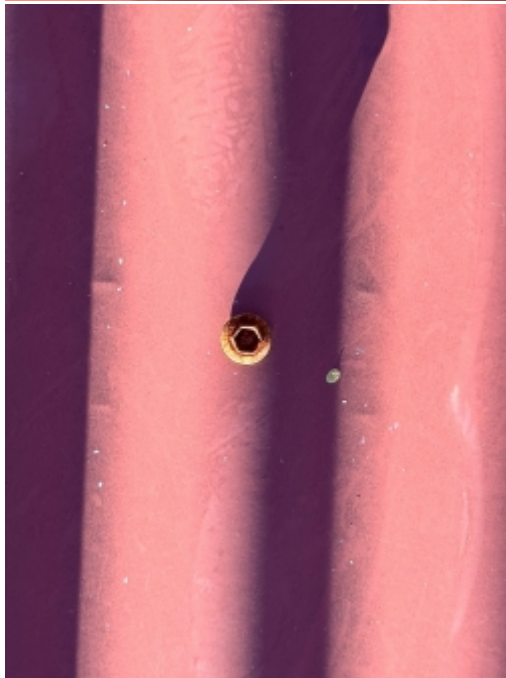
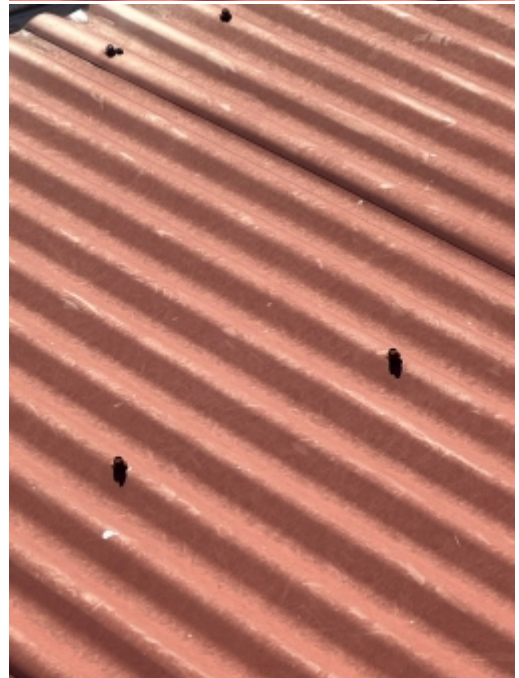
Other external primary elements	No evidence of Major Defect was found
Other external secondary & finishing elements	No evidence of Major Defect was found
Roof exterior (including roof covering, penetrations, flashings)	The following evidence of Major Defects was found
Roof Exterior Defects	
Details of Major Defect	Rusting fixings to roof. Recommend engaging a roofing contractor/plumber to repair/replace fixings to reduce the risk of rust worsening and spreading.
Photo(s) of Defect

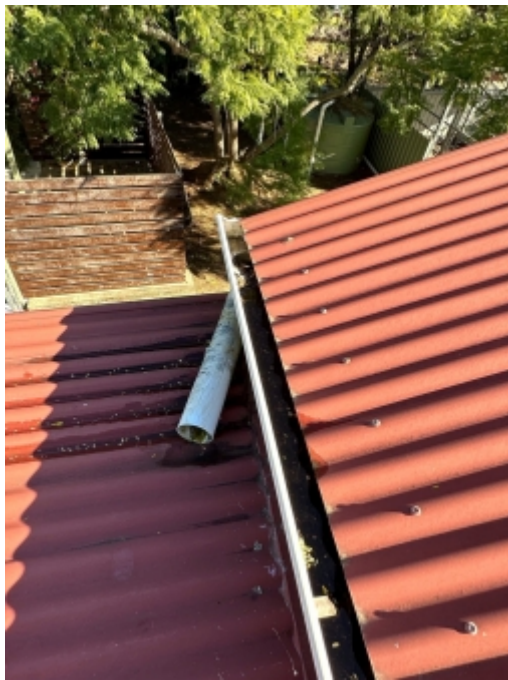
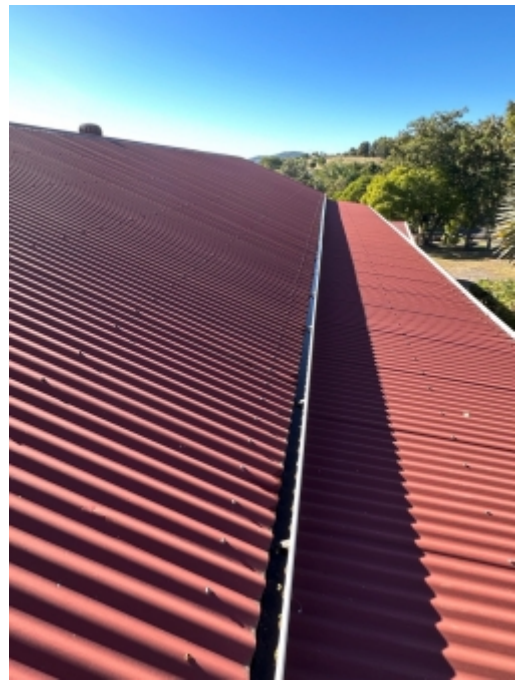
To front side of the roofing

Insufficient fall to gutters, gutter is holding water. Recommend engaging a plumber to rectify to reduce the risk of rust and water overflowing into the building.

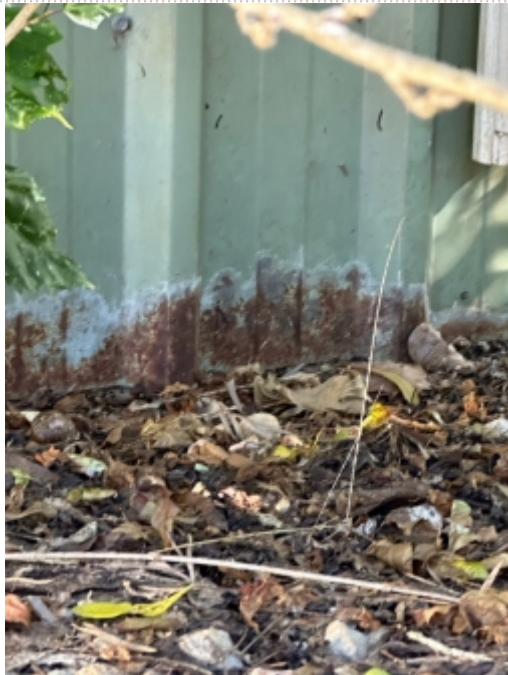
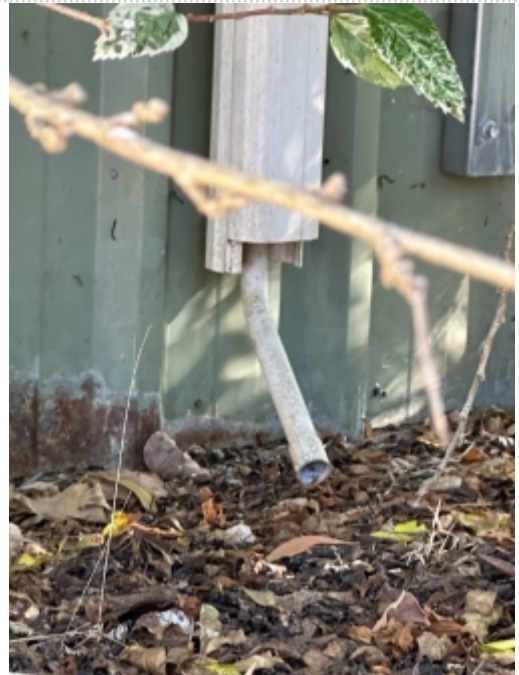
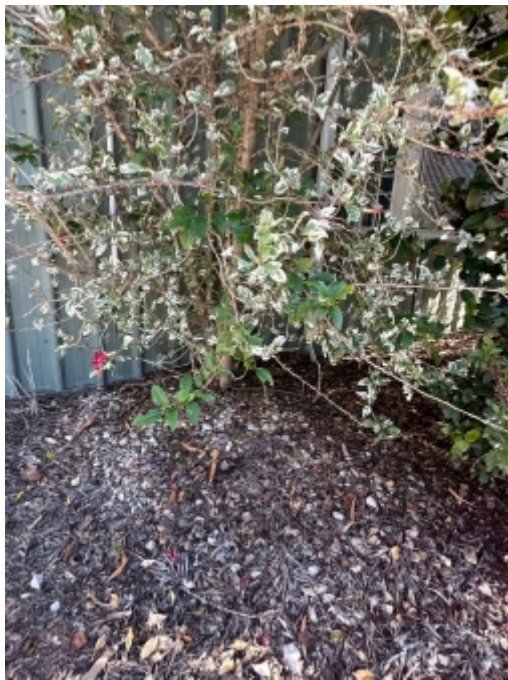
Details of Major Defect	Rust to parts of metal sheeting. Recommend engaging a builder to repiar/replace as required to reduce the risk of further deterioration.
	To granny flat external walls

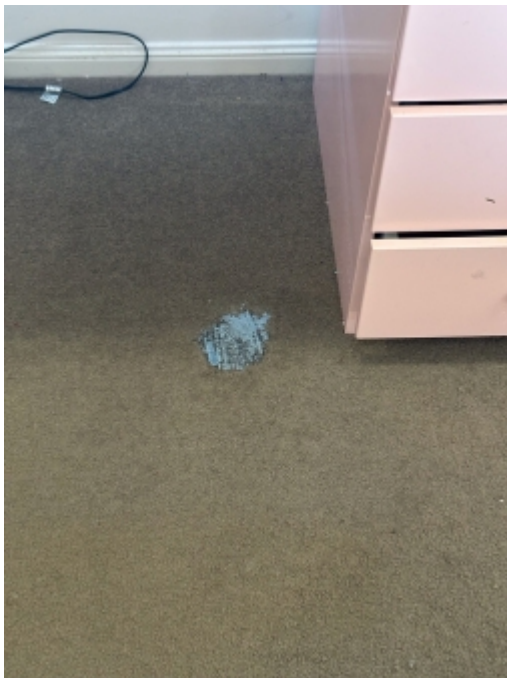
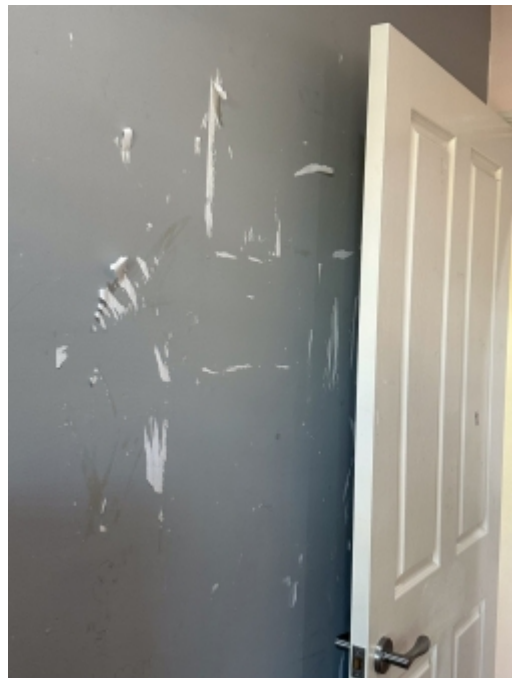
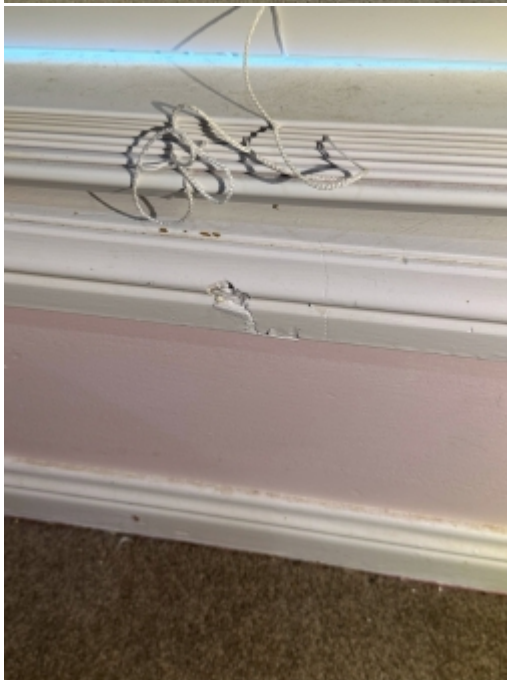
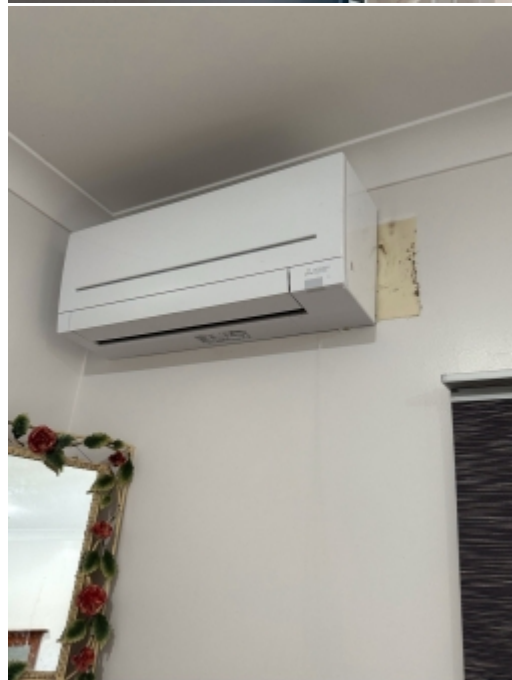
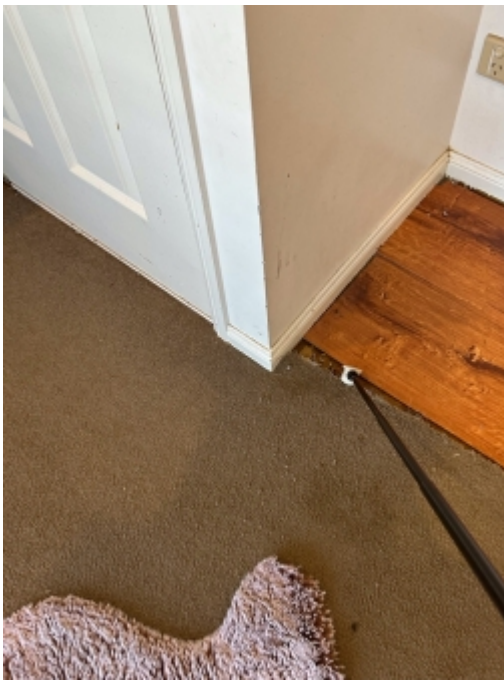
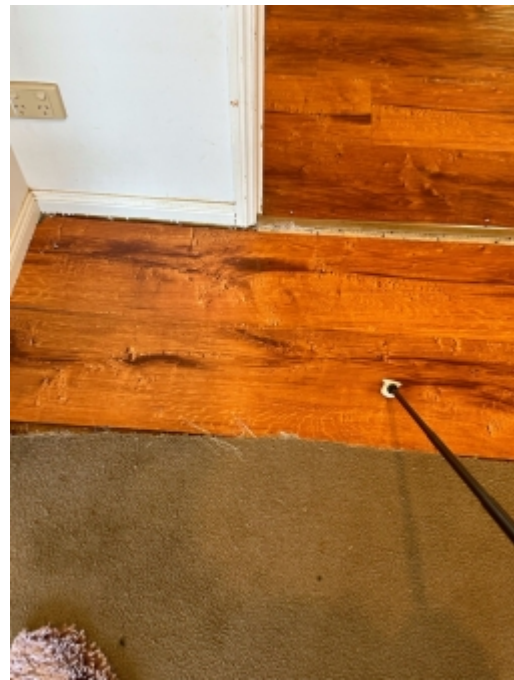
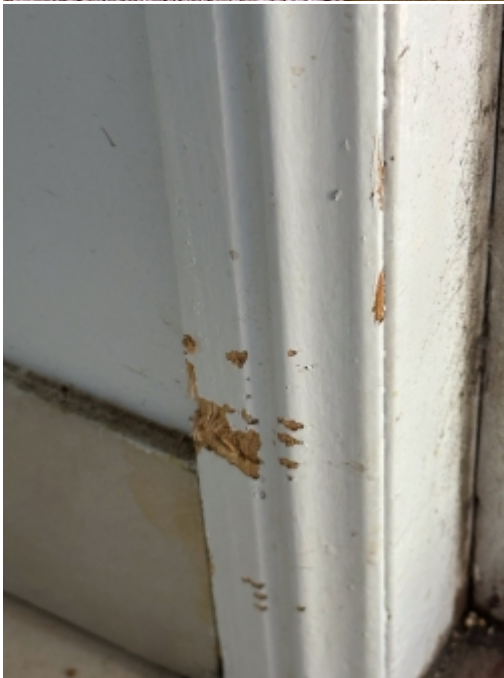
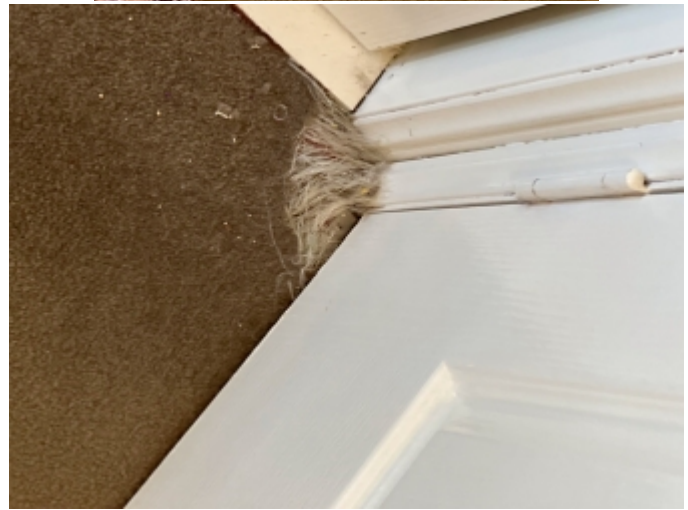
Showing examples of paint issues, damages, scuffing and chipping throughout the property

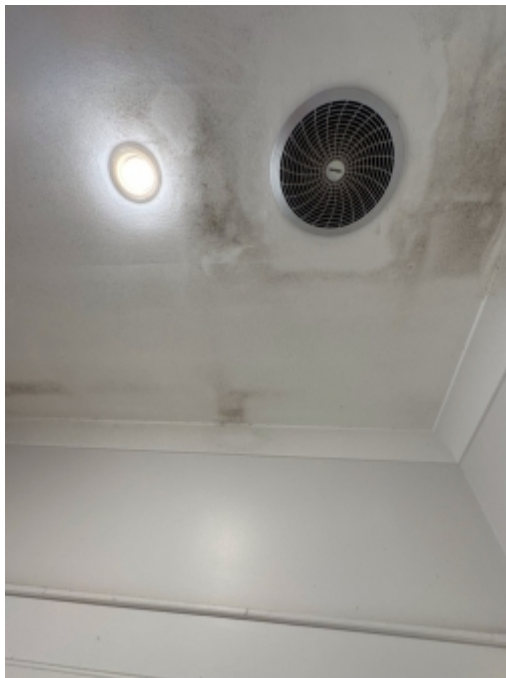
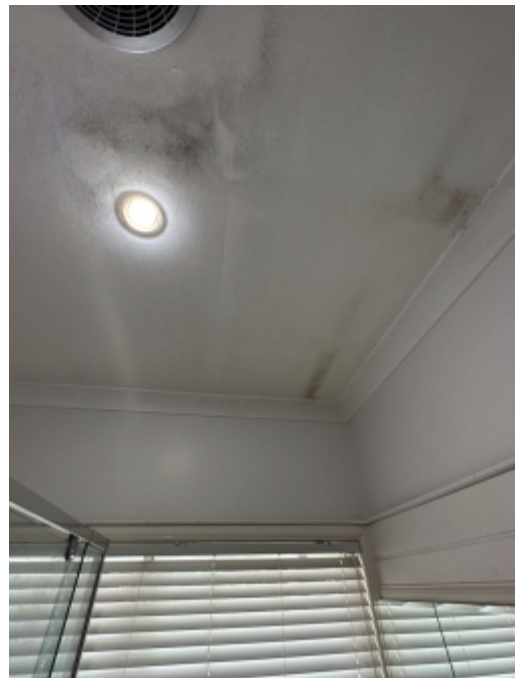
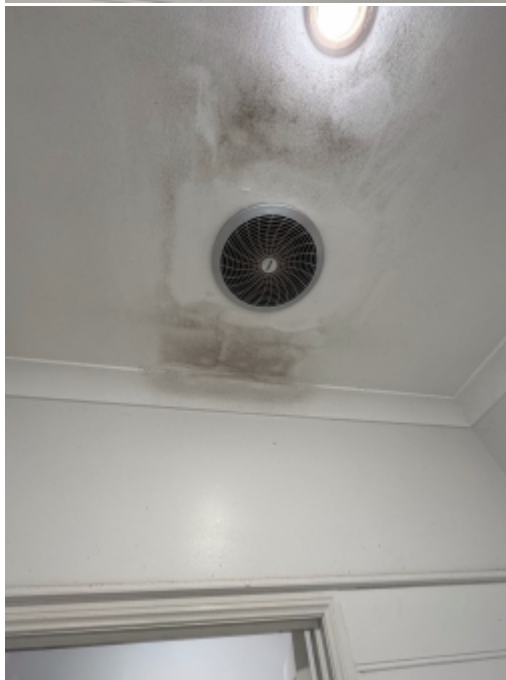
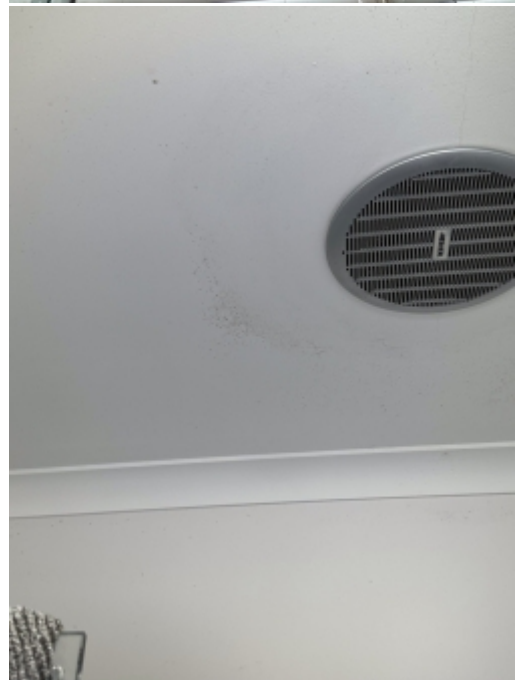
Showing examples of staining to parts of ceiling at bathroom and ensuite

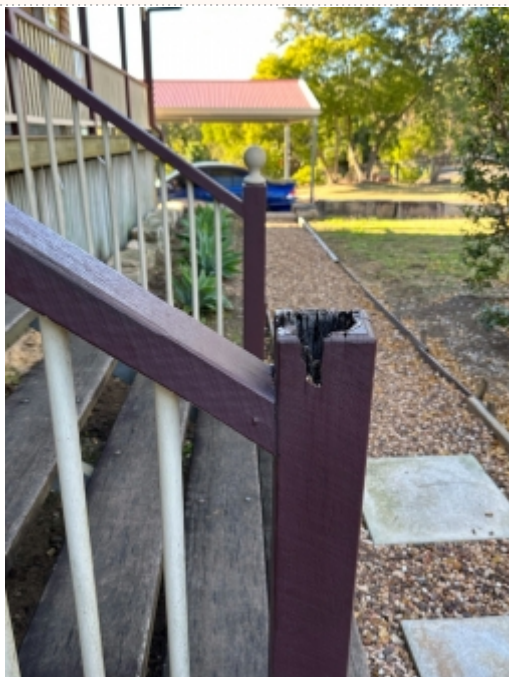
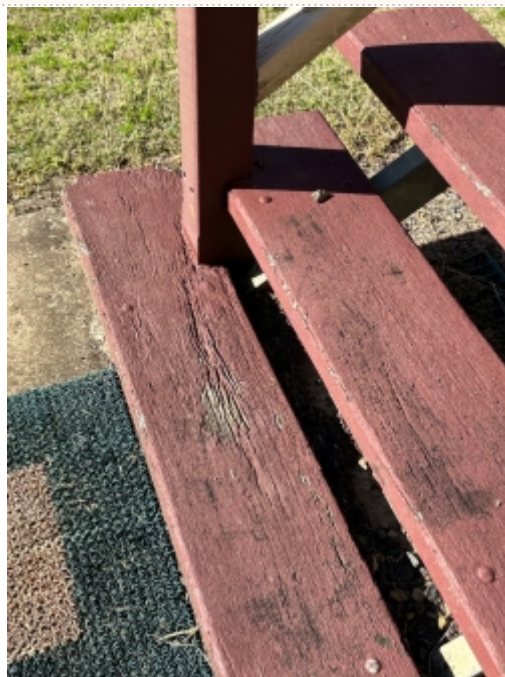
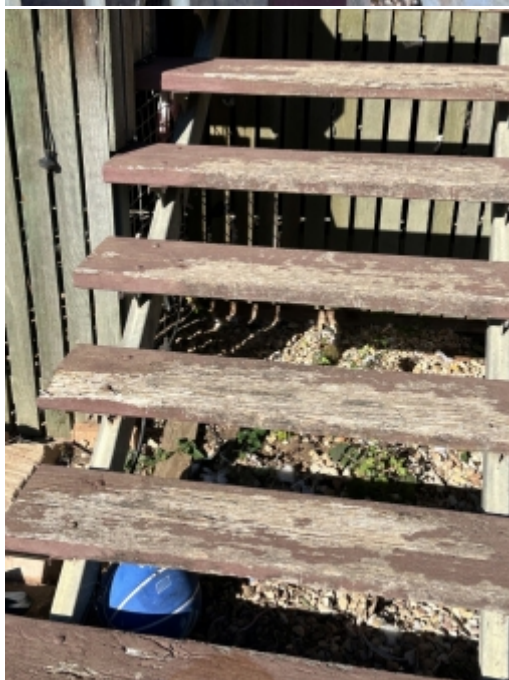
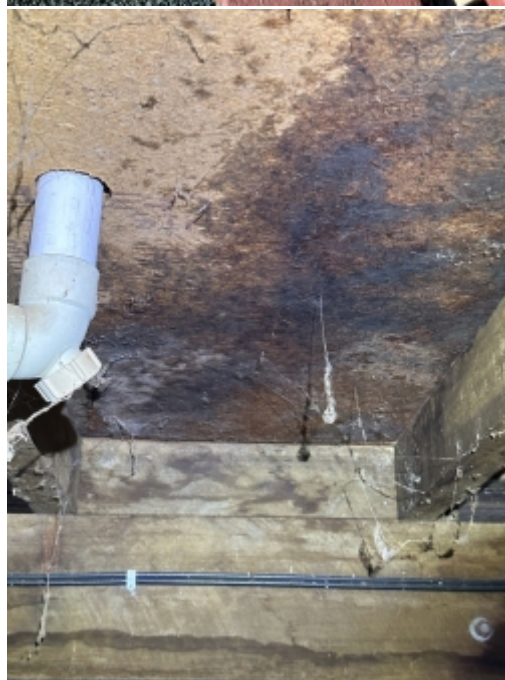
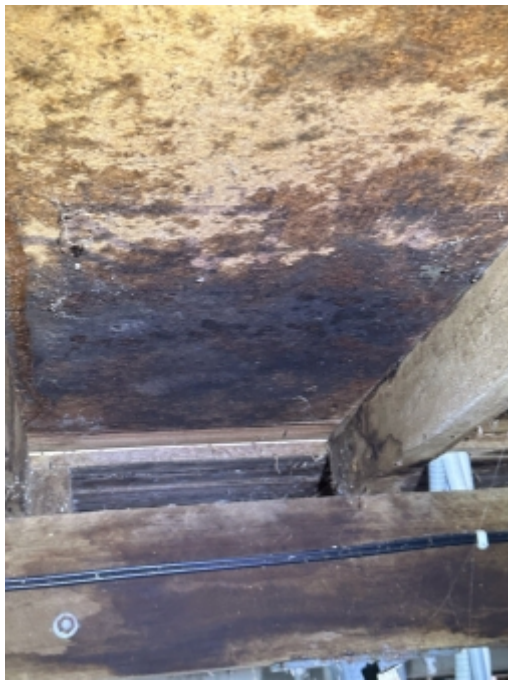
Photo Comments	Showing examples of wood rot
----------------	------------------------------

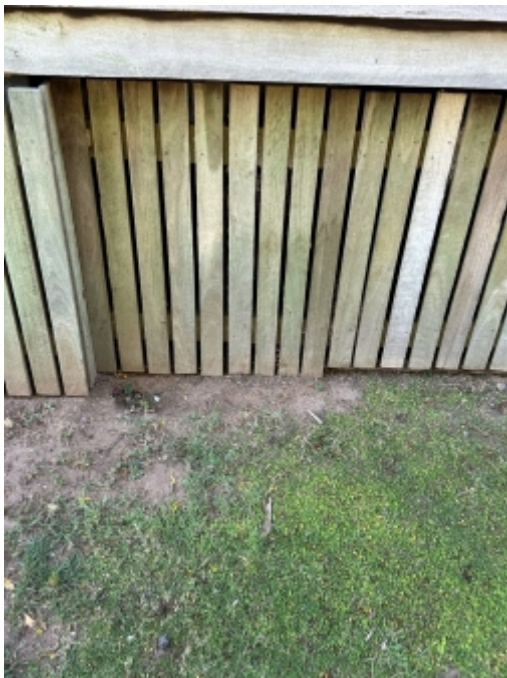
Additional Comments	Timbers in contact with ground - recommend exposing 75mm under timbers to allow for visual inspection zone and to prevent the risk of wood rot and termite attack
---------------------	---

Photo Comments	Showing examples of timber in contact with ground to parts of subfloor batten screens
E12 Untreated or non-durable timber used in a hazardous environment	No evidence was found
E13 Other conditions conducive to timber pest attack	The following evidence was found
Additional Comments	Timber debris accumulated to gardens, eliminate any source of timber debris Garden beds and vegetation against external walls - recommend removing

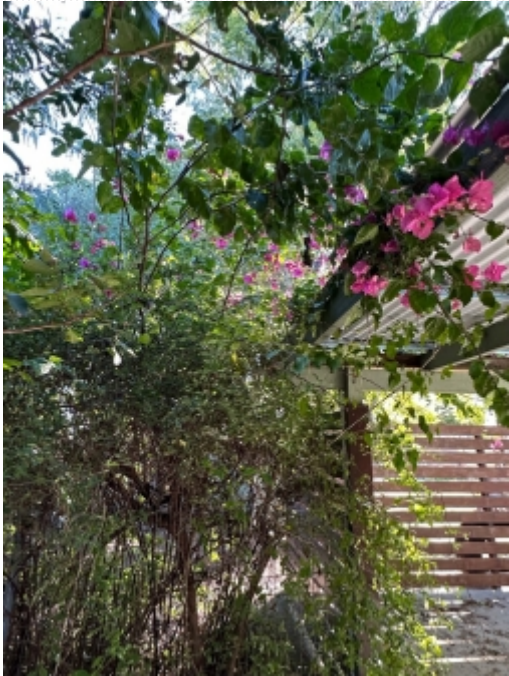
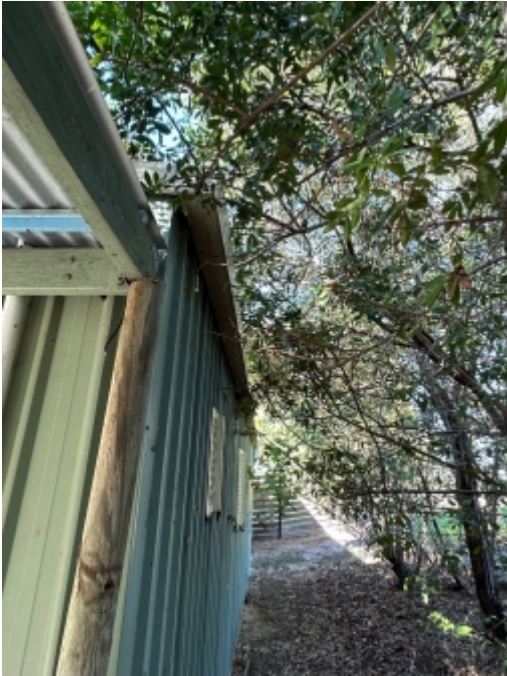
Photo Comments	Showing examples of tree branches against the granny flat
----------------	---

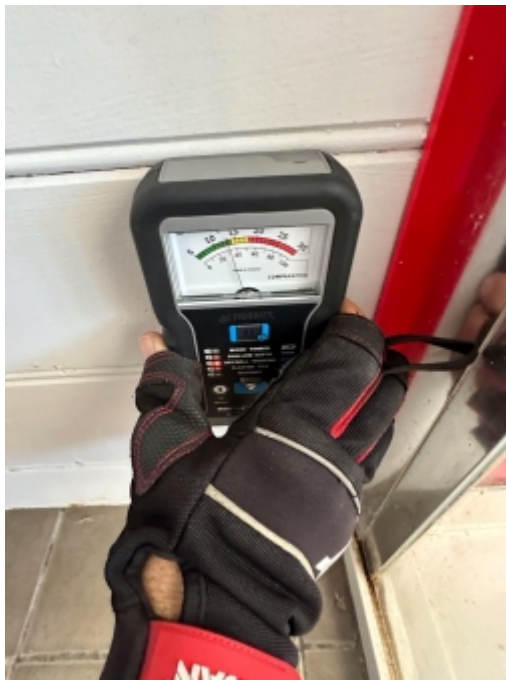
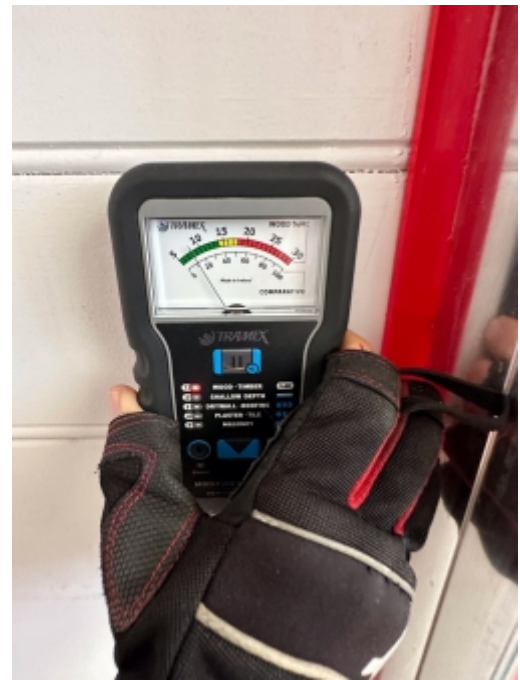
Showing examples of moisture readings in the property that did not show a high moisture reading
