SI - SDA STAGE - Stage Inspection Report

08 Feb 2024

Email Report To:	info@articon.com.au
Report Number:	APCI01531
Inspection Date:	08 Feb 2024
Address of the Property Inspected:	lot 8735/84 Barham Way Spring Mountain 4300 Queensland Australia
Photo of Property

Inspection Type: Frame

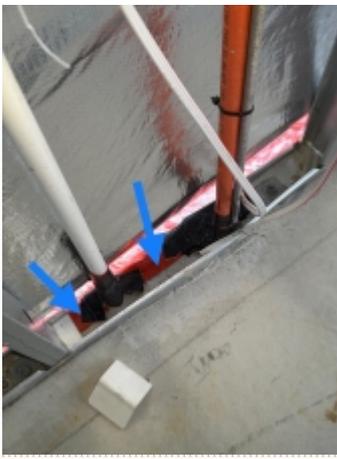
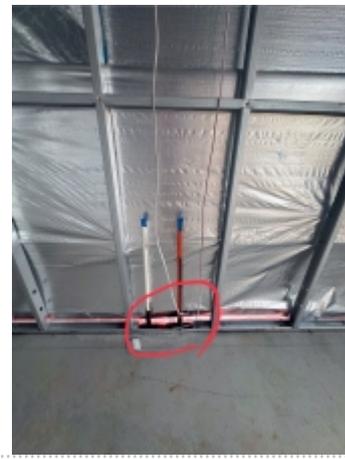
Wall Frame

Discontinues loadbearing wall to the Lounge area

Top and bottom plate in load-bearing and/or bracing walls must be continuous. The cut-out sections of such bottom plates must be fixed using an alternative solution. Top and bottom plates in internal non-loadbearing and non-bracing walls may be discontinuous up to 60 mm (cut or drilled) to permit installation of services provided that, at the discontinuity, the plates are trimmed or otherwise reinforced either side of the discontinuity to maintain the lateral and longitudinal integrity of the wall. AS1684.4 - 6.2.1.4

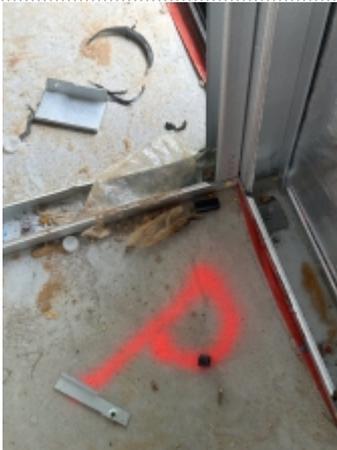
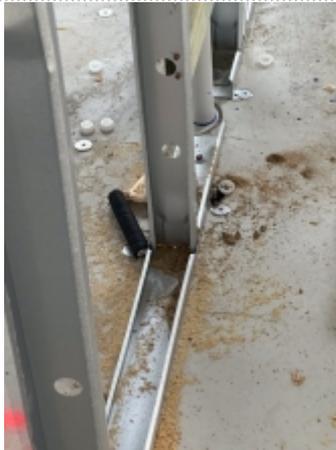
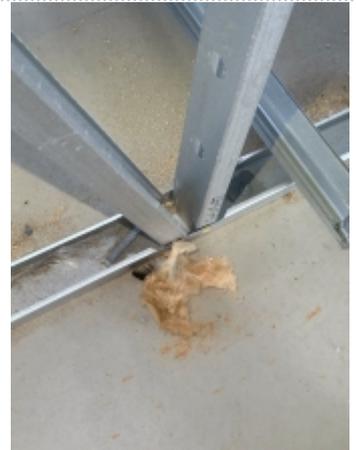
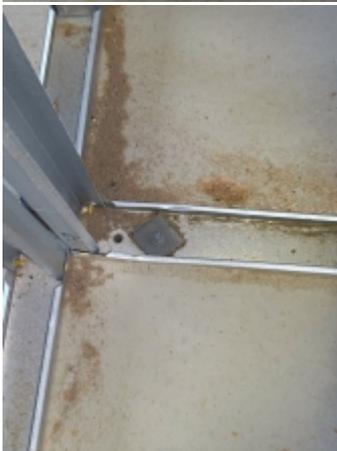
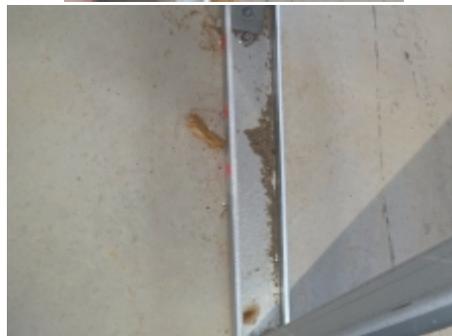
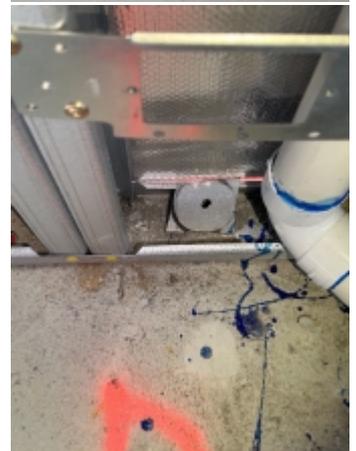
Wall Frame

Debris to parts of bottom plate throughout the property, needs cleaning prior to wall lining installation to reduce the risk of rust.

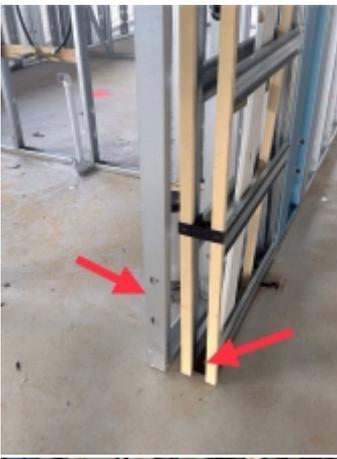
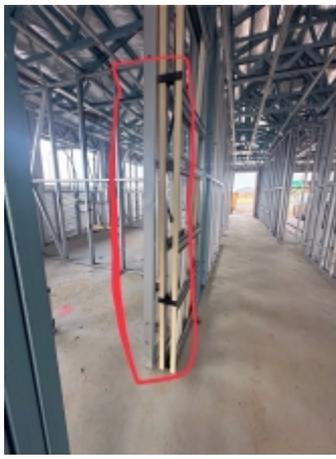
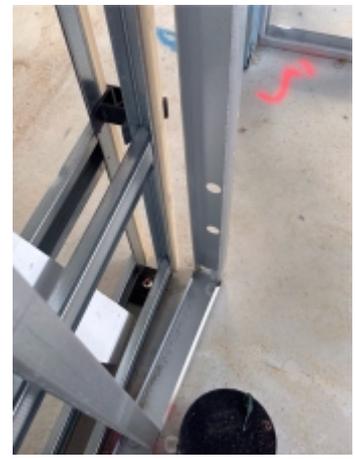
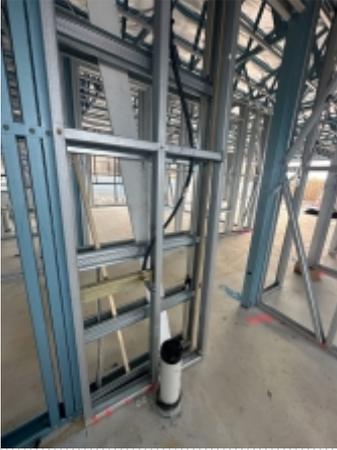
Wall Frame

Loose/unsecured wall frame to the bathroom, additional support required to prevent the wall from the lateral movement. Recommend engaging a builder for further advice on repairs to prevent possible deterioration of the building.

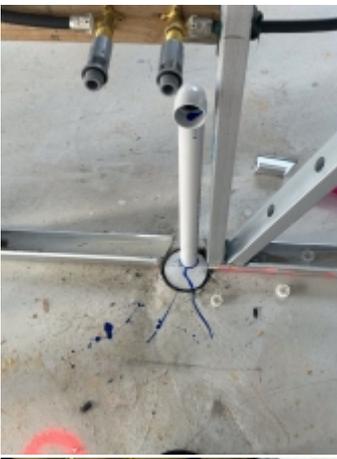
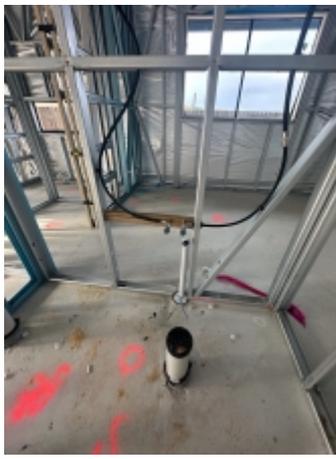
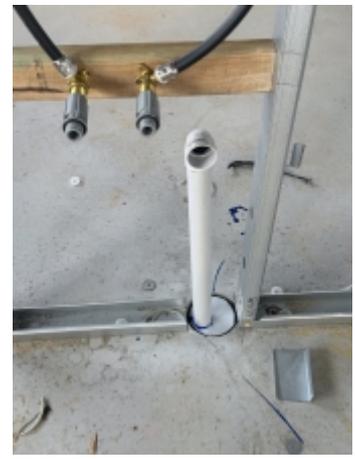
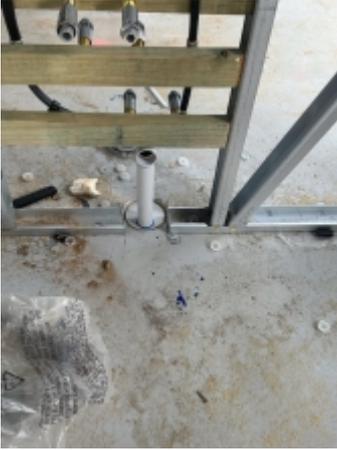
Discontinues- NON- loadbearing walls

Wall Frame

Bottom plates in internal non-loadbearing and non-bracing walls may be discontinuous up to 60 mm (cut or drilled) to permit installation of services provided that, at the discontinuity, the plates are trimmed or otherwise reinforced either side of the discontinuity to maintain the lateral and longitudinal integrity of the wall. AS1684.4 - 6.2.1.4

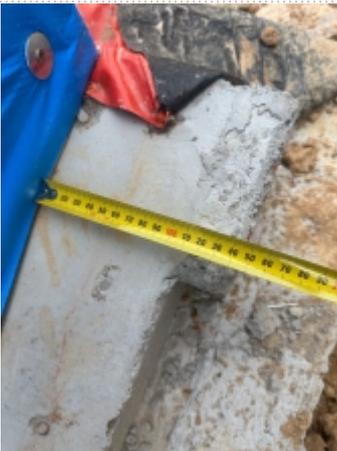
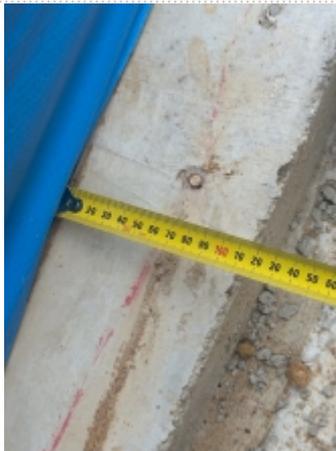
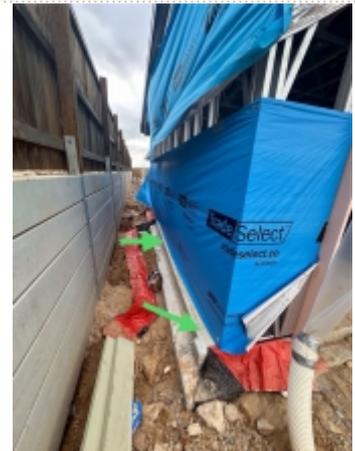
The concrete slab is out of the steel frame over 20mm, which reduces the cavity between the steel frame and brickwork to less than the minimum required. Trimming required to so that the slab is flush with the steel frame. Builder to ensure the reinforcement concrete cover maintains, otherwise the application of proper rod protection required. Slab trimming required.

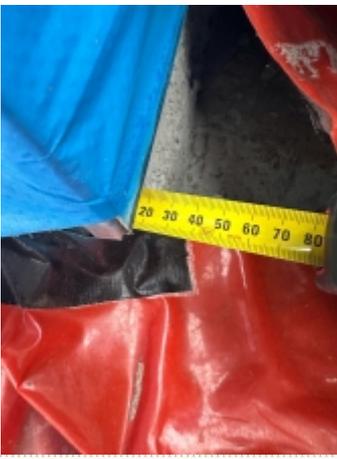
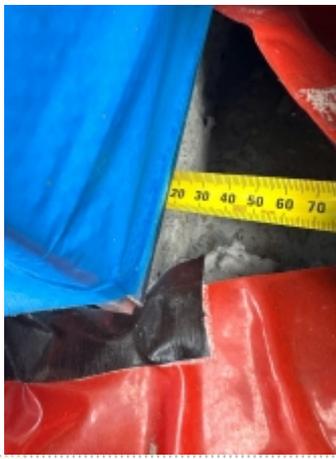
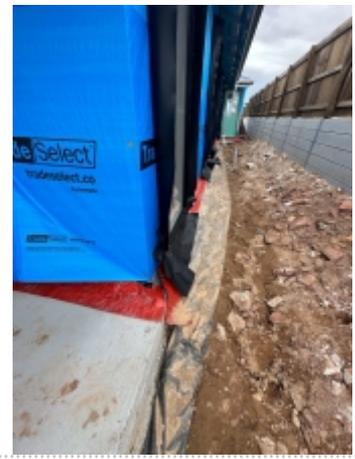
Steel frame bottom plates are overhung more than the maximum allowance of 10mm in one or more areas of the slab. Non-shrinkage cement-based material to be applied to the side of the slab rebate to cover under the bottom plate.

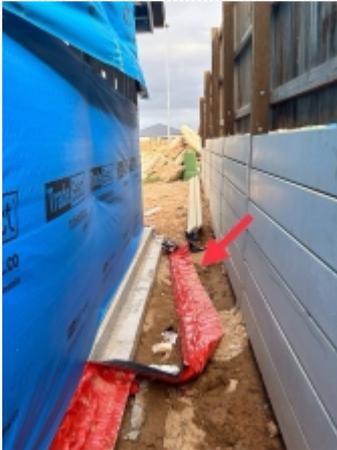
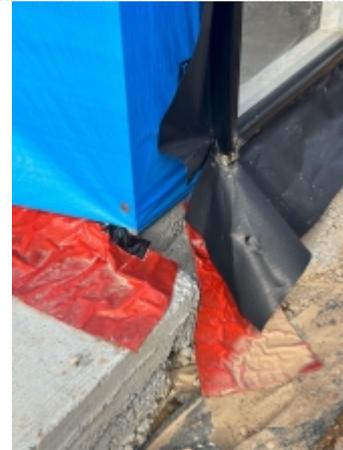
Some parts of physical termite barrier damaged or installed improperly. Fixing required.

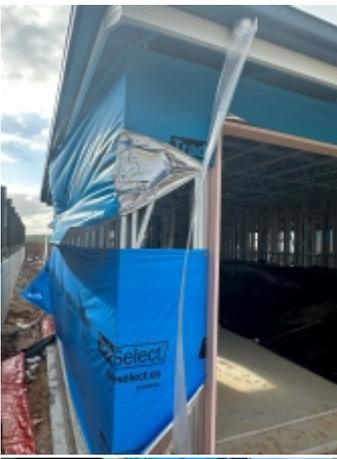
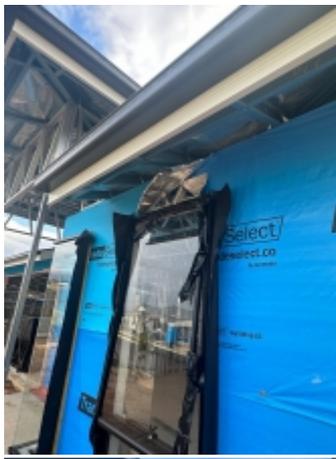
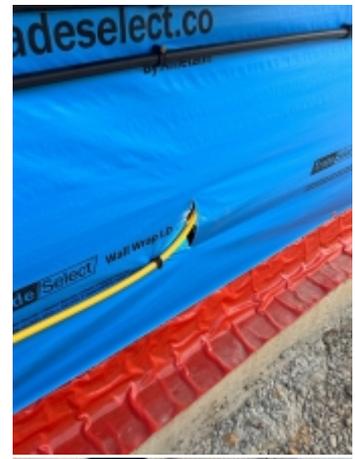
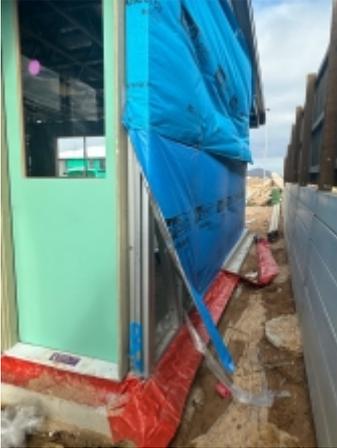
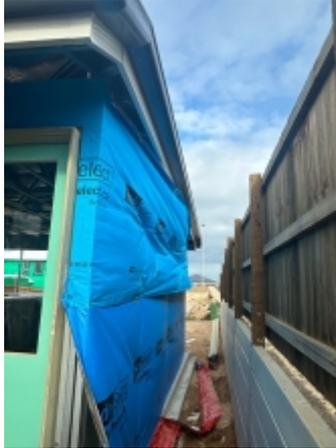
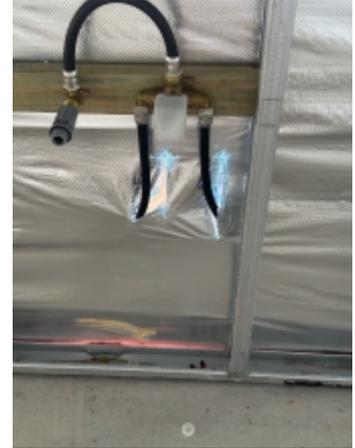
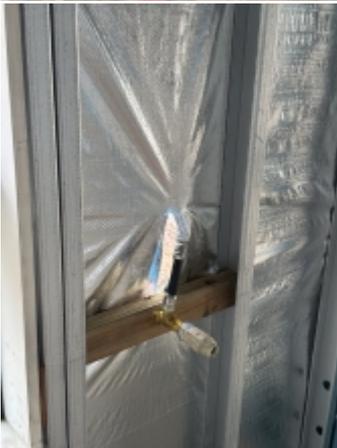
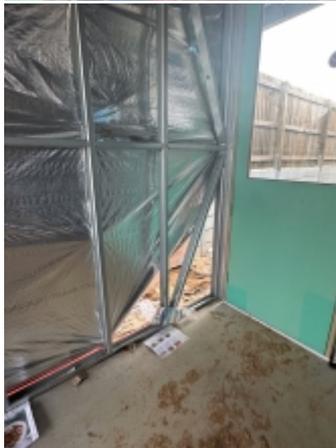
Missing/loose wall wrap/sarking to parts. Recommend engaging a carpenter to rectify.

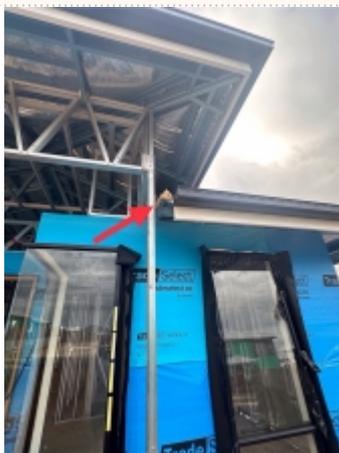
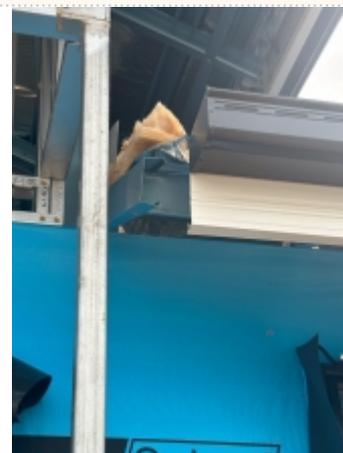
Missing Flashing/Facia to parts of front right side of the building. Recommend engaging a roofer for further advice on installation.
