LOT 13 MOON CRESCENT, STRETTON RESERVE

## **Pre-Purchase Standard Property Report**

Report number:	APCI01566
Inspection Date:	08 Mar 2024
Property Address	LOT 13 MOON CRESCENT, STRETTON RESERVE
Special conditions or instructions	
Special conditions or instructions	There are no special conditions or instructions.
The parties	
Name of Client:	Benjamin McDonough
Client's email:	benjamin.a.mcdonough@gmail.com
Client's telephone number:	0433876670

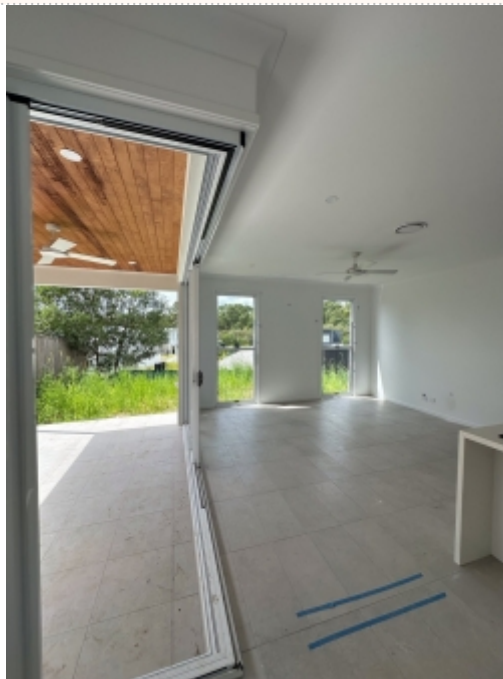
Photo of Obstruction

Showing an example of floor covering, walls and ceiling linings

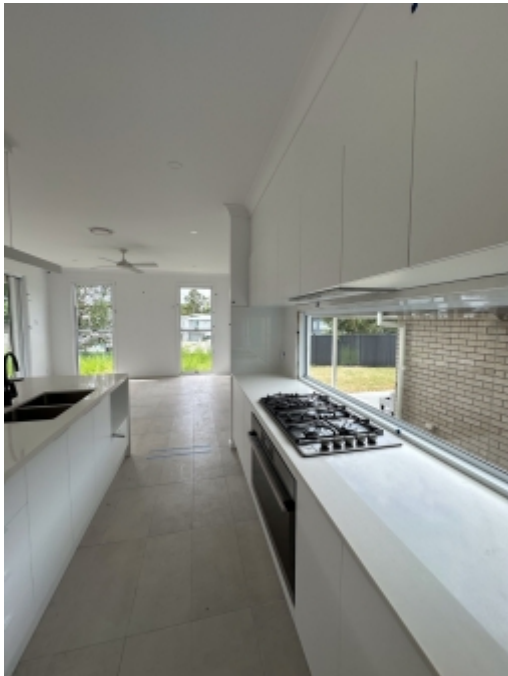
Photo of Obstruction

Showing an example of cabinetry

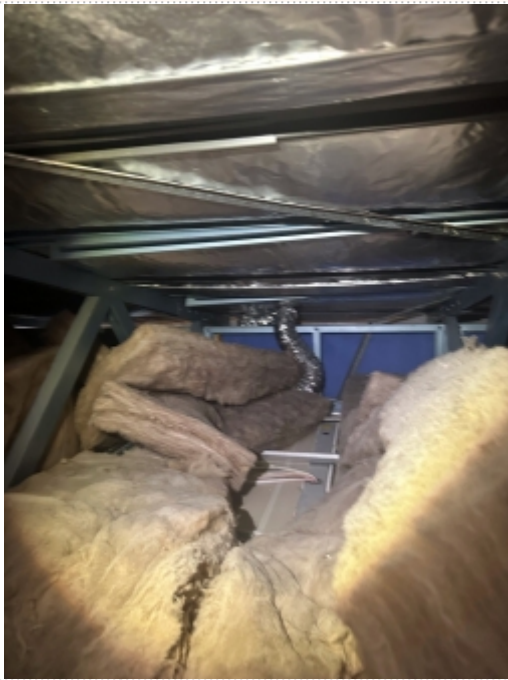
Photo of Obstruction

Showing an example of ducted AC and insulation

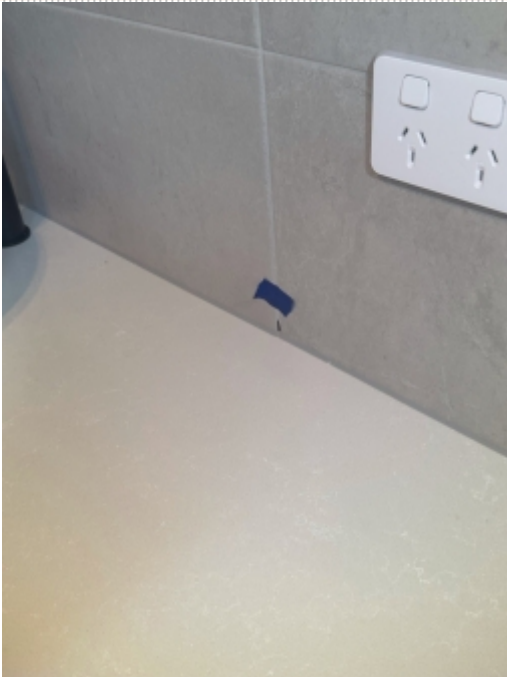
Details of Major Defect	Cracked/loose and missing silicone/grout to parts of wet areas. Recommend engaging a tiler to reseal the areas to reduce the risk of water leaks and damage
Photo(s) of Defect

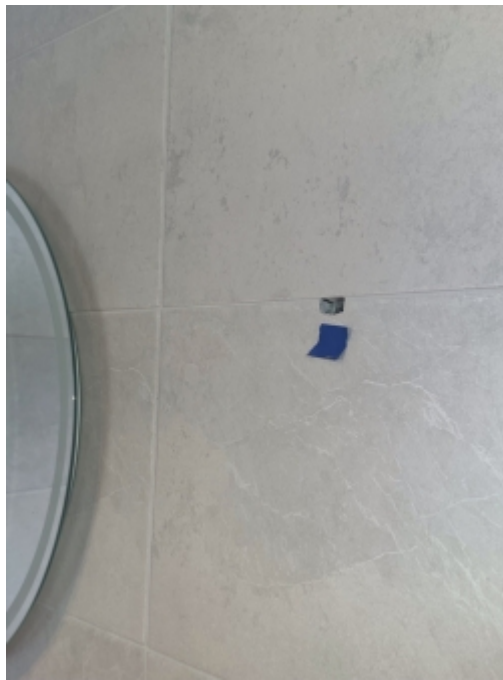
Hole to wall tile above vanity splash back to the Ensuite. Recommend engaging a tiler to replace the damaged tile.

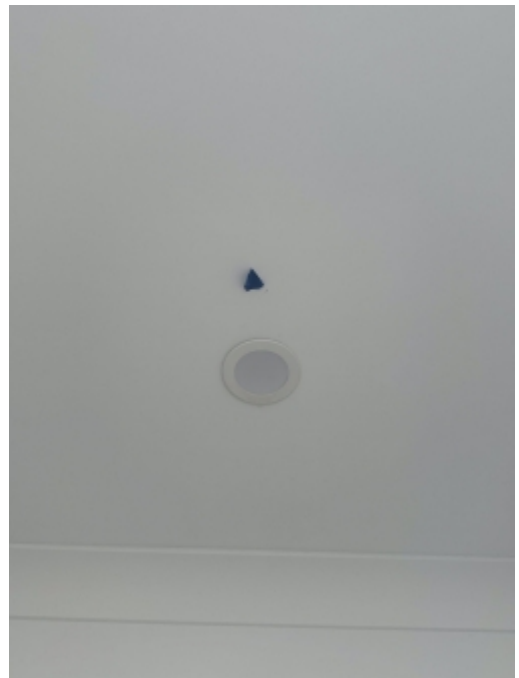
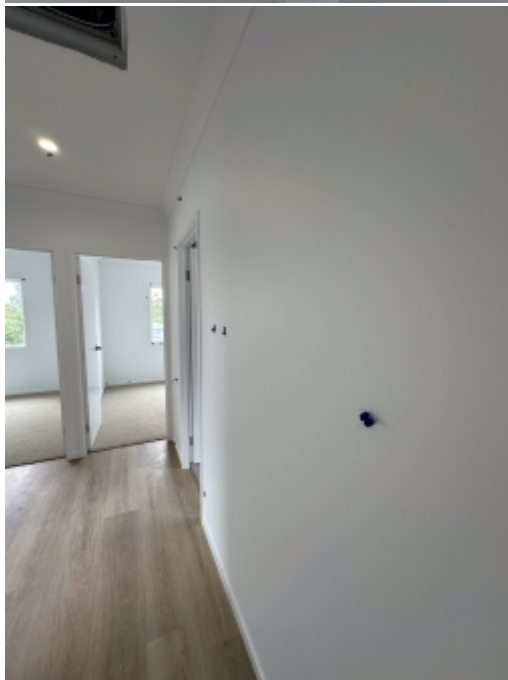
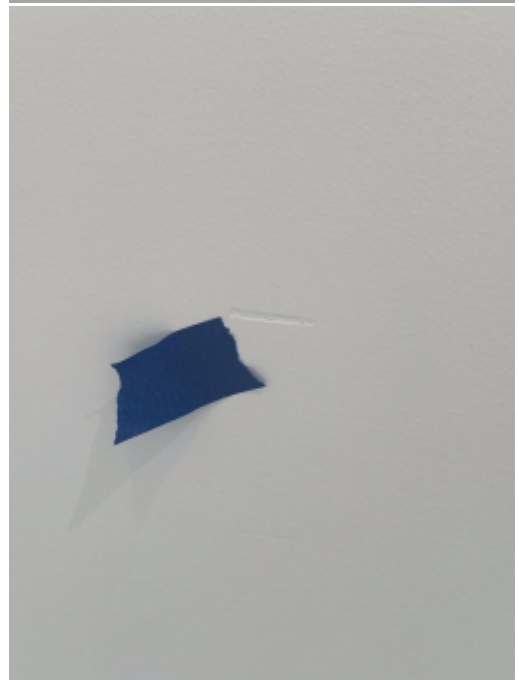
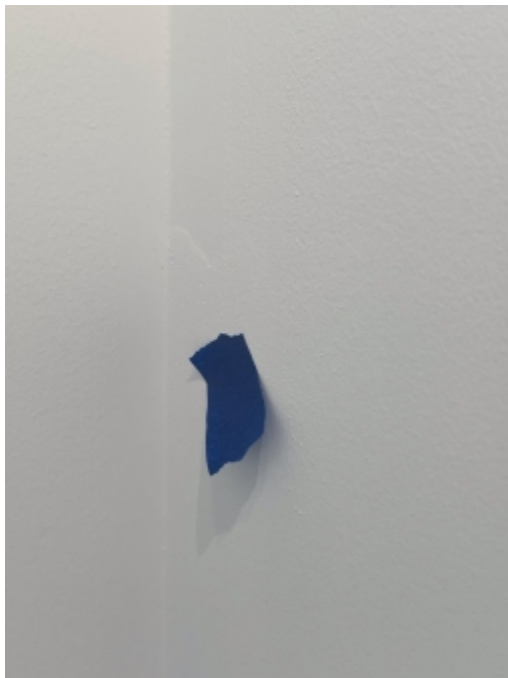
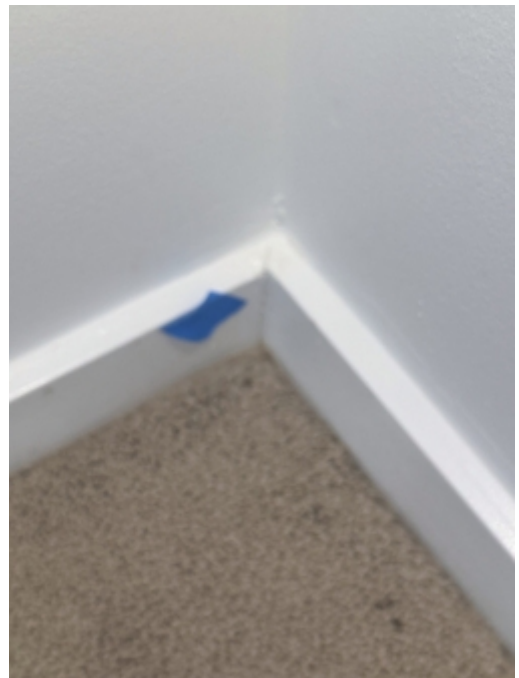
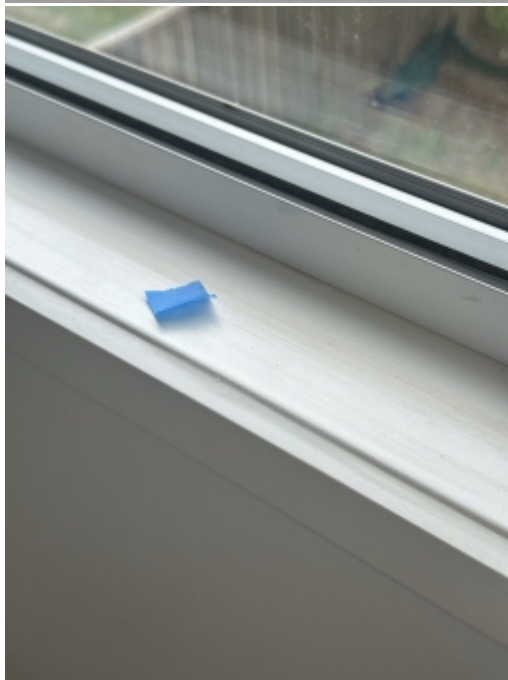
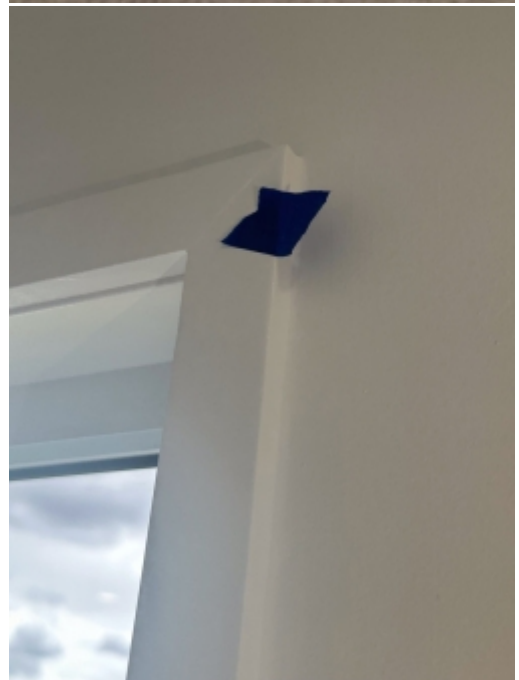
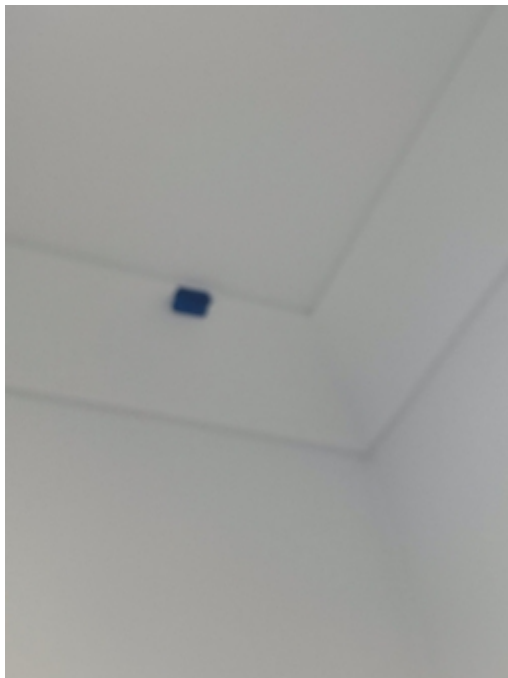
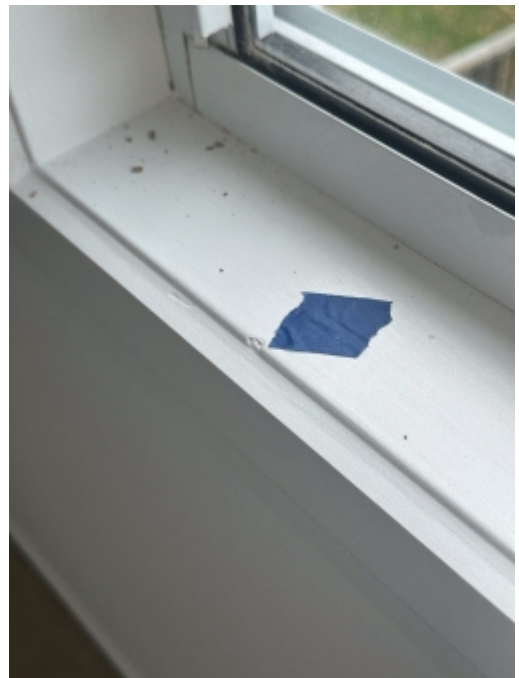
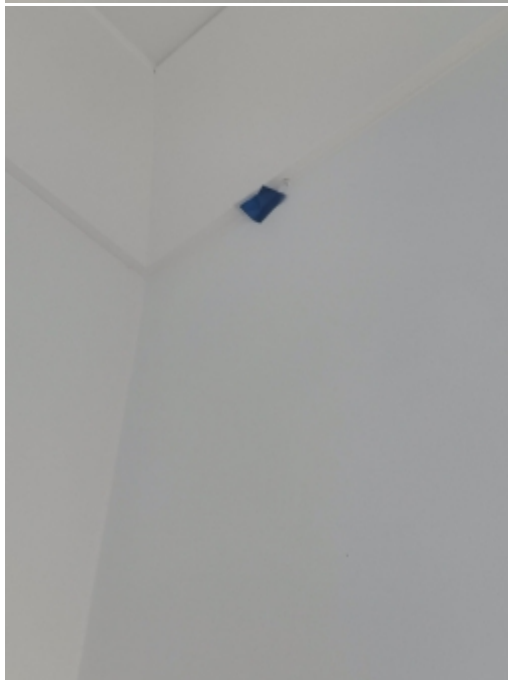
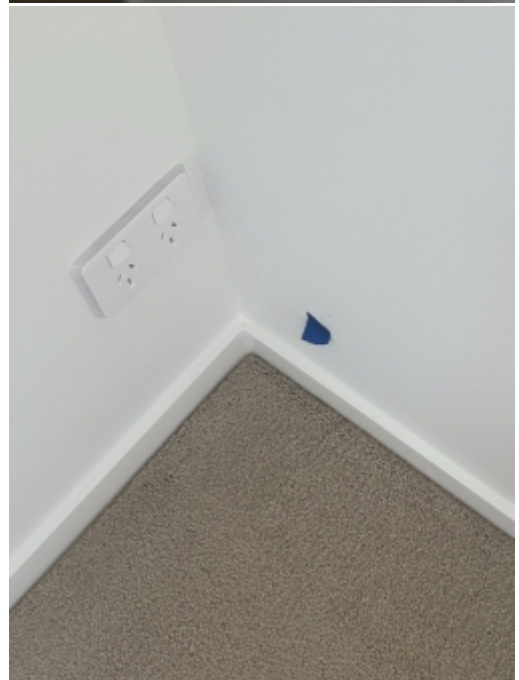
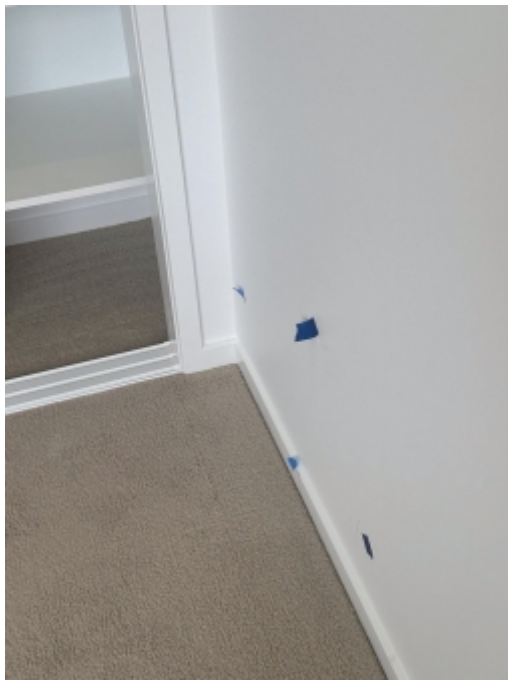
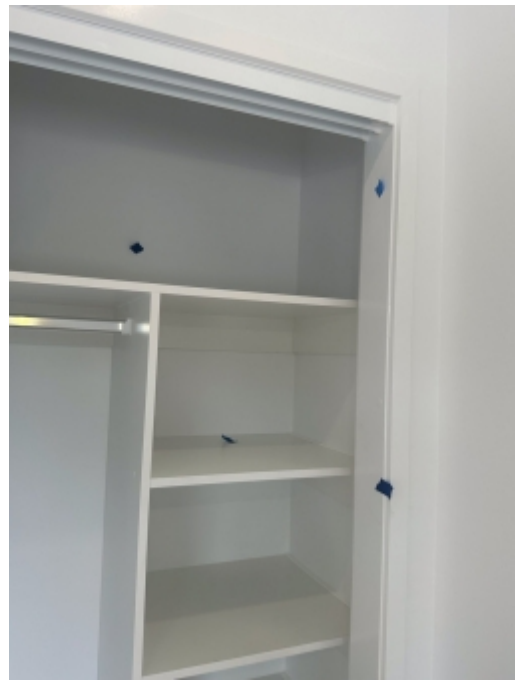
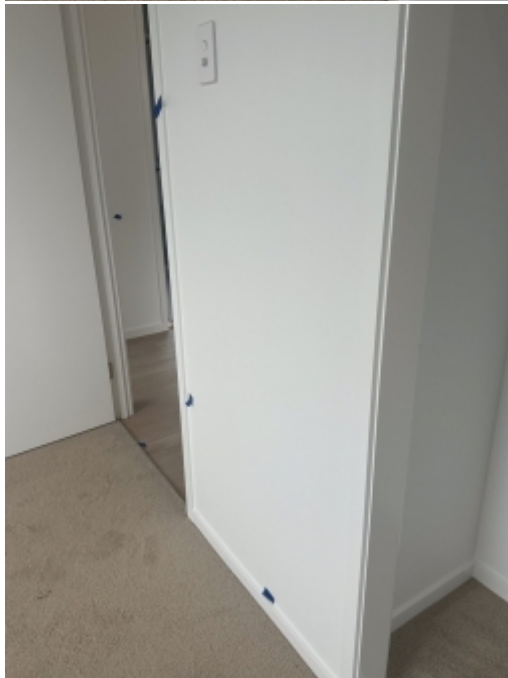
Showing examples of defective paintwork to the upstairs common area

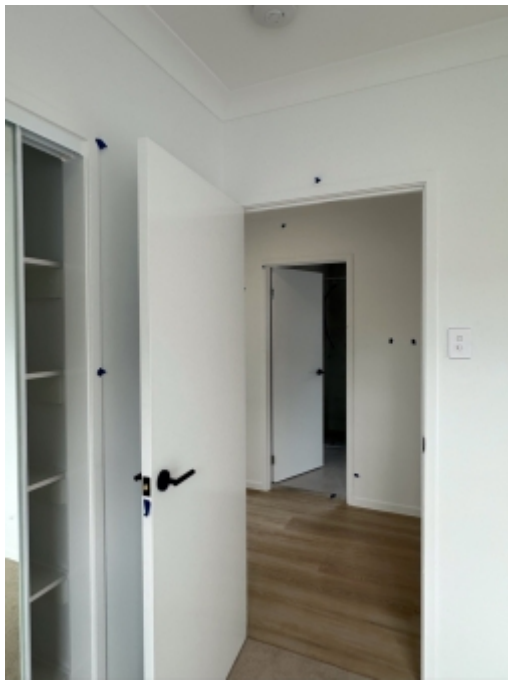
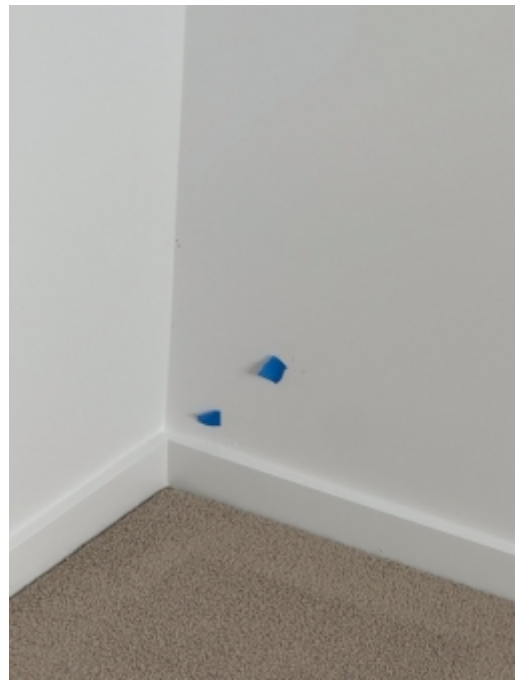
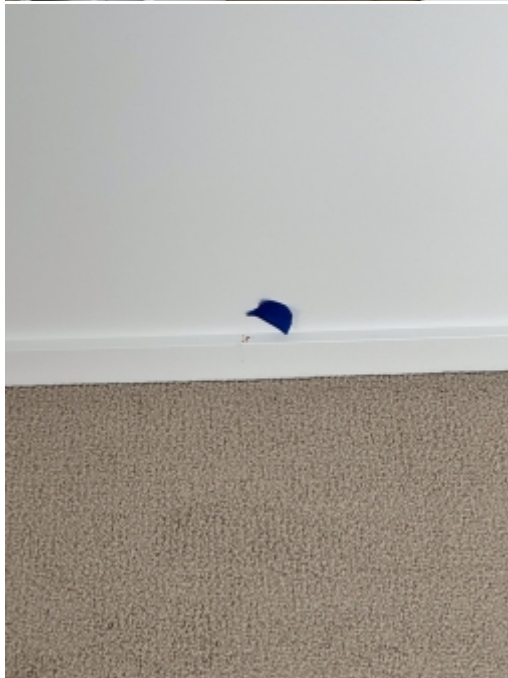
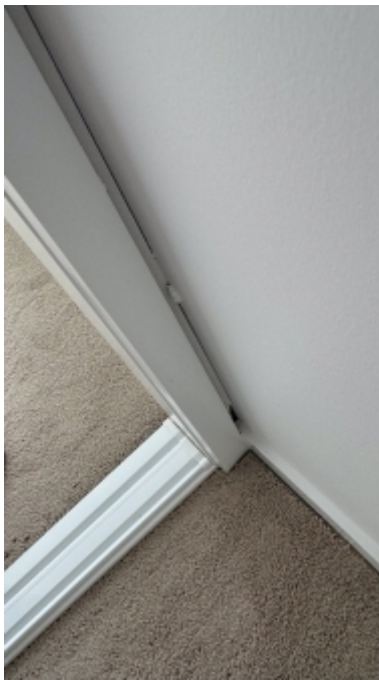
Showing examples of defective paintwork to the Bedroom 2

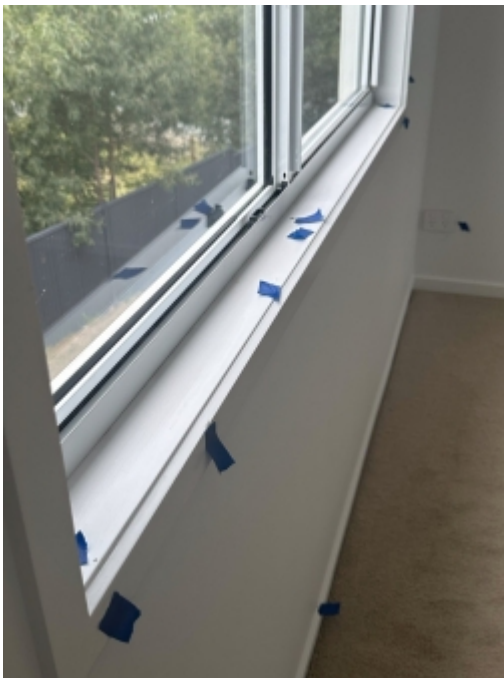
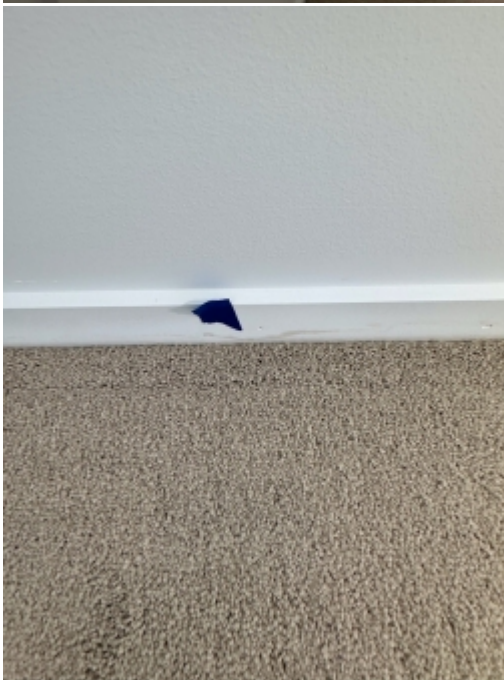
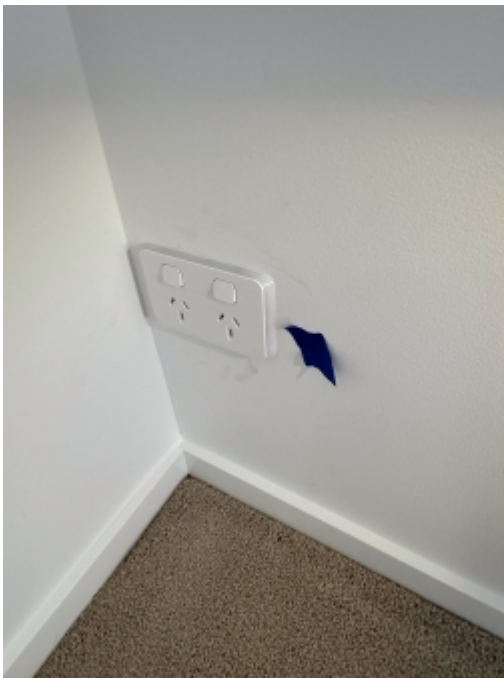
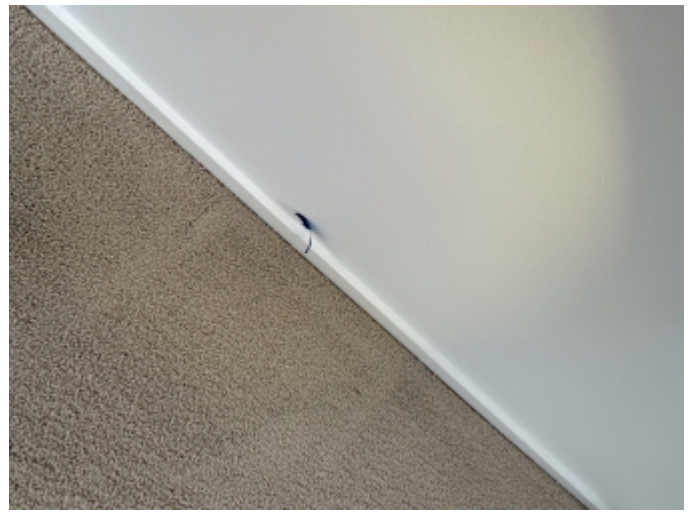
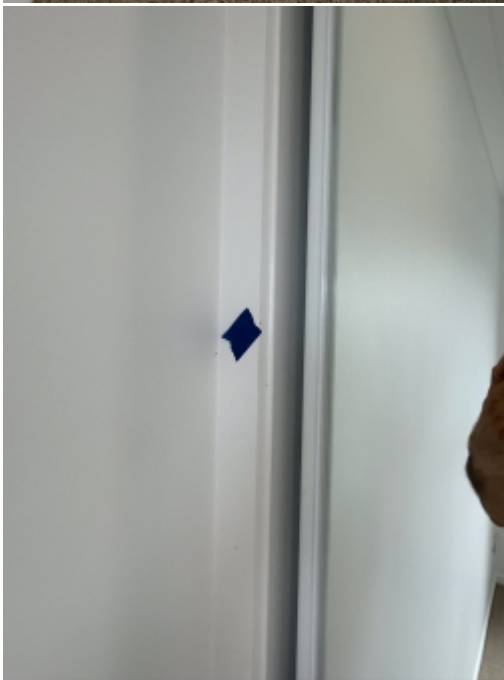
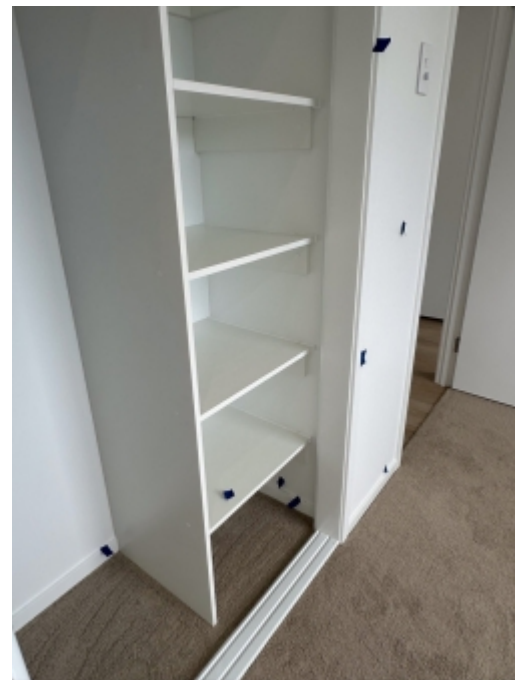
Showing examples of defective paintwork to the Bedroom 3

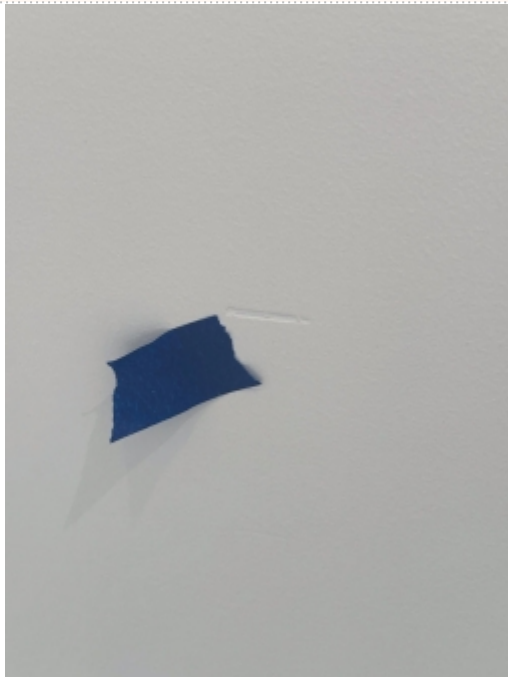
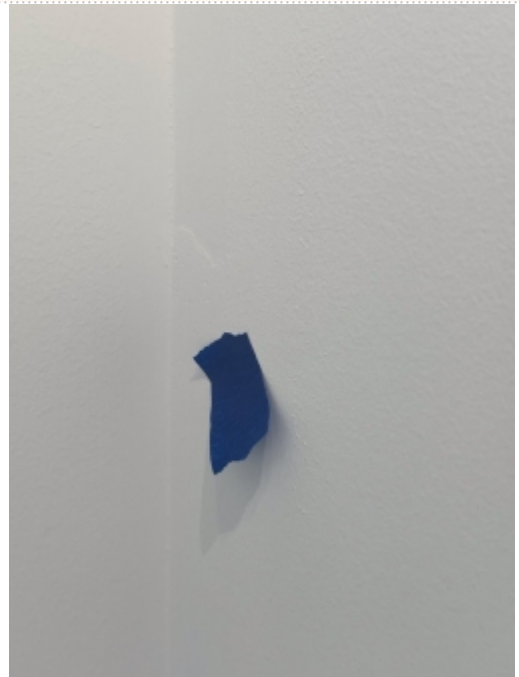
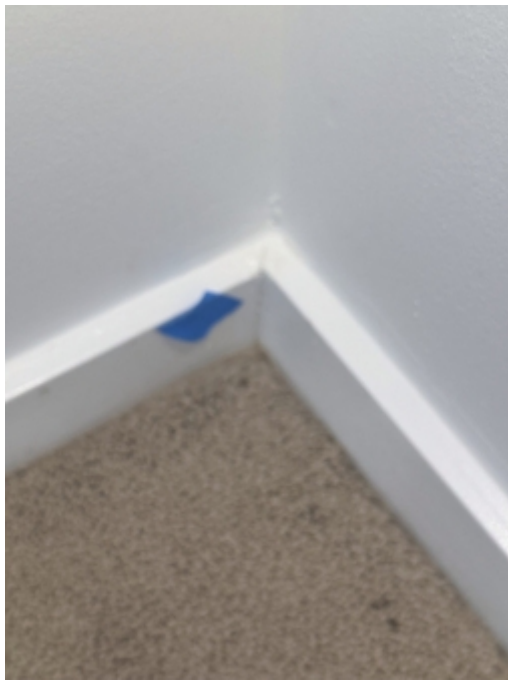
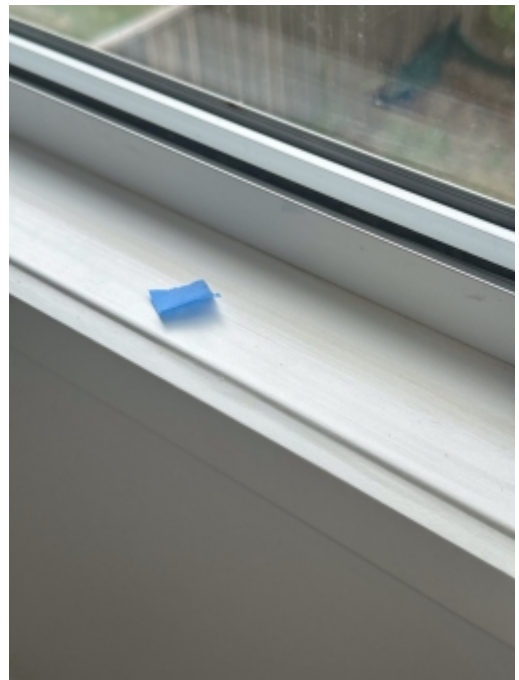
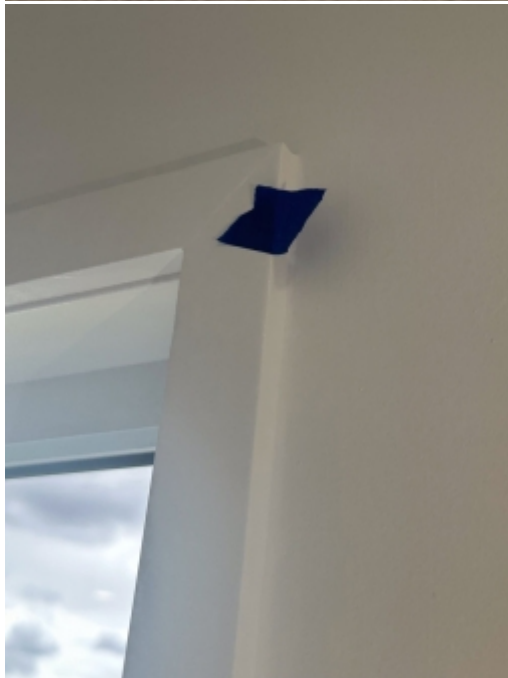
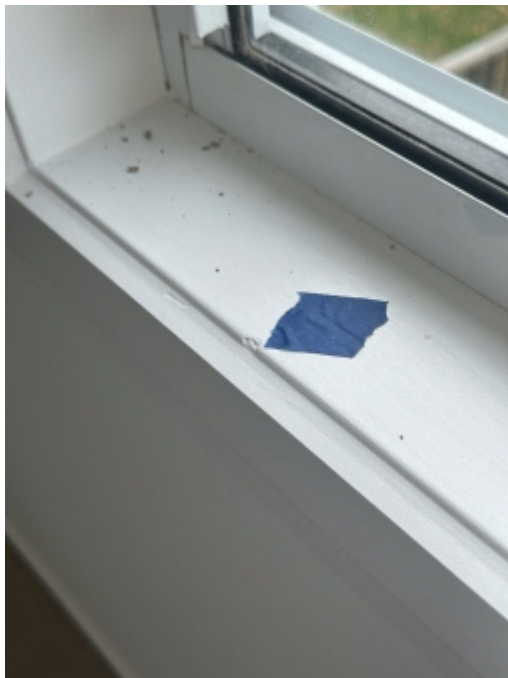
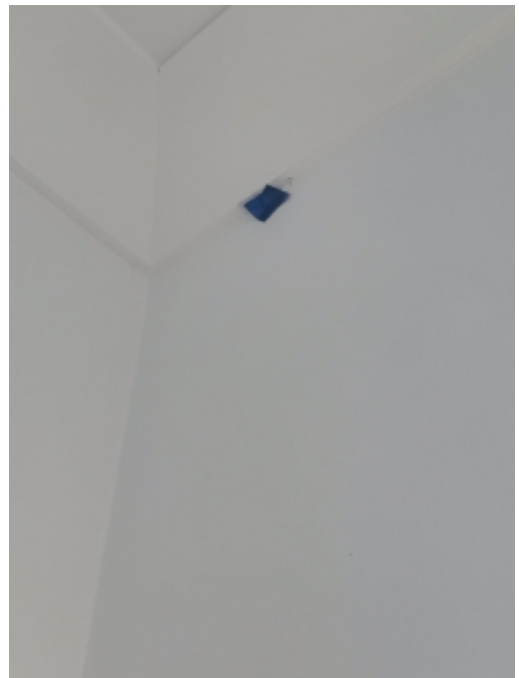
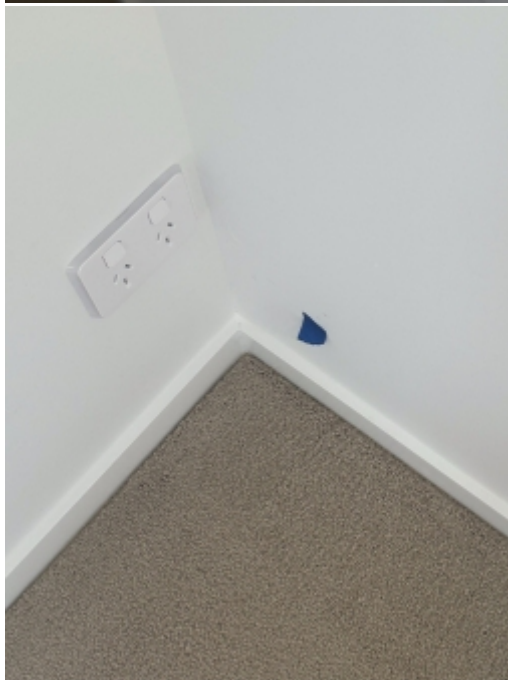
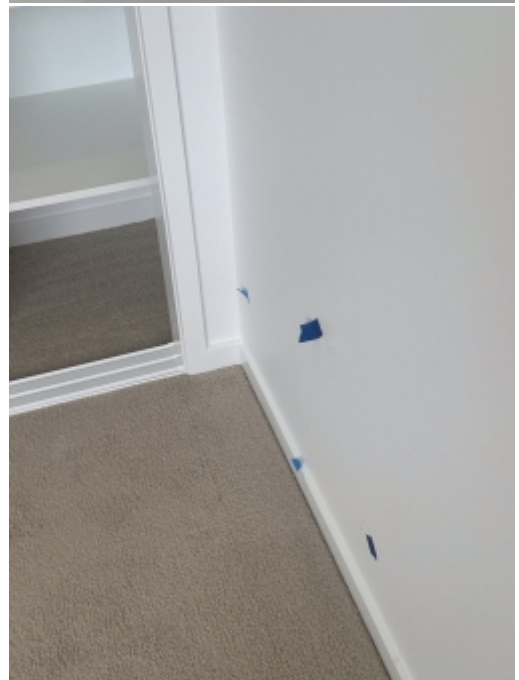
Showing examples of defective paintwork to the Bedroom 4
