LOT 13 MOON CRESCENT, STRETTON RESERVE

## **Pre-Purchase Standard Property Report**

Report number:	APCI01566
Inspection Date:	08 Mar 2024
Property Address	LOT 13 MOON CRESCENT, STRETTON RESERVE
Special conditions or instructions	
Special conditions or instructions	There are no special conditions or instructions.
The parties	
Name of Client:	Benjamin McDonough
Client's email:	benjamin.a.mcdonough@gmail.com
Client's telephone number:	0433876670

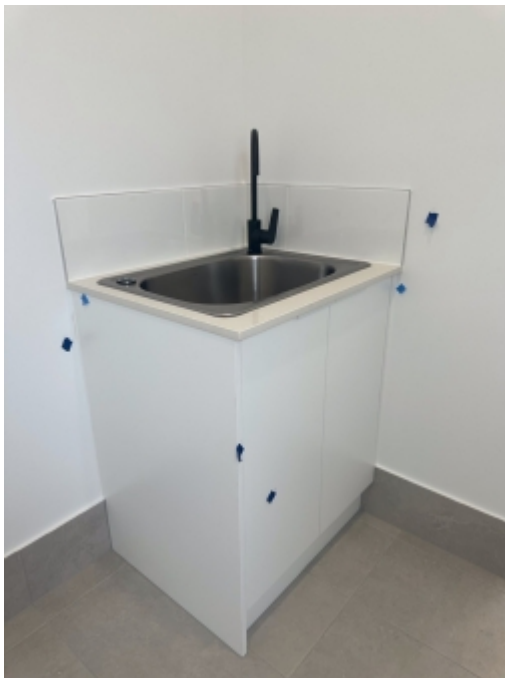
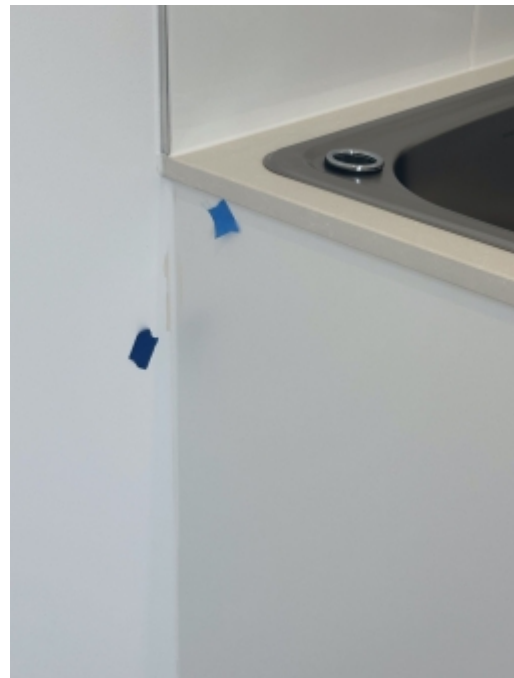
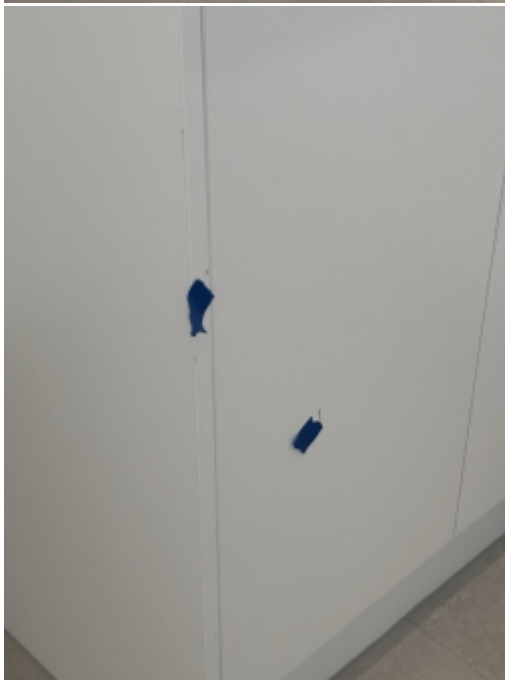
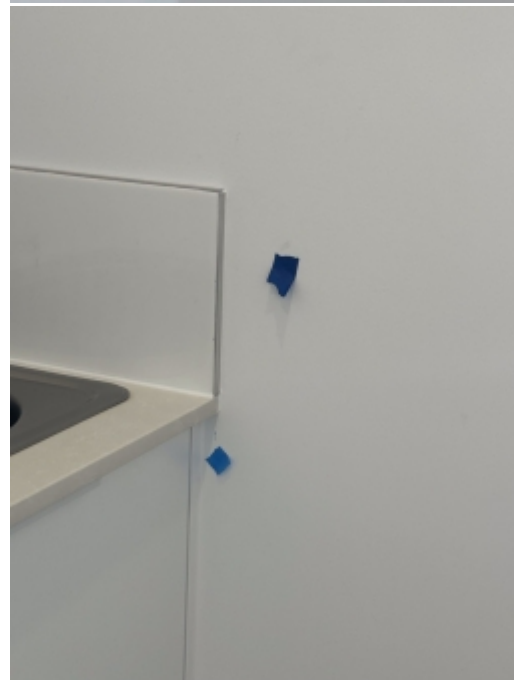
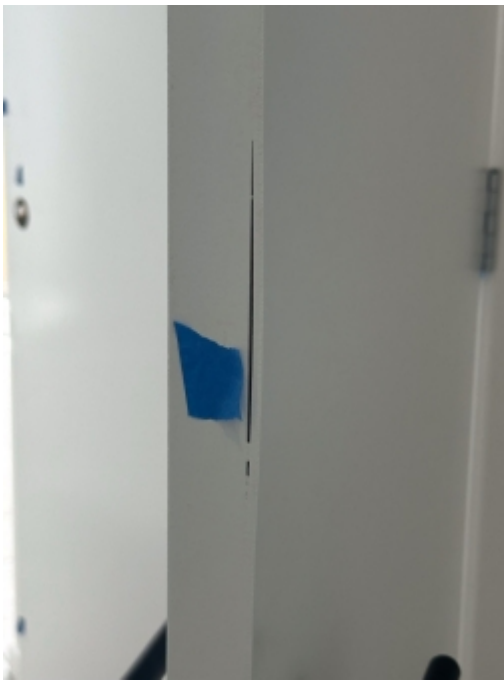
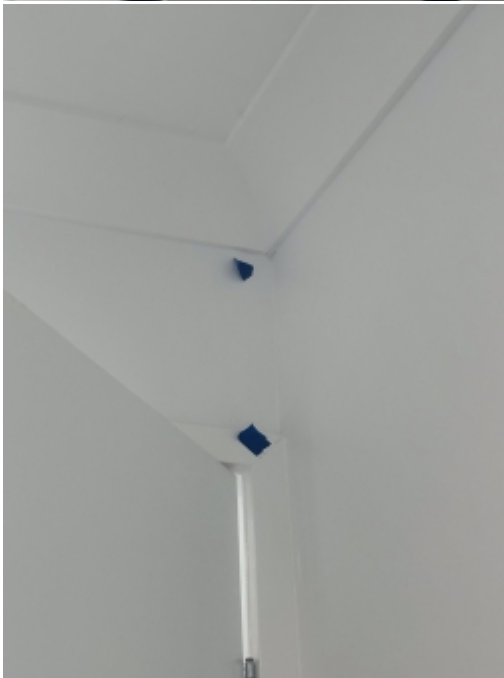
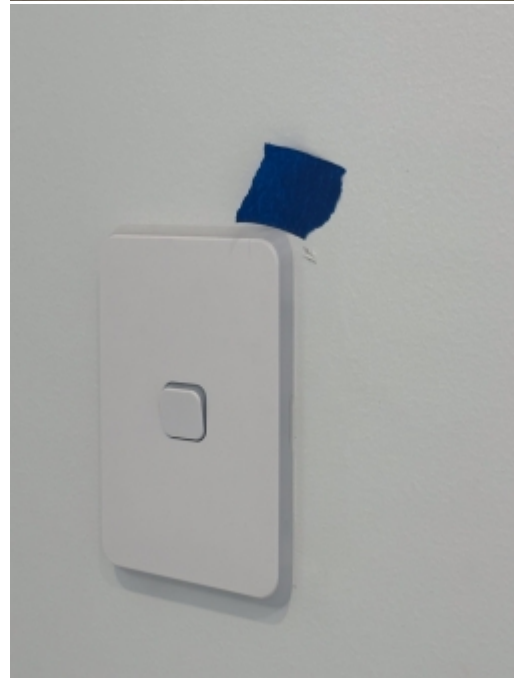
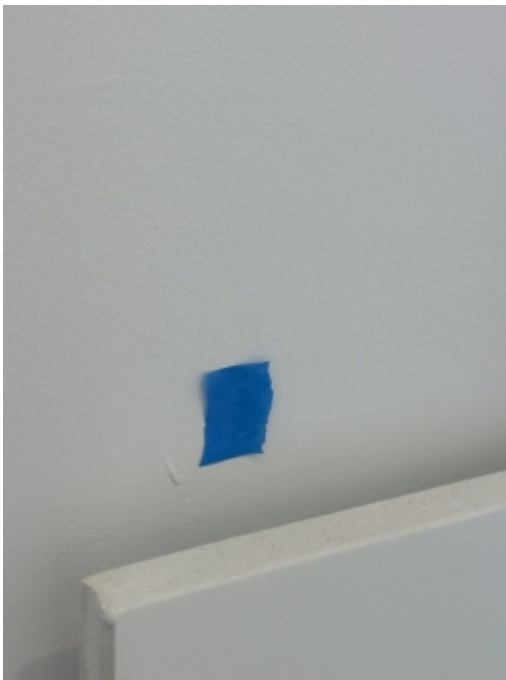
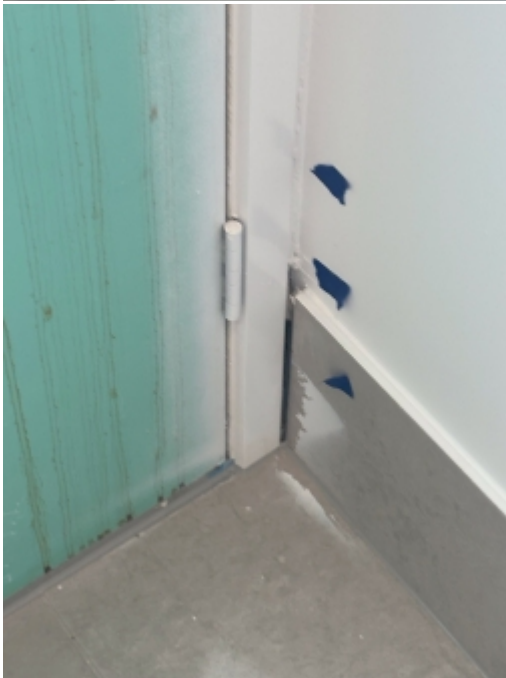
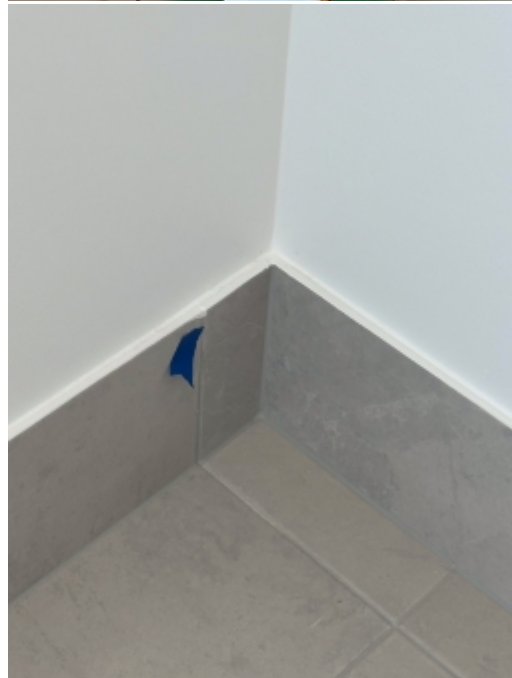
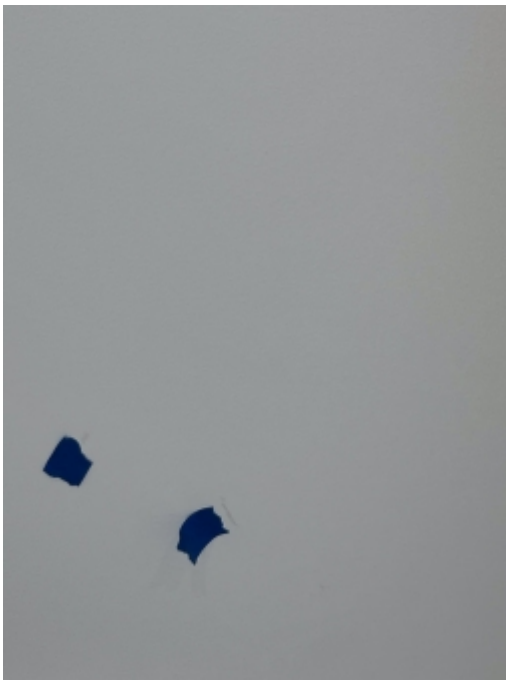
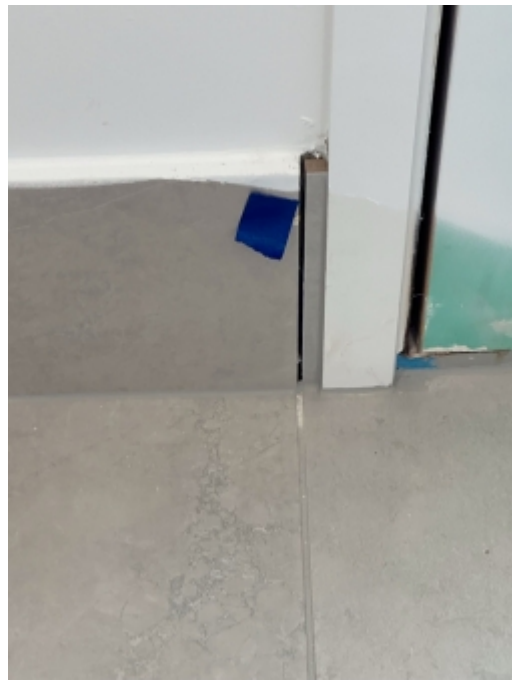
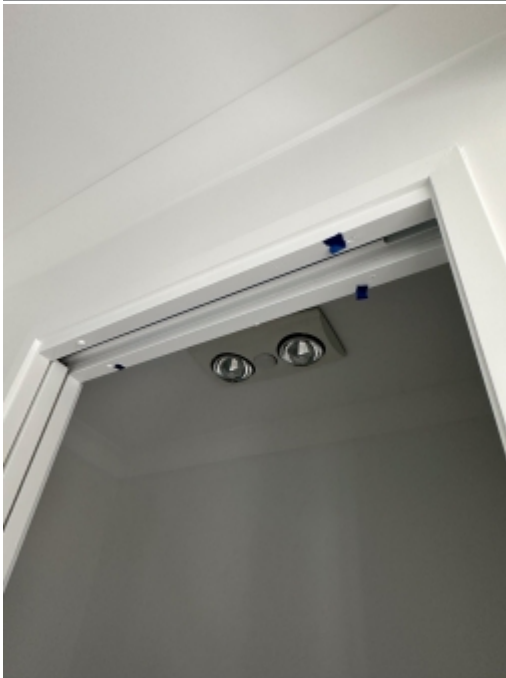
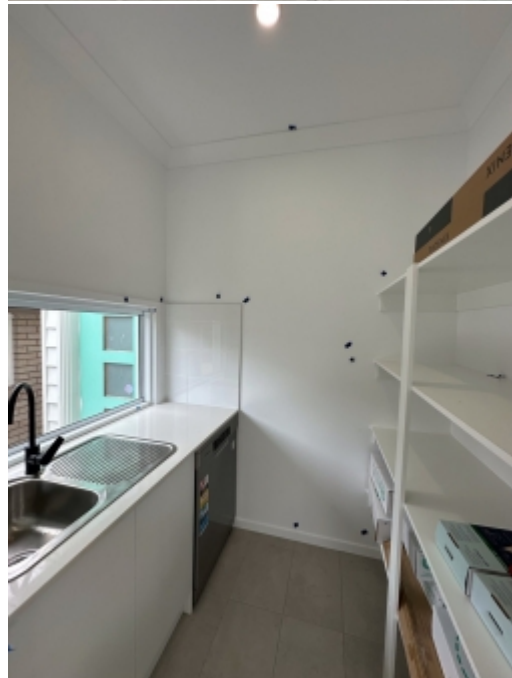
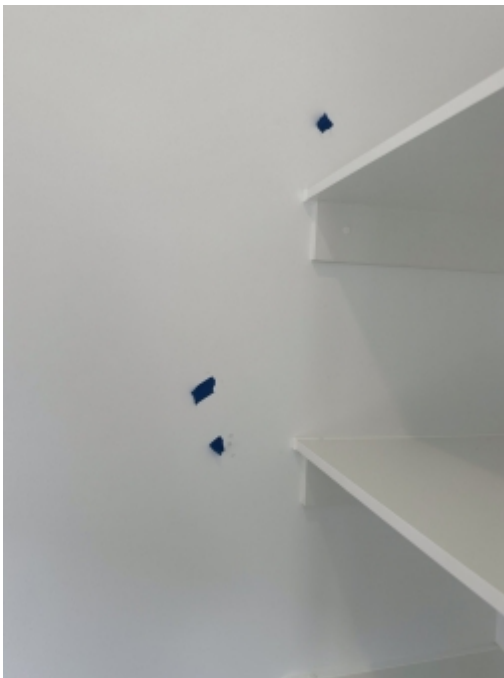
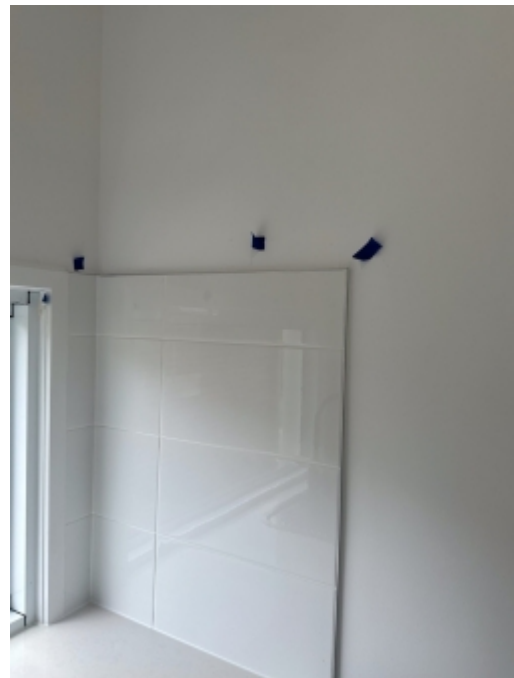
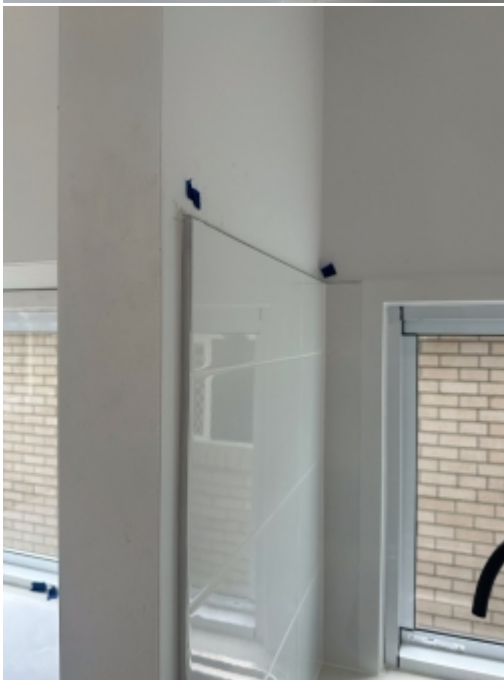
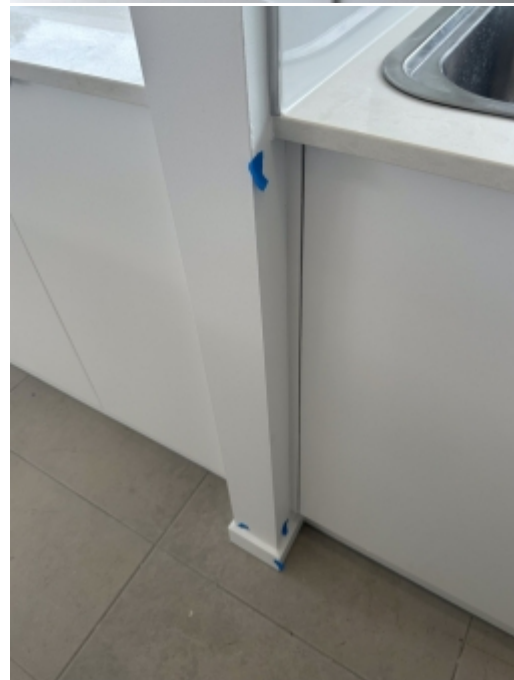
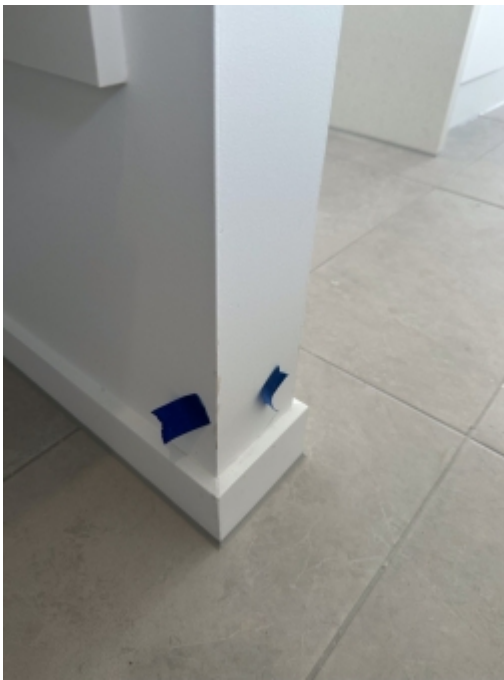
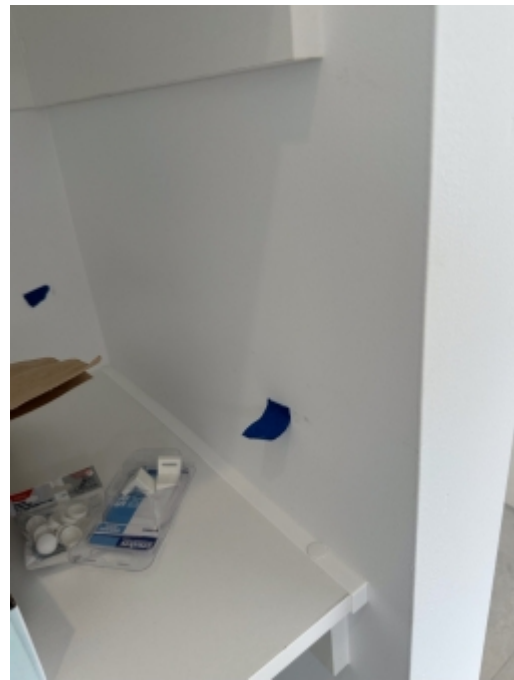
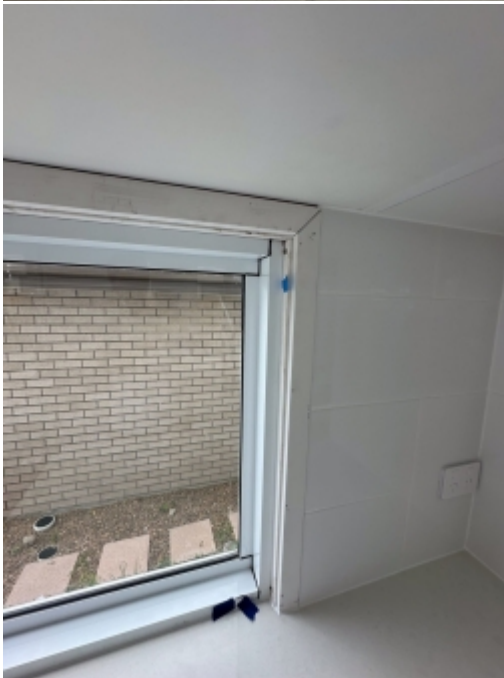
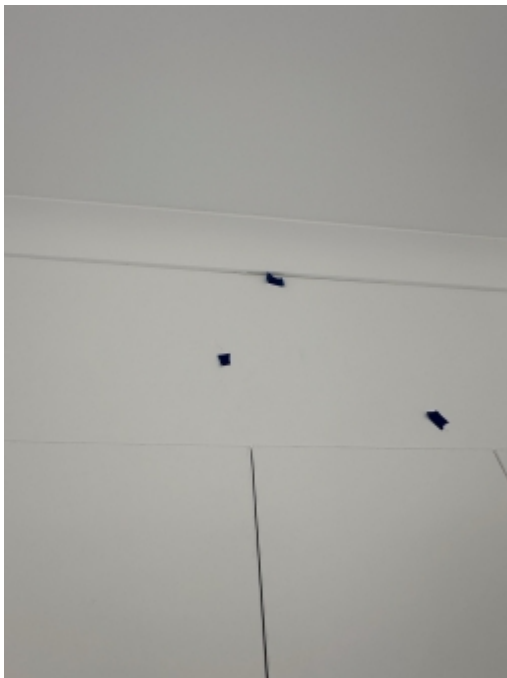
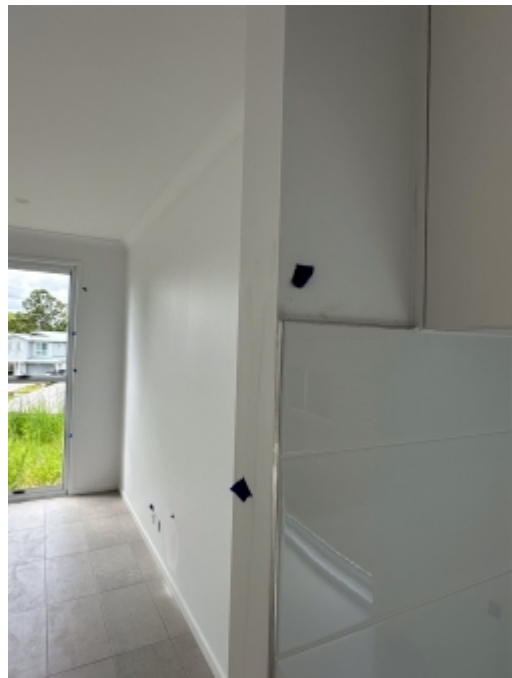
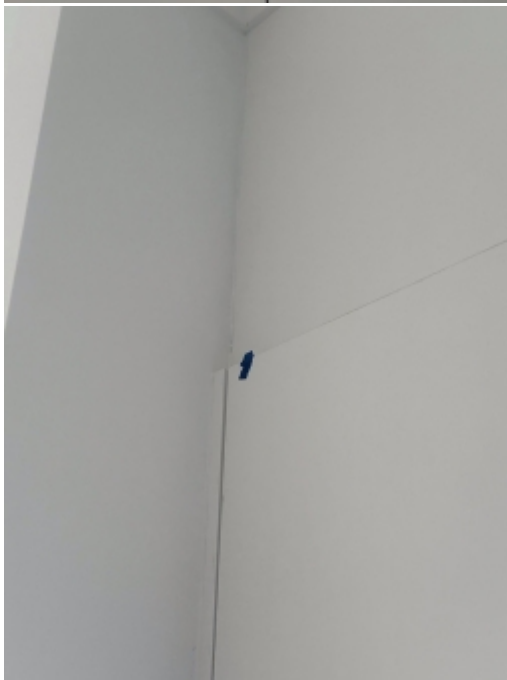
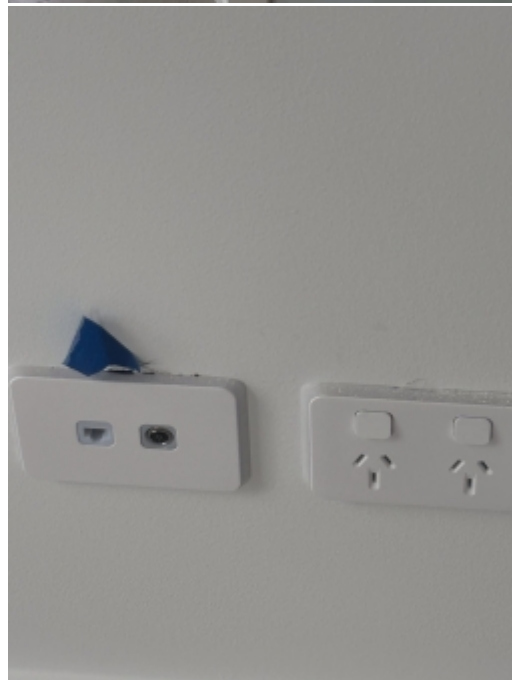
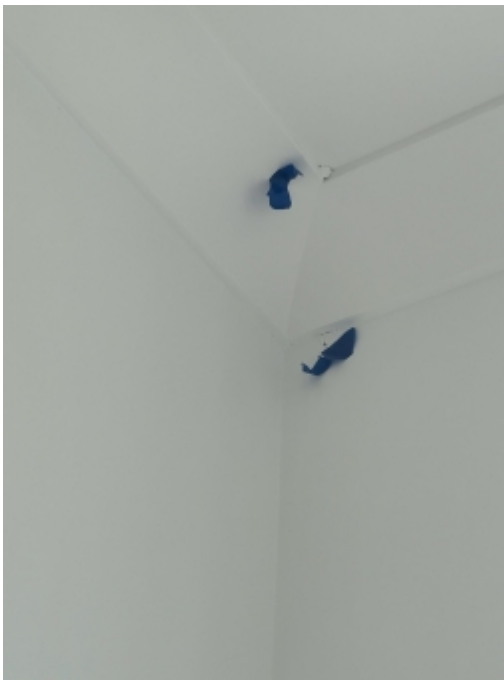
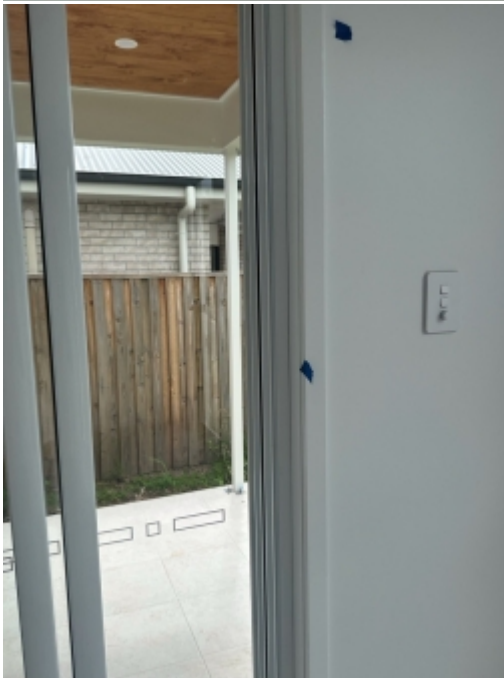
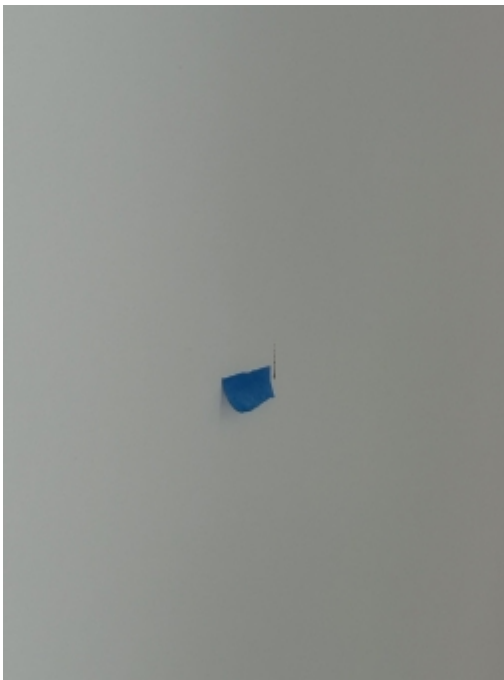
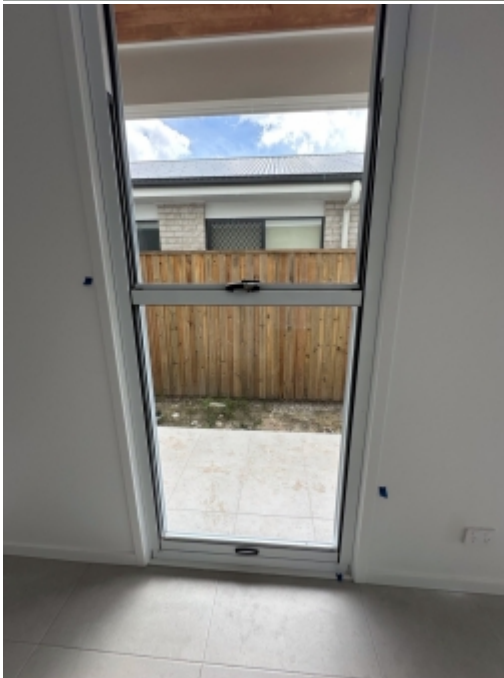
Photo Comments	Showing examples of defective paintwork to the downstairs common areas
Photo

- Paintwork is defective in several areas and marked by flagging tape. These defects must be fixed prior to the handover. Photos may not be showing all relevant areas. Builder to check the paintwork again through the dwelling.
- Removing of construction debris, removing stickers on windows and appliances, cleaning windows inside and outside are required prior to the Handover.
- Missing cavity door tract to the Powder room
- Loose door handle to Master bedroom sliding door needs fixing
- Construction debris in the gutters needs removing
- Denting to fascia to the rear side of the garage needs repairing
- Rust to post plates to the Alfresco needs repairing
- Ducted Ac unit not secured to the slab needs fixing

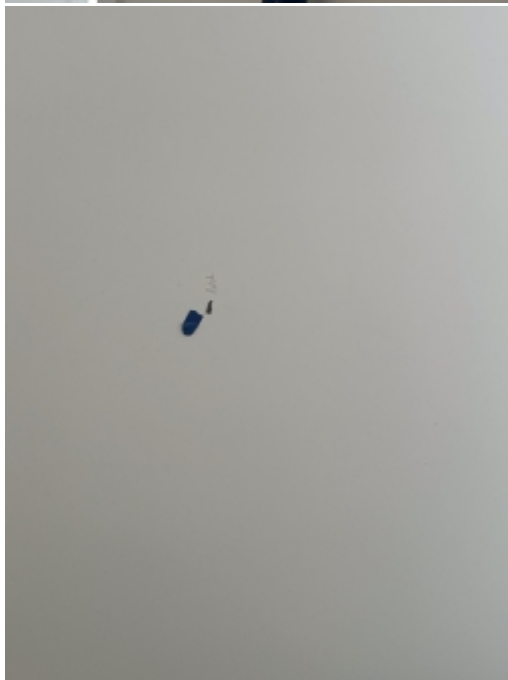
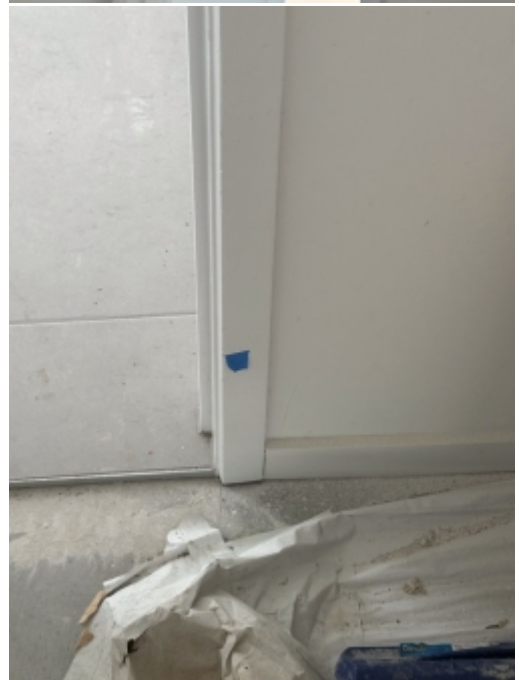
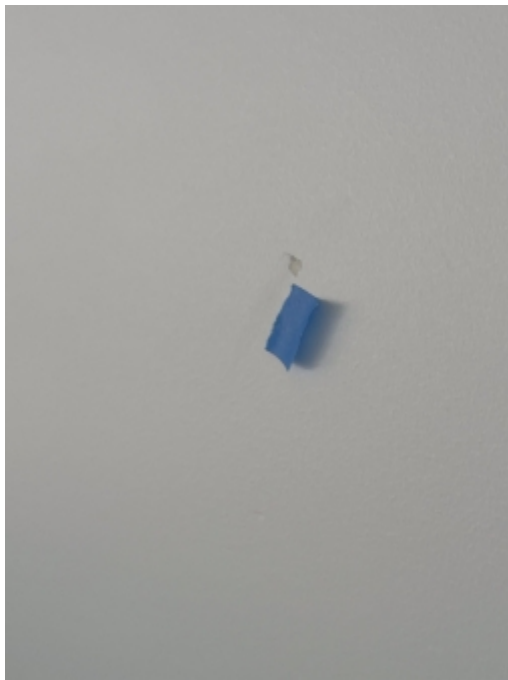
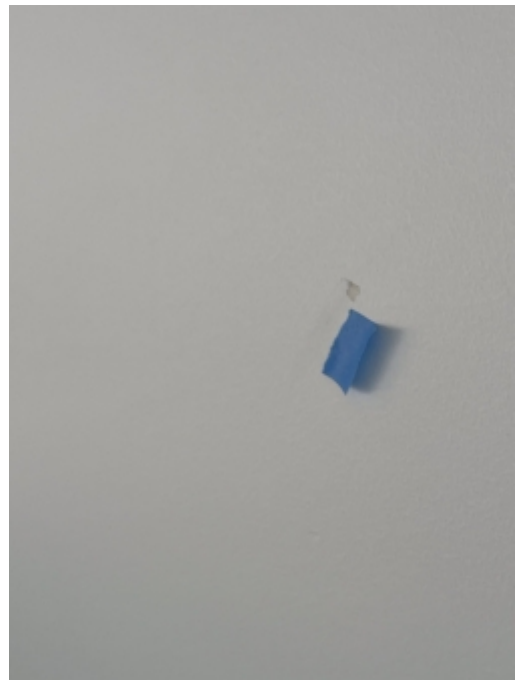
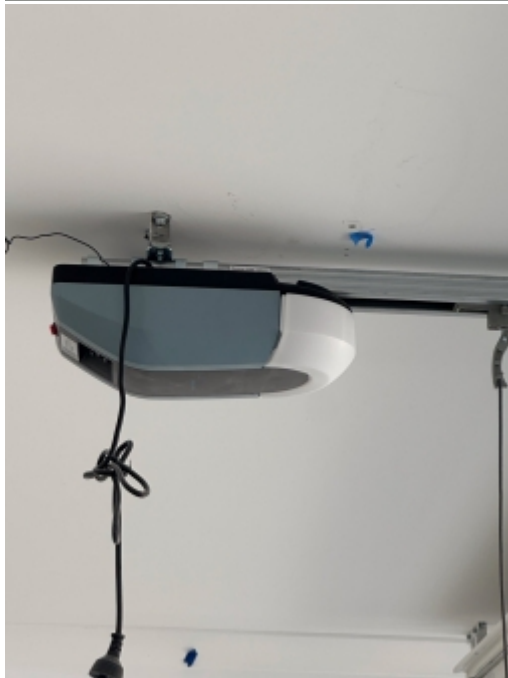
Showing examples of defective paintwork to the garage

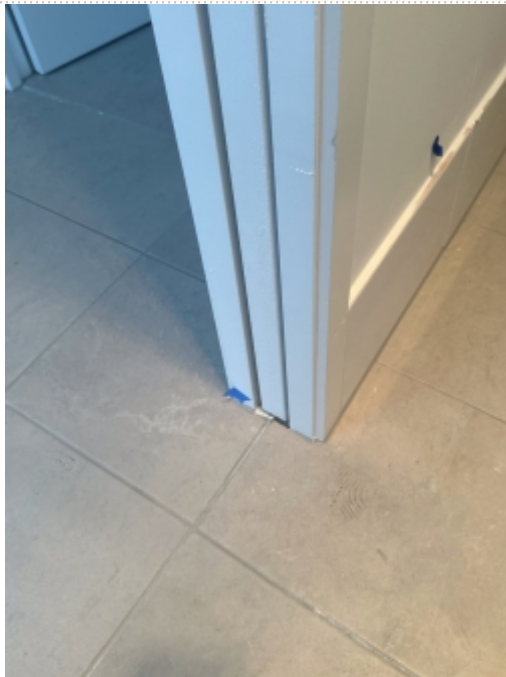
Showing missing cavity door tract to the separate toilet

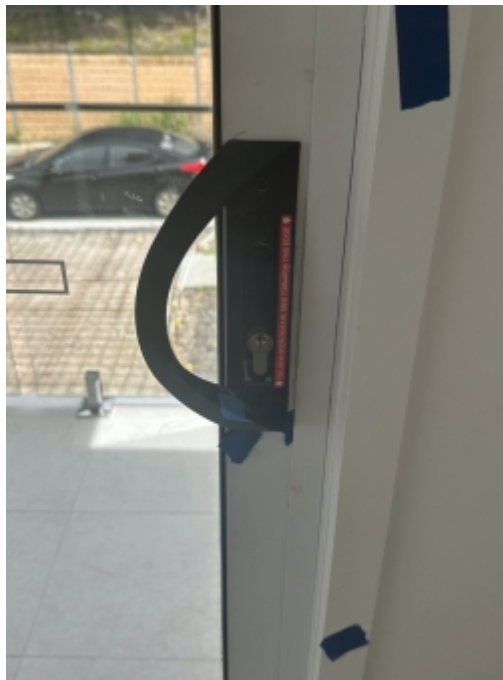
Showing loose door handle to Master bedroom sliding door

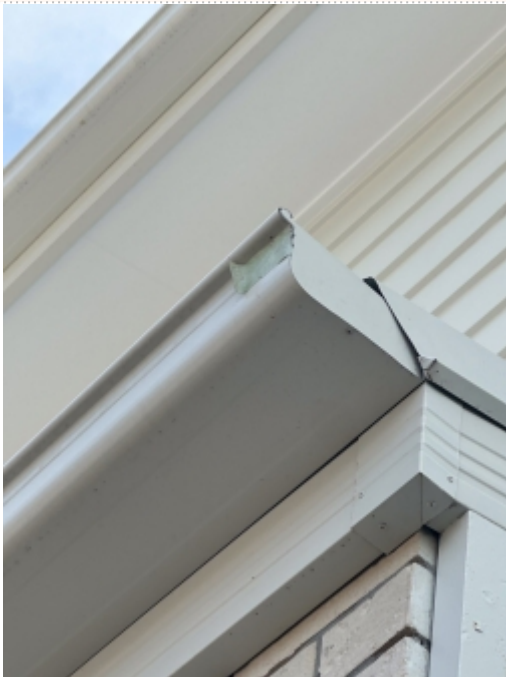
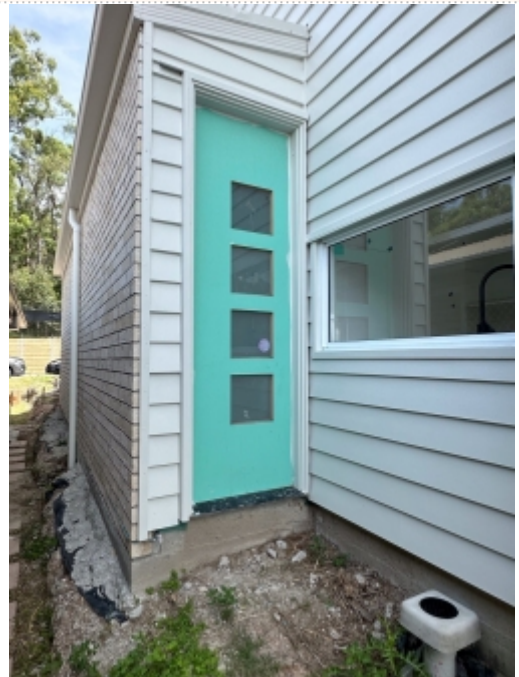
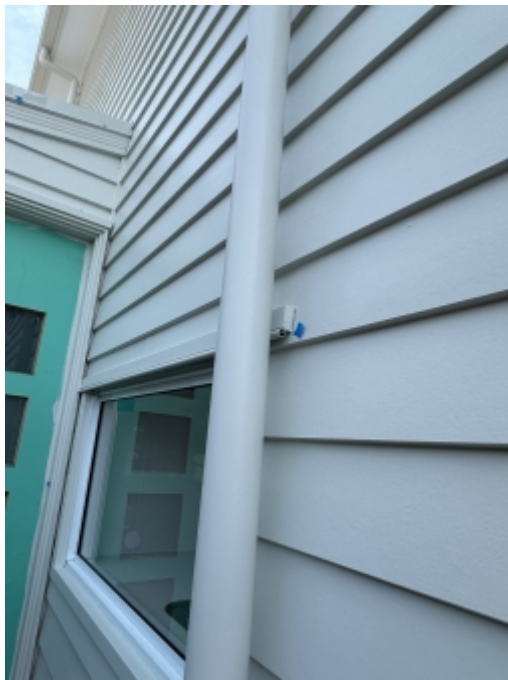
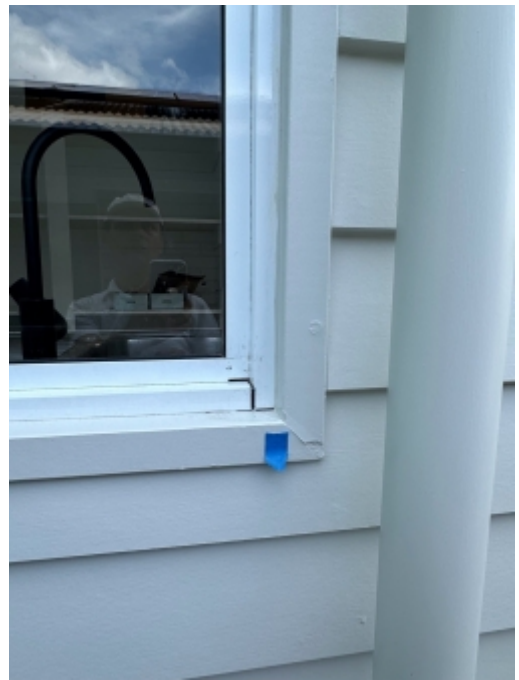
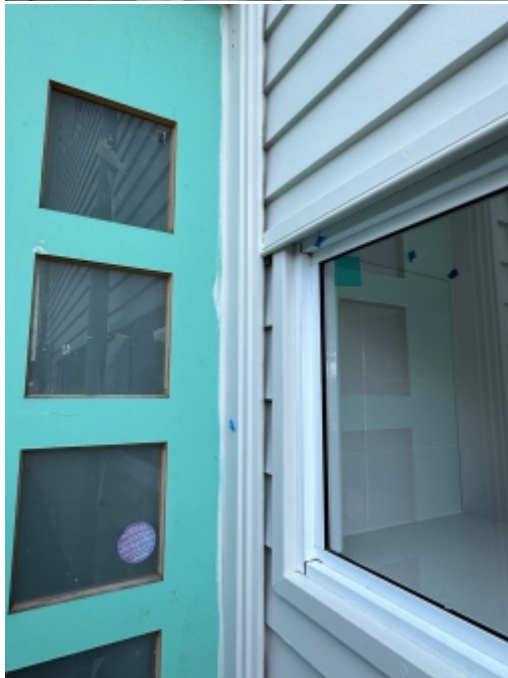
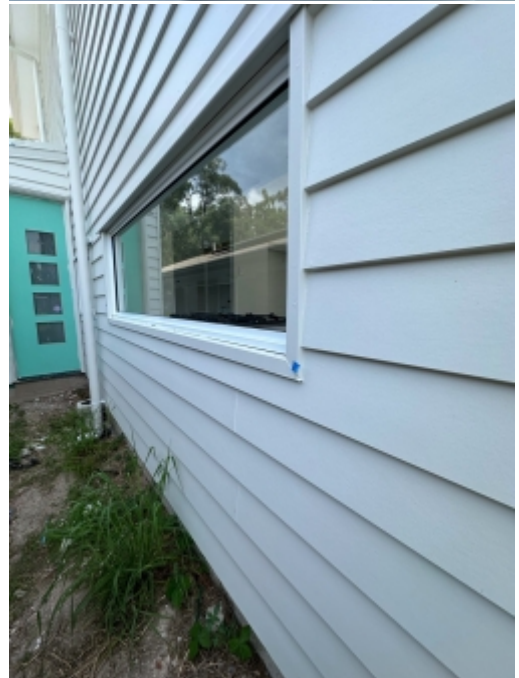
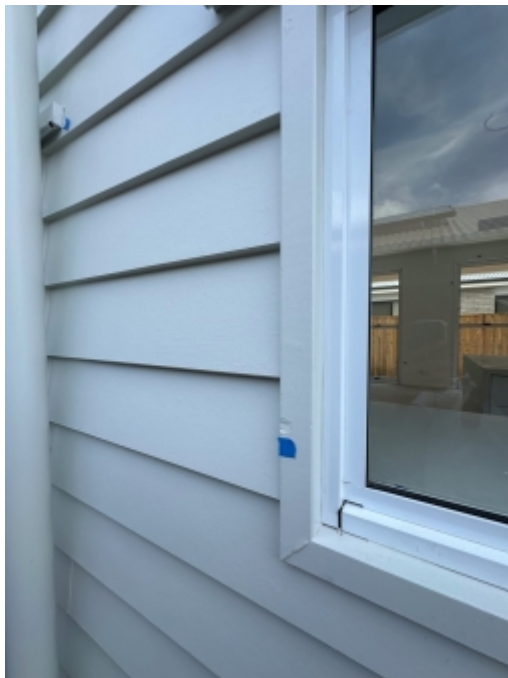
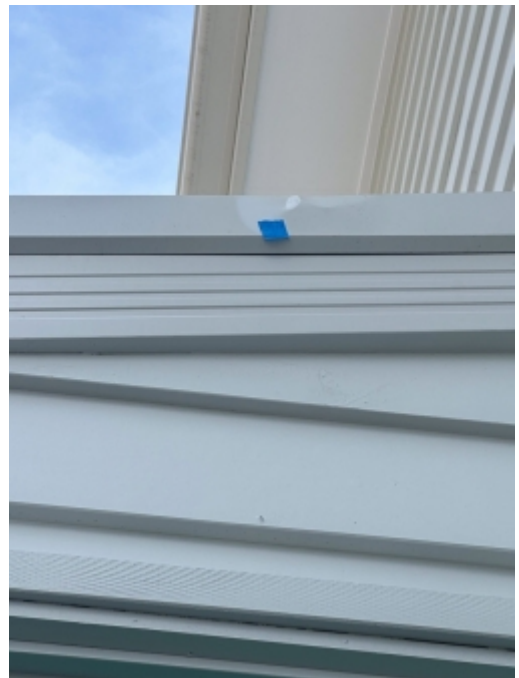
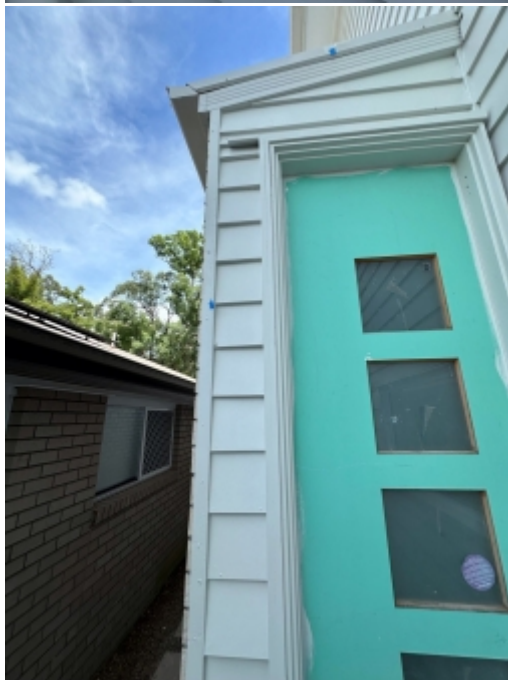
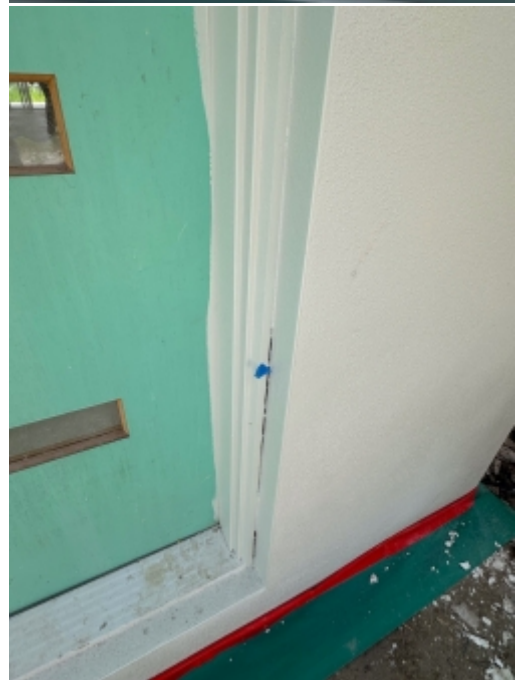
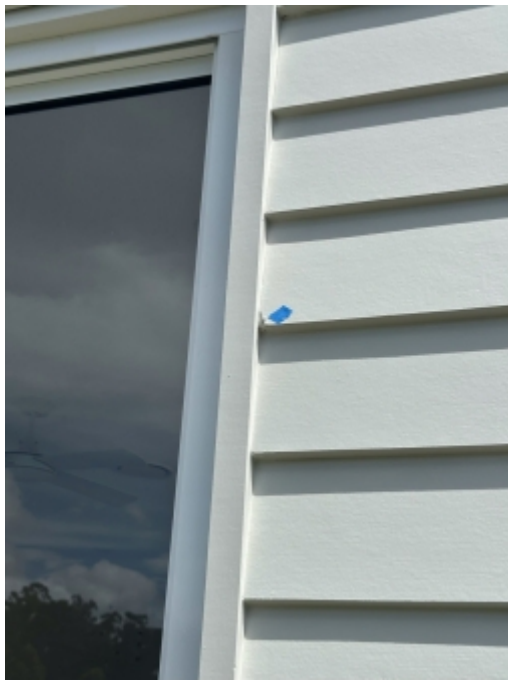
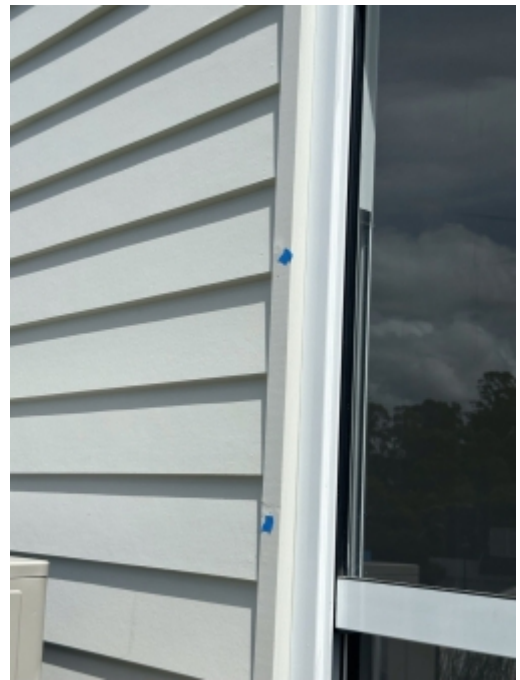
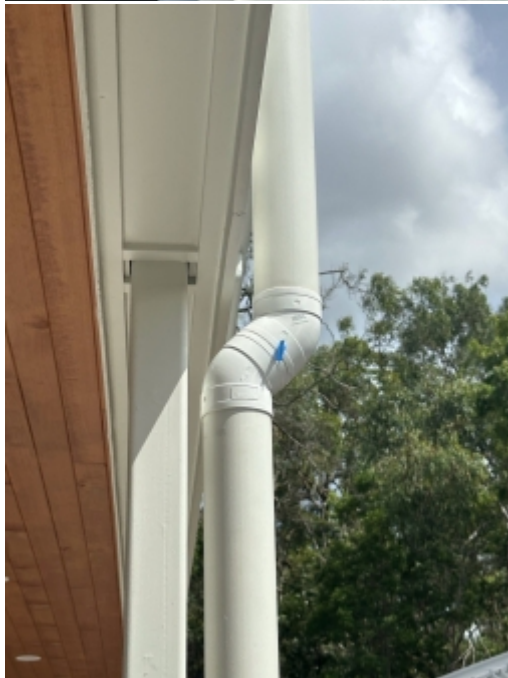
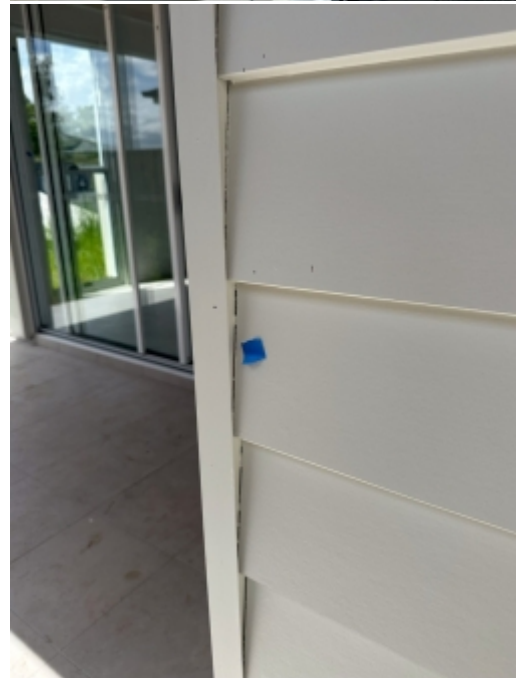
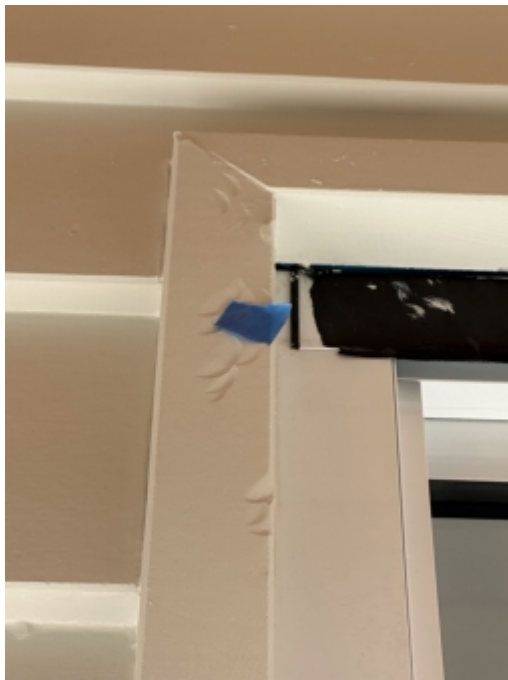
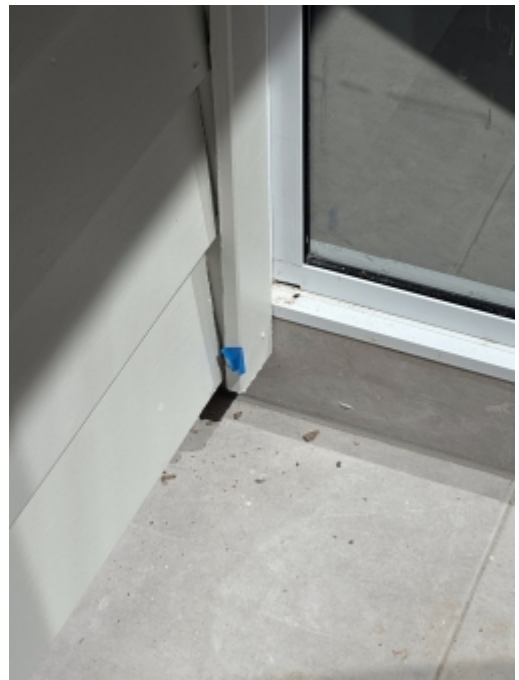
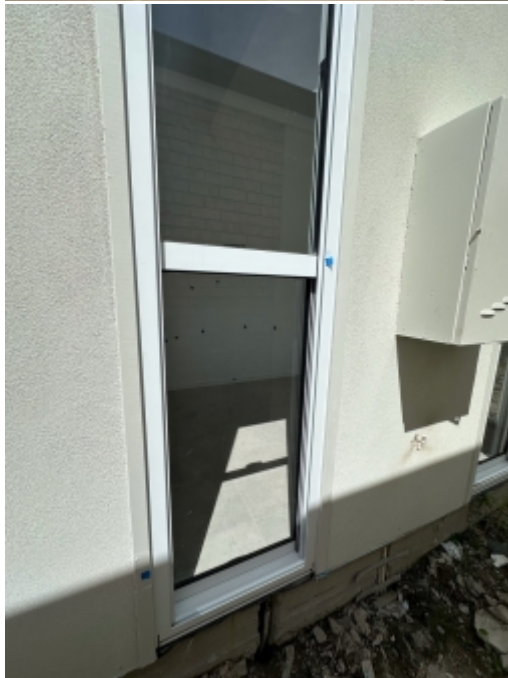
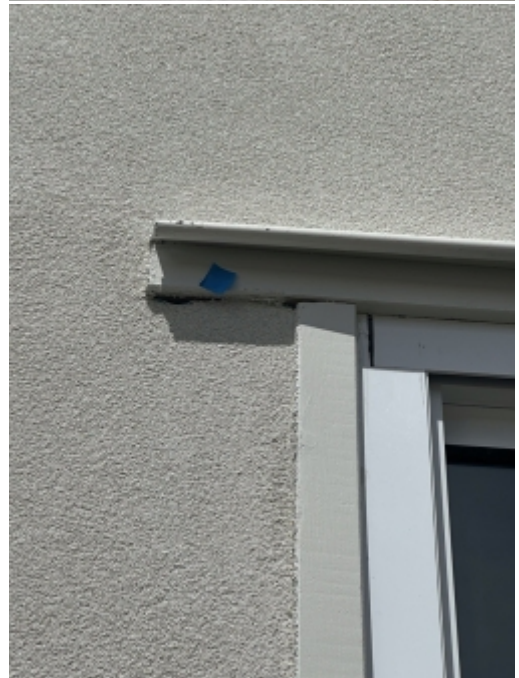
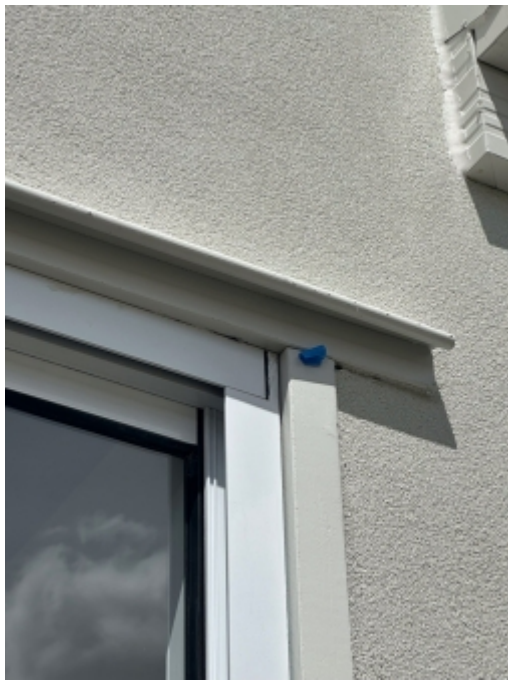
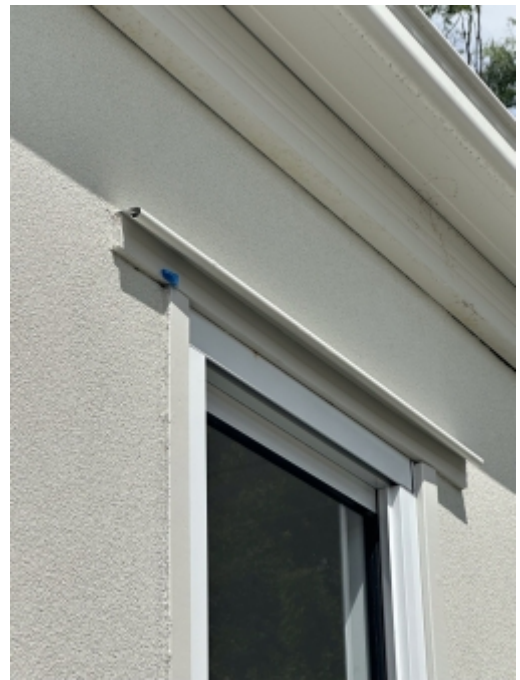
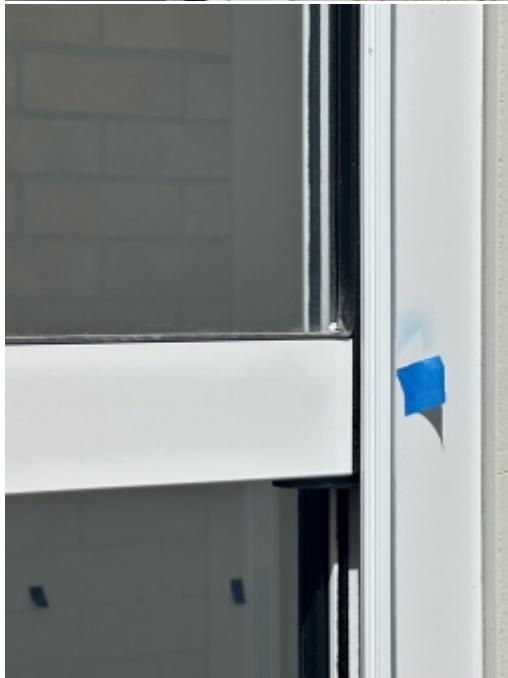
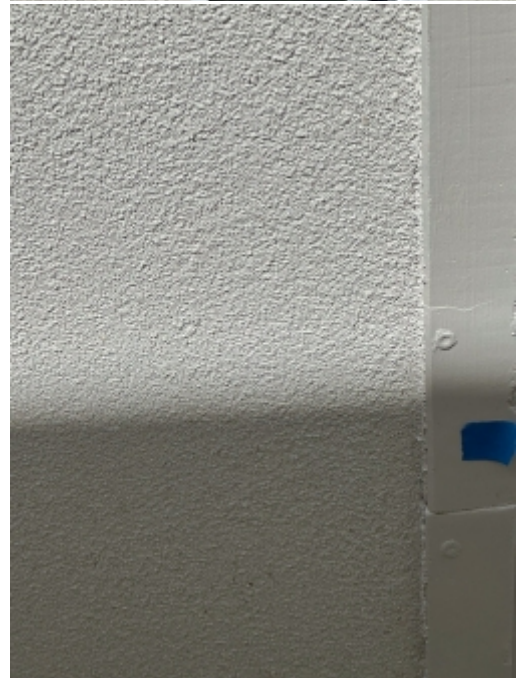
Showing examples of defective paintwork to the house external

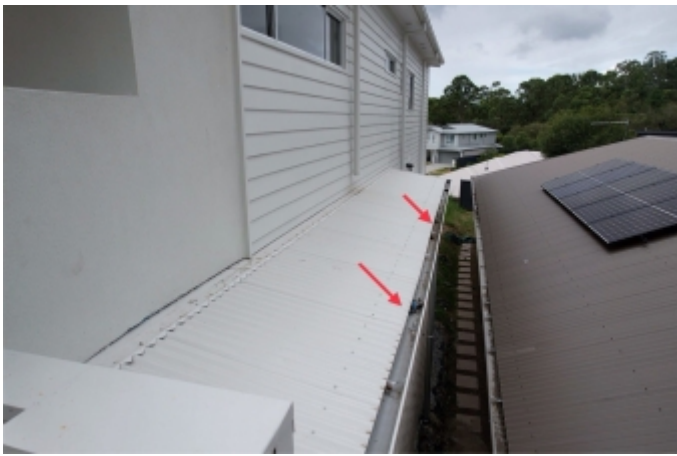
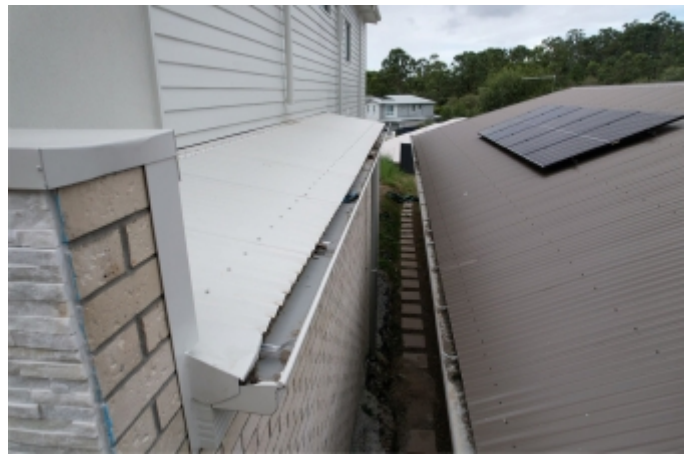
Showing construction debris in the gutters

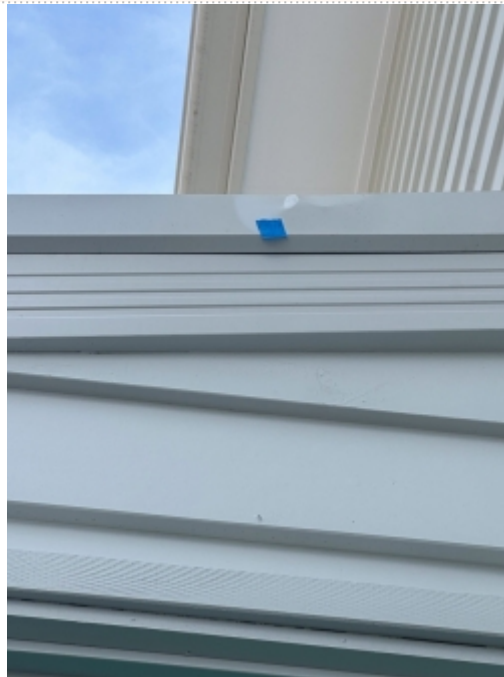
Showing denting to fascia to the rear side of the garage

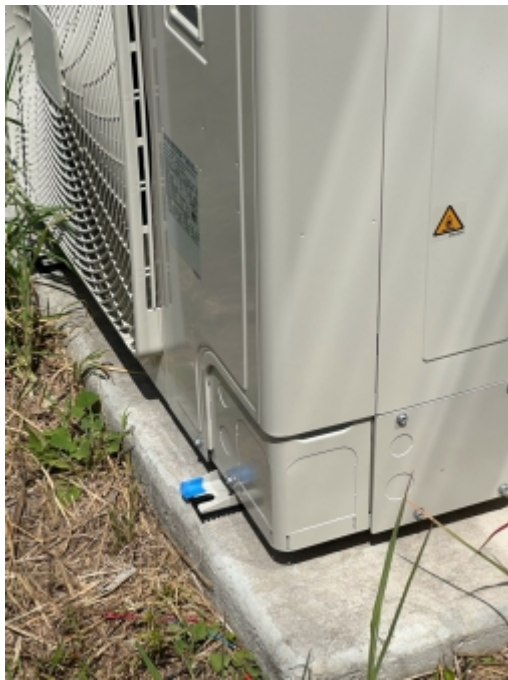
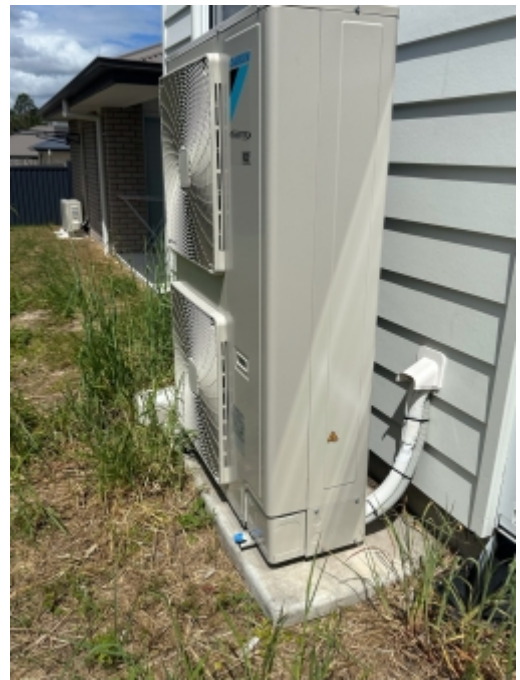
Showing Ducted Ac unit not secured to the slab

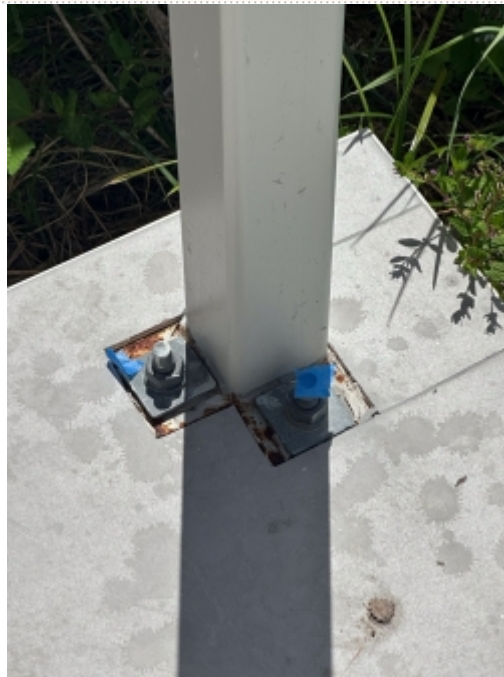
Showing rust to post plates to the Alfresco
