Pre-Purchase Standard Property & Timber Pest Report

9 Ruthenberg Street Lowood 4311 Queensland Australia

15 Jun 2023

Report number:	ABP01341
Inspection Date:	15 Jun 2023
Property Address	9 Ruthenberg Street Lowood 4311 Queensland Australia

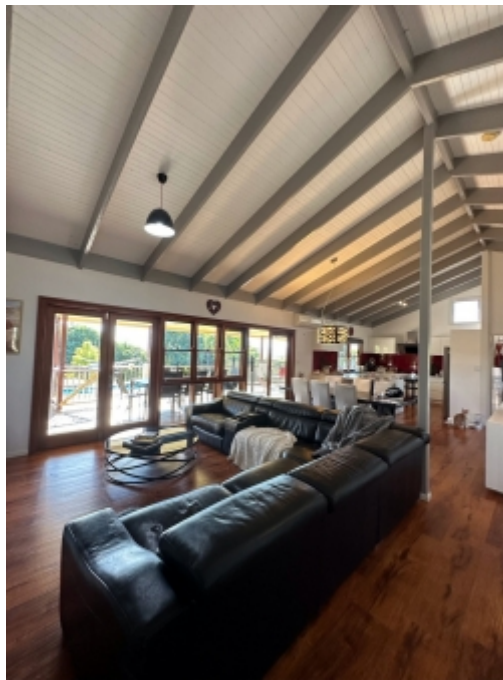
Photo of Obstruction

Showing an example of furniture, floor covering, stored goods, walls, and ceiling linings

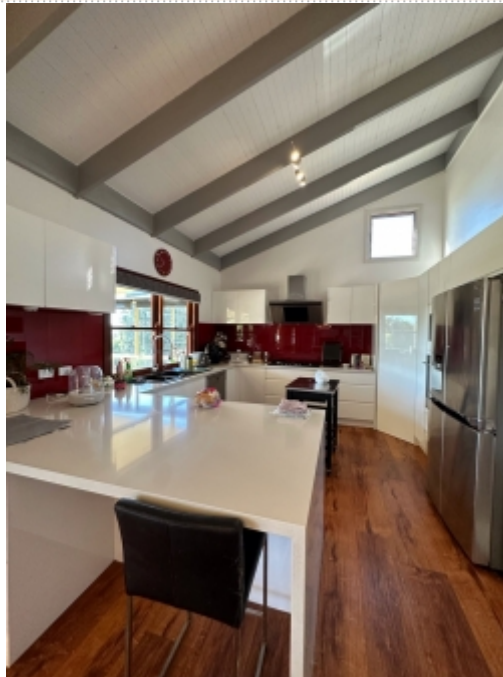
Photo of Obstruction

Showing an example of cabinetry

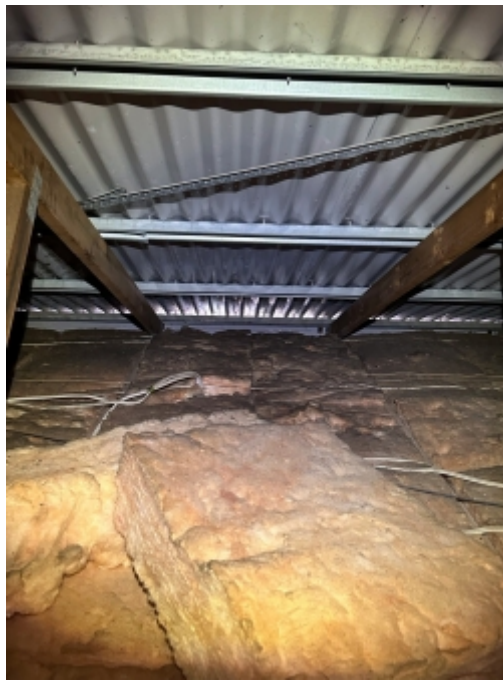
Photo of Obstruction

Showing an example of insulation

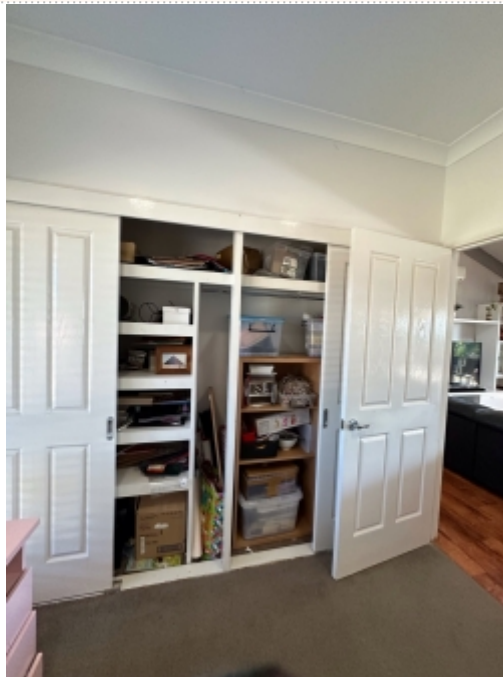
Photo of Obstruction

Showing an example of stored goods

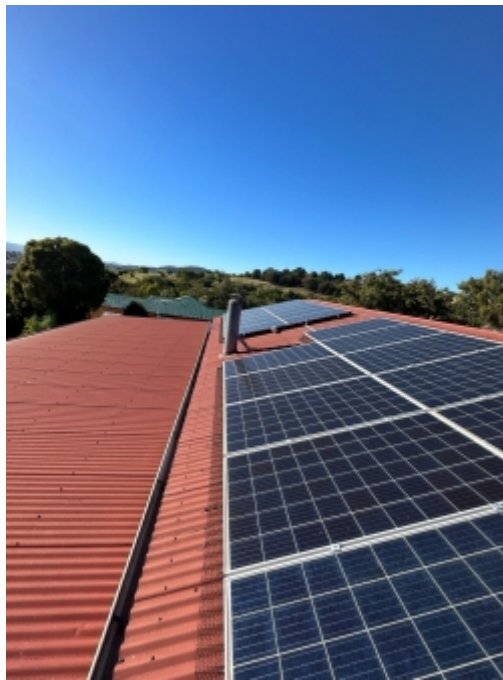
Photo of Obstruction

Comments on Obstructions: Showing an example of solar panels
