SI - SDA STAGE - Stage Inspection Report

08 Feb 2024

Email Report To:	info@articon.com.au
Report Number:	APCI01531
Inspection Date:	08 Feb 2024
Address of the Property Inspected:	lot 8735/84 Barham Way Spring Mountain 4300 Queensland Australia
Photo of Property

Inspection Type: Frame

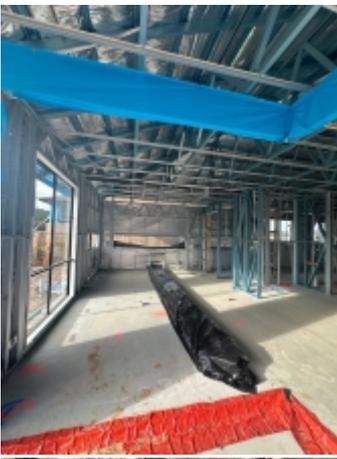
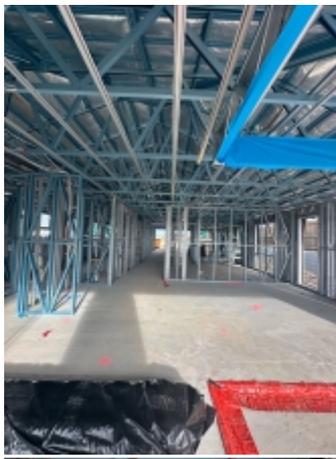
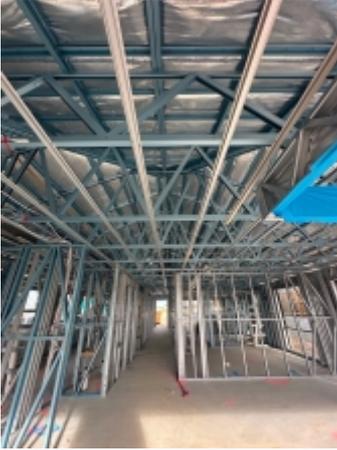
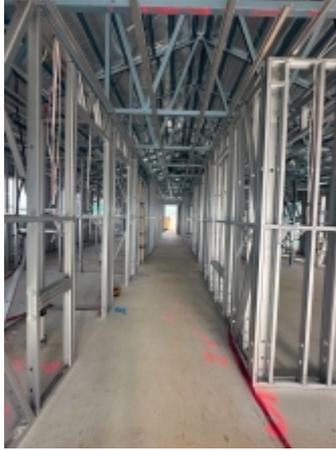
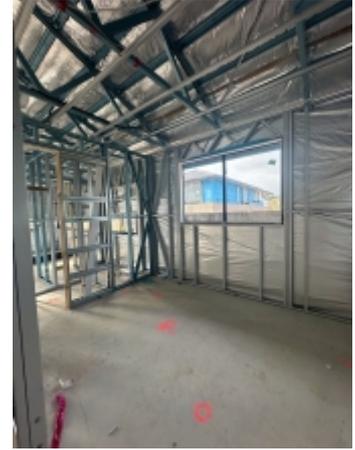
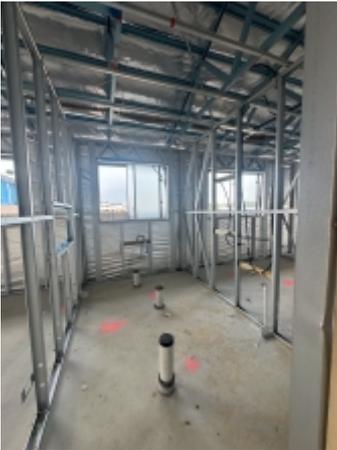
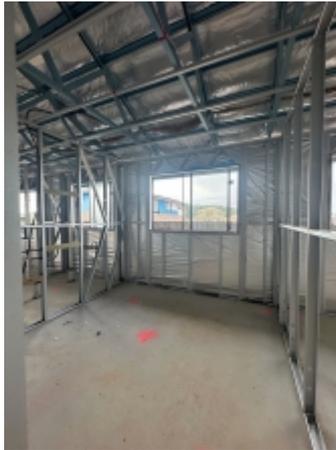
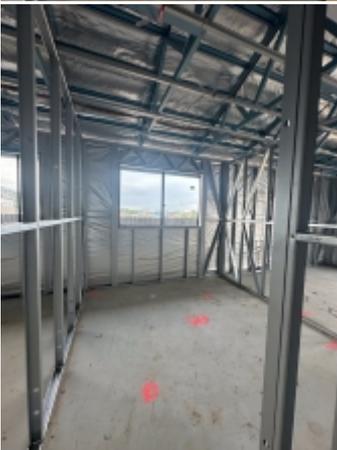
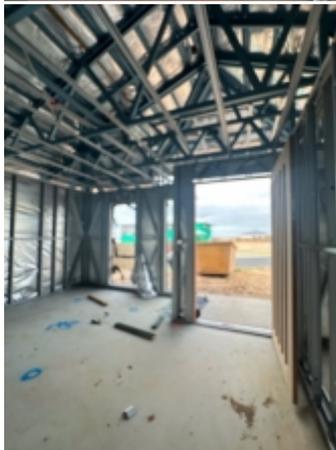
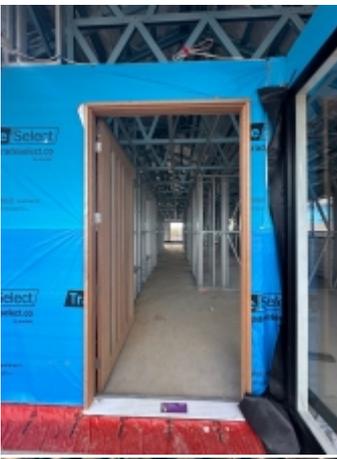
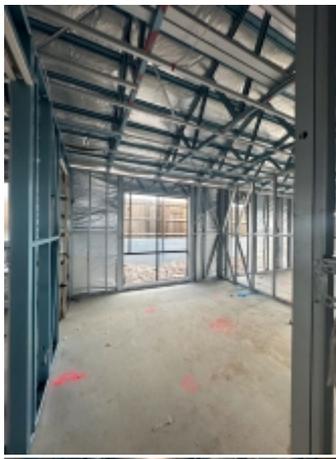
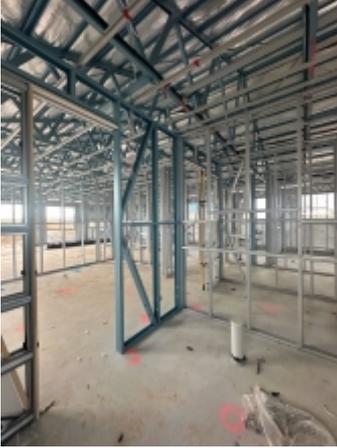
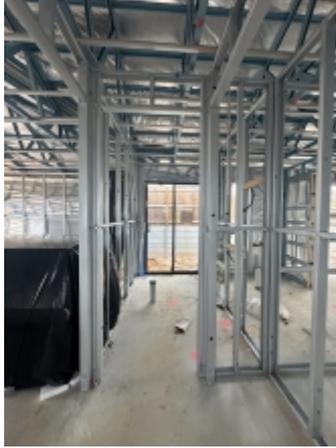
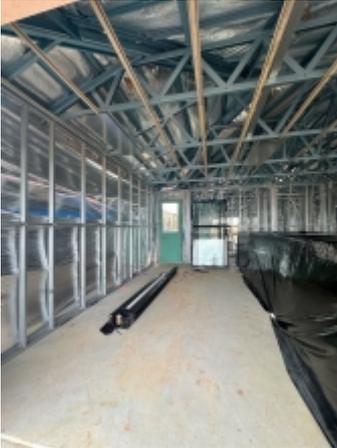
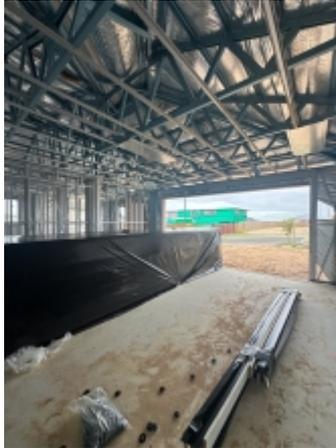
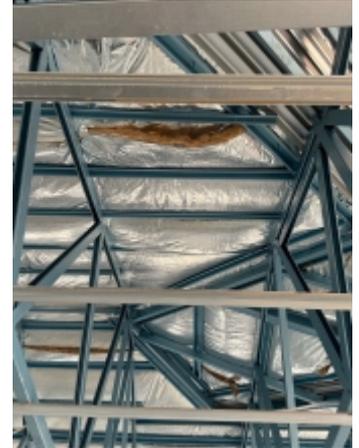
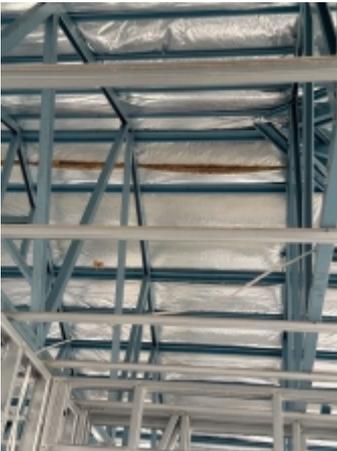
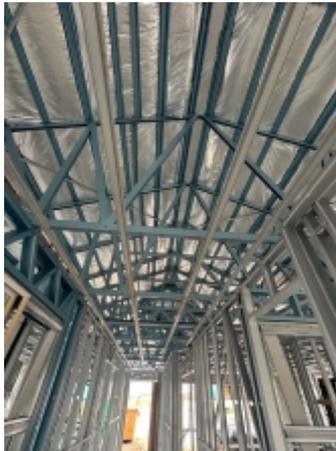
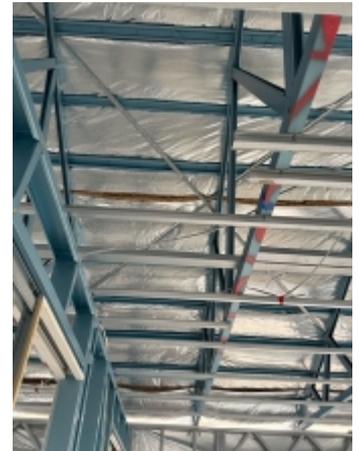
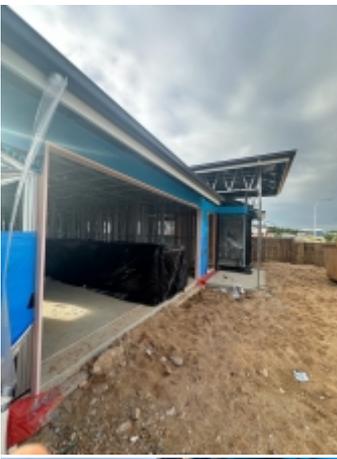
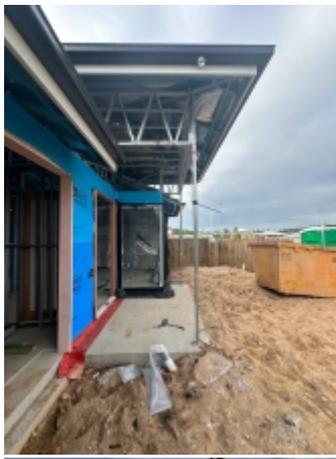
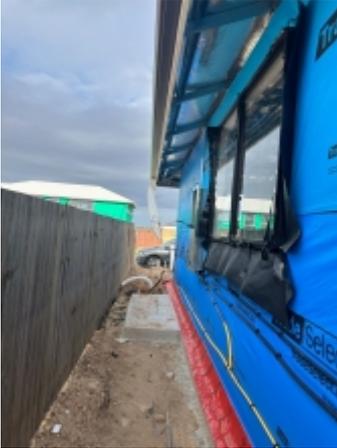
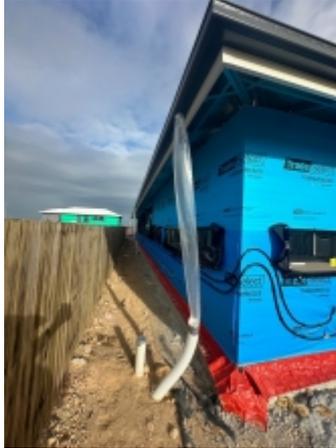
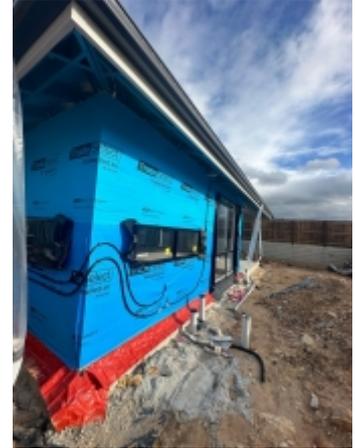
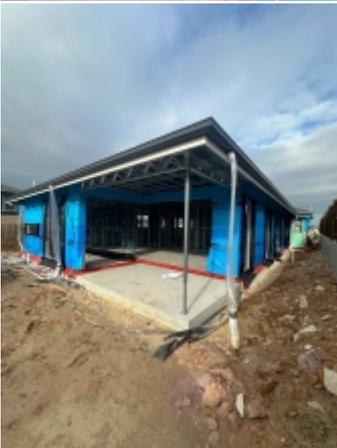
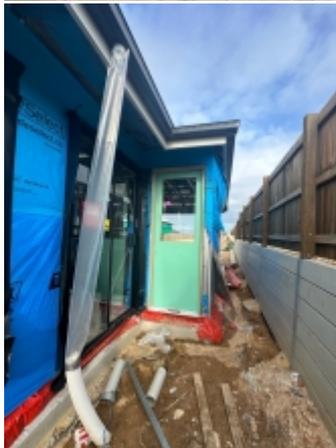
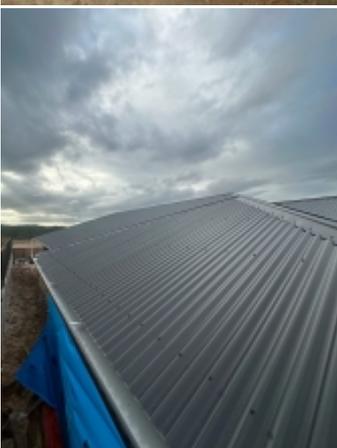
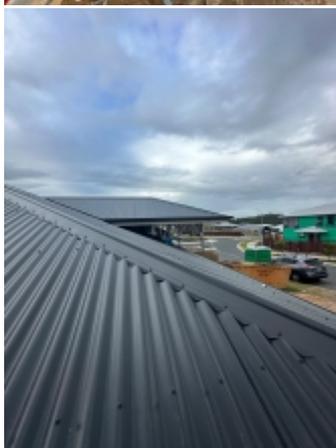
Showing a general view of the property at the time of the inspection
